**ARCHEOLOGICAL OVERVIEW AND ASSESSMENT  
BLOW-ME-DOWN FARM**

**SAINT-GAUDENS NATIONAL HISTORIC SITE  
CORNISH, NEW HAMPSHIRE**

**James Lee, M.A., Principal Investigator  
Eryn Boyce, M.A., Historian**

**JULY 2017**

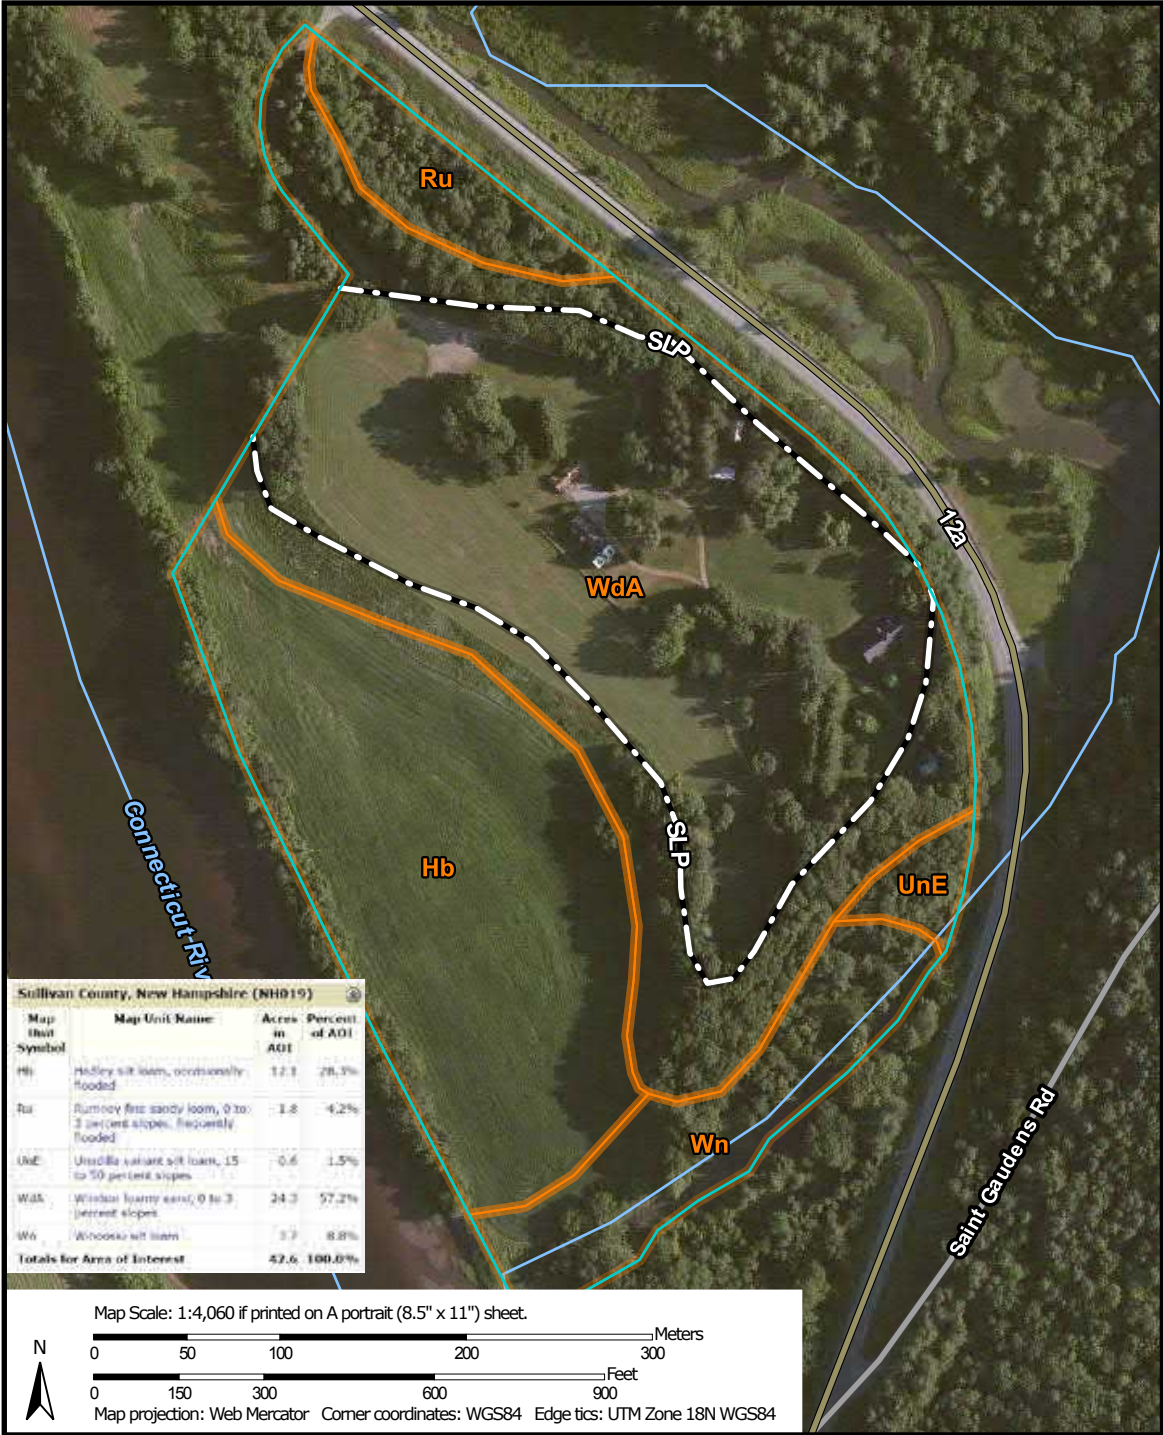
Figure 2.2. Soils Map of the Blow-Me-Down Farm Property. Source: NRCS 2017.

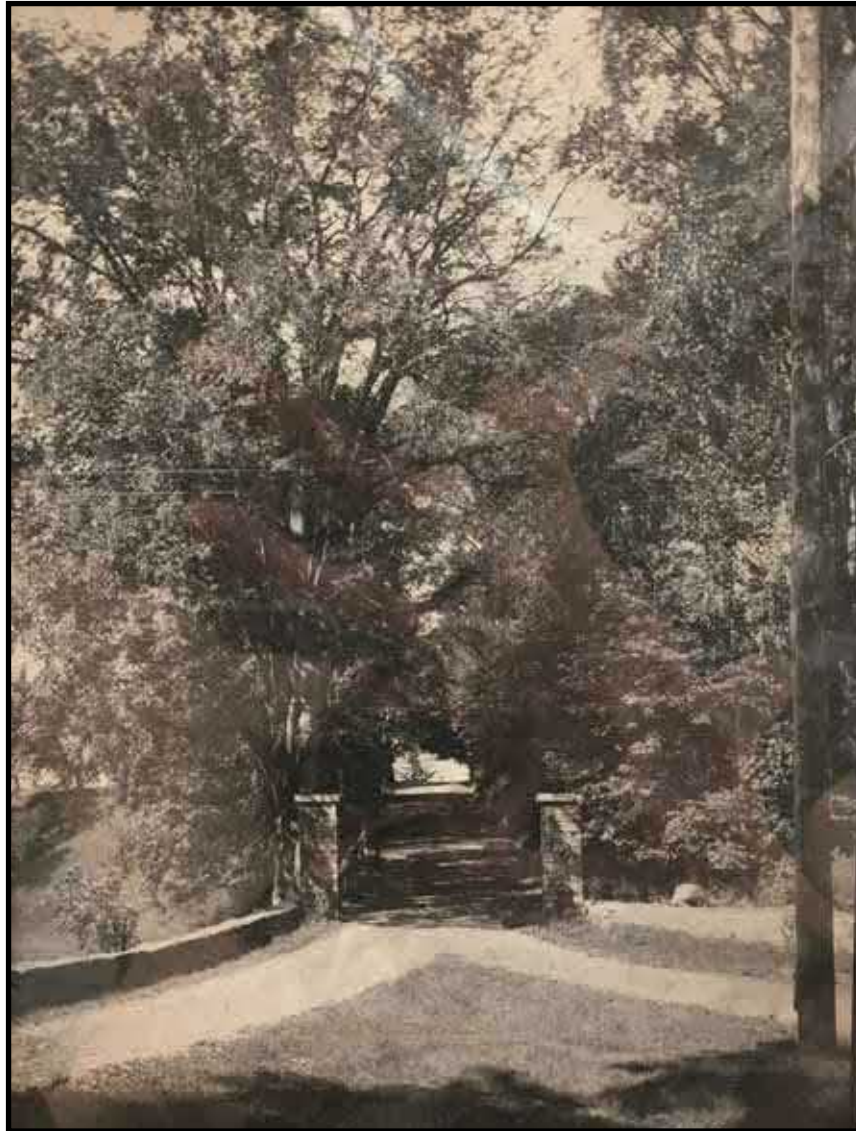
landscape occurred during this period. Landscape architect Ernest Bowditch designed and implemented significant improvements to the driveway system at Blow-Me-Down Farm between 1896 and 1898, and landscape architect/architect Charles Adams Platt designed the stone posts of the gate located on the south driveway, which was erected in the fall of 1898 (Photograph 3.6) (Beaman Family 1884-1917:145, 148; PAL, Inc. 2012:44).

Photograph 3.6. South Gate. Undated. Source: Saint-Gaudens National Historic Site Archives.

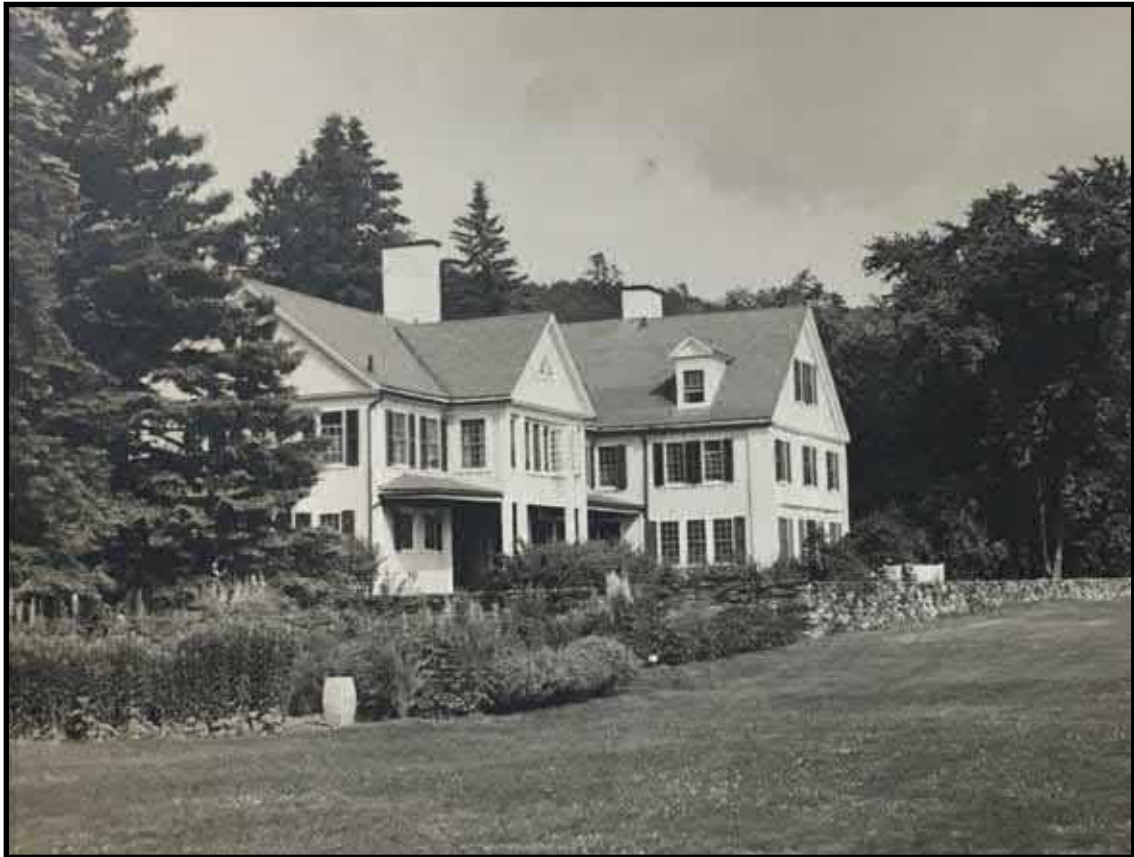
Photograph 3.7. "Casino" after 1927 renovation. Undated. Source: Saint-Gaudens National Historic Site Archives.

Hopkins and Greely to convert the “Casino” into a residence in 1927, while he occupied “Chaseholme” with his family. The firm, which was known for its work in the Colonial Revival style, designed a two-and-a-half-story rear addition that roughly doubled the size of the “Casino” (Photograph 3.7) (Dryfhout 2000:72-73). The bowling alley was detached, moved behind the “Casino” and remodeled into a new ballroom (Photograph 3.8). According to Wade (1976:87), the ballroom was known as the “Reformatory” because it was intended to keep the younger generation of Beamans and their friends from visiting local dance halls that played jazz. A U.S. Geological Survey map from 1929 shows the ballroom and three other buildings, likely the bank barn, the “Casino,” which was renamed “Blow-Me-Down” after the remodel, and “Chauncey Cottage,” arrayed along a driveway west of the River Road (Figure 3.9). Unfortunately, the U.S. Geological Survey map offers little detail and does not include all of the buildings and outbuildings on the property.

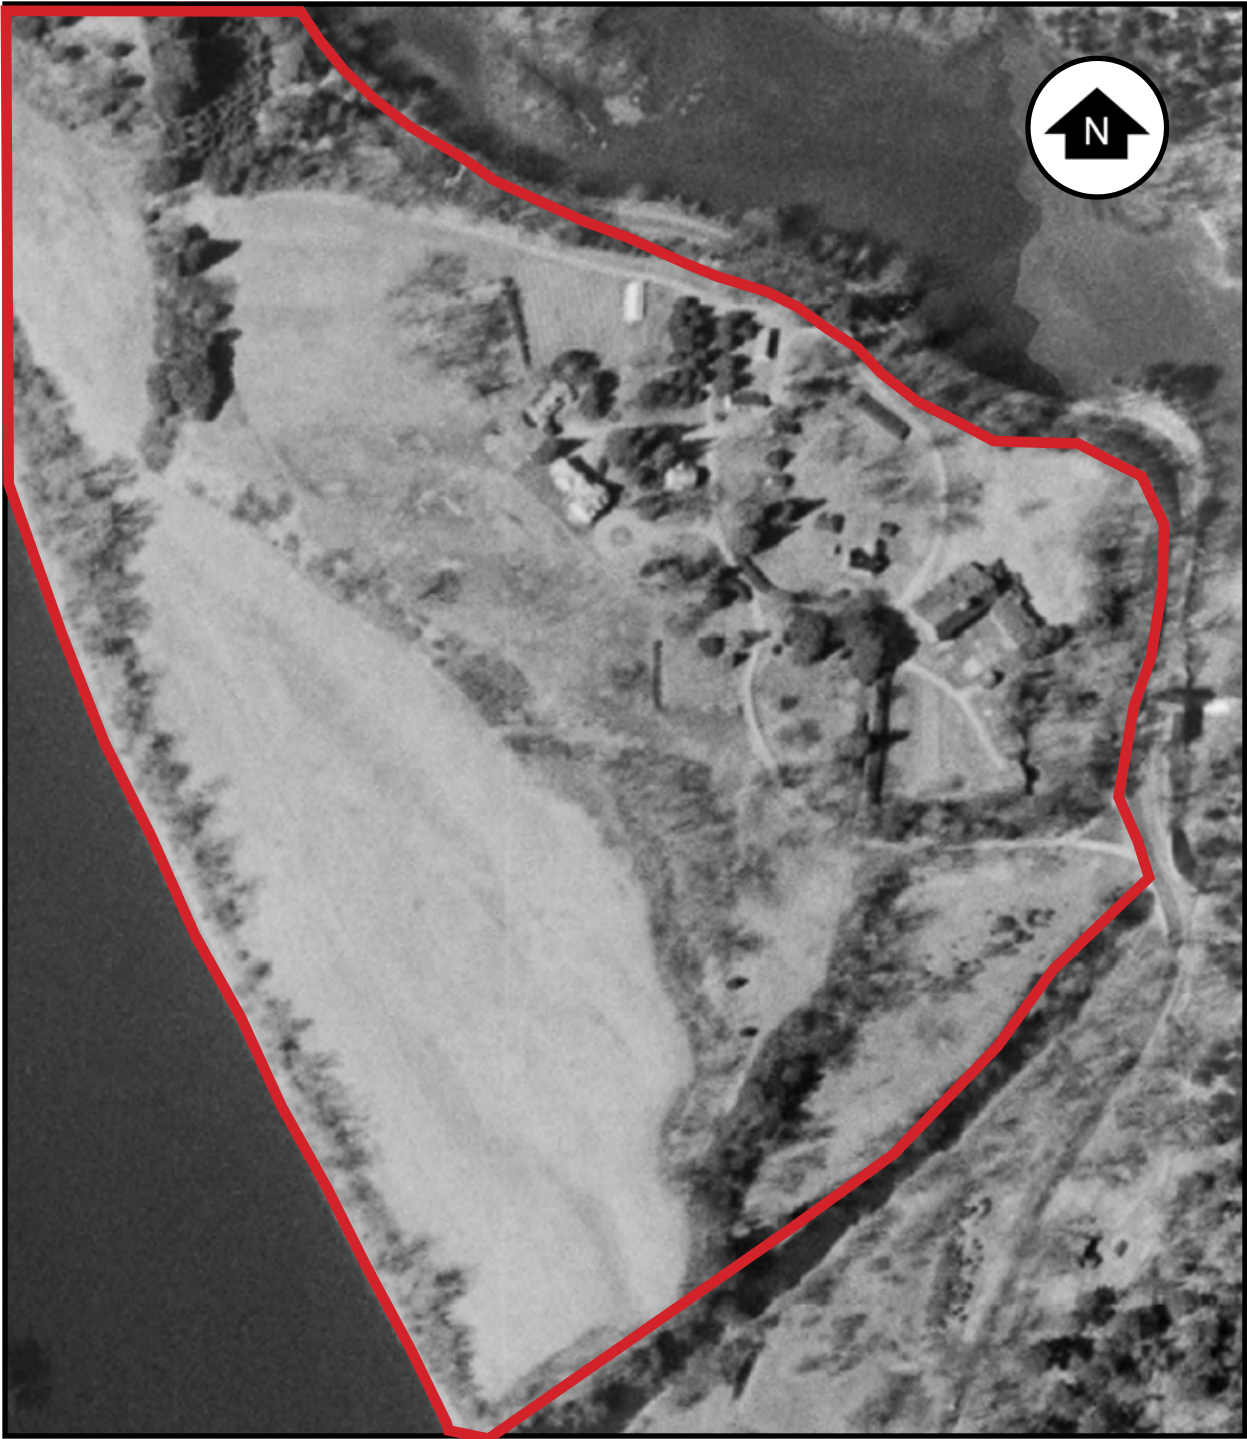
Figure 3.11. Aerial Photograph. 1956. Scale 1 inch = 230 feet (approximately). Location of project site outlined. Source: Nationwide Environmental Title Research 2016.

Bolos & Smith subdivided the properties into a number of parcels and auctioned them off individually. During this process, Bolos & Smith relocated the one-and-a-half-story “Coachman’s House,” which was designed by Daniel Appleton and constructed by Beaman in 1896, to one of the subdivided properties (Dryfhout 2000: 73). Bolos & Smith were likely responsible for demolishing or relocating other buildings from Blow-Me-Down Farm, for an aerial photograph from 1956 shows that all or most of these buildings remained in their original locations during the tenure of James and Elizabeth Campbell Lewis (Figure 3.11).

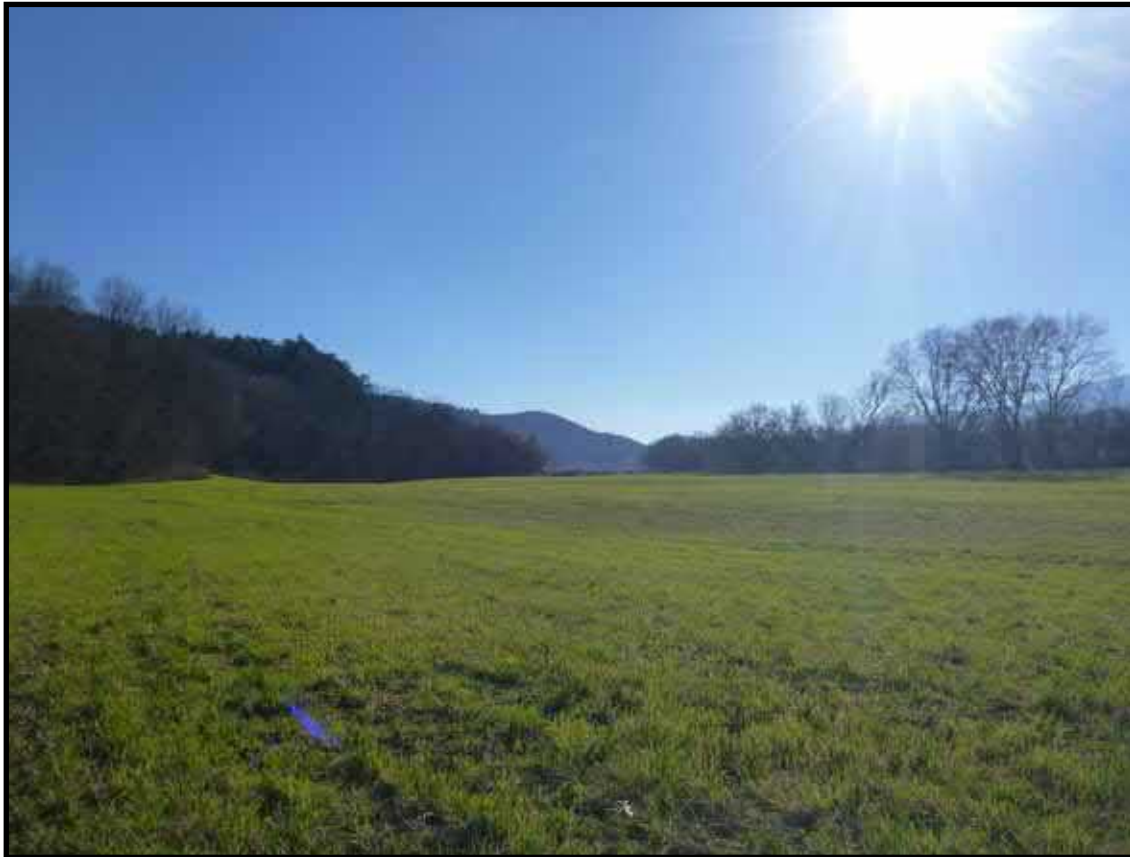
Photograph 6.1. View south showing the southern end of the lower terrace with the Connecticut River visible in the background (photographer: James Lee, November 2016) [HRI Neg.#16048/D2-055].

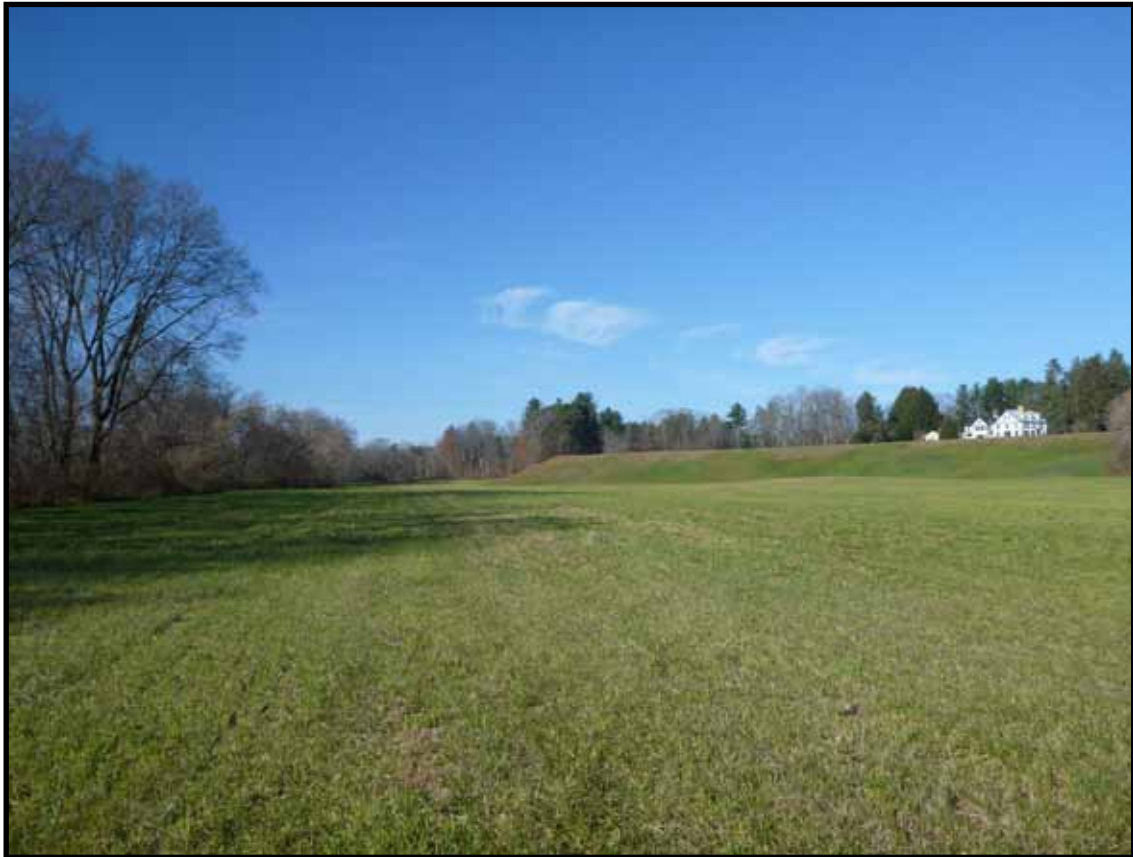
Photograph 6.2. View north showing lower terrace with Casino visible in background (photographer: James Lee, November 2016) [HRI Neg.#16048/D2-075].

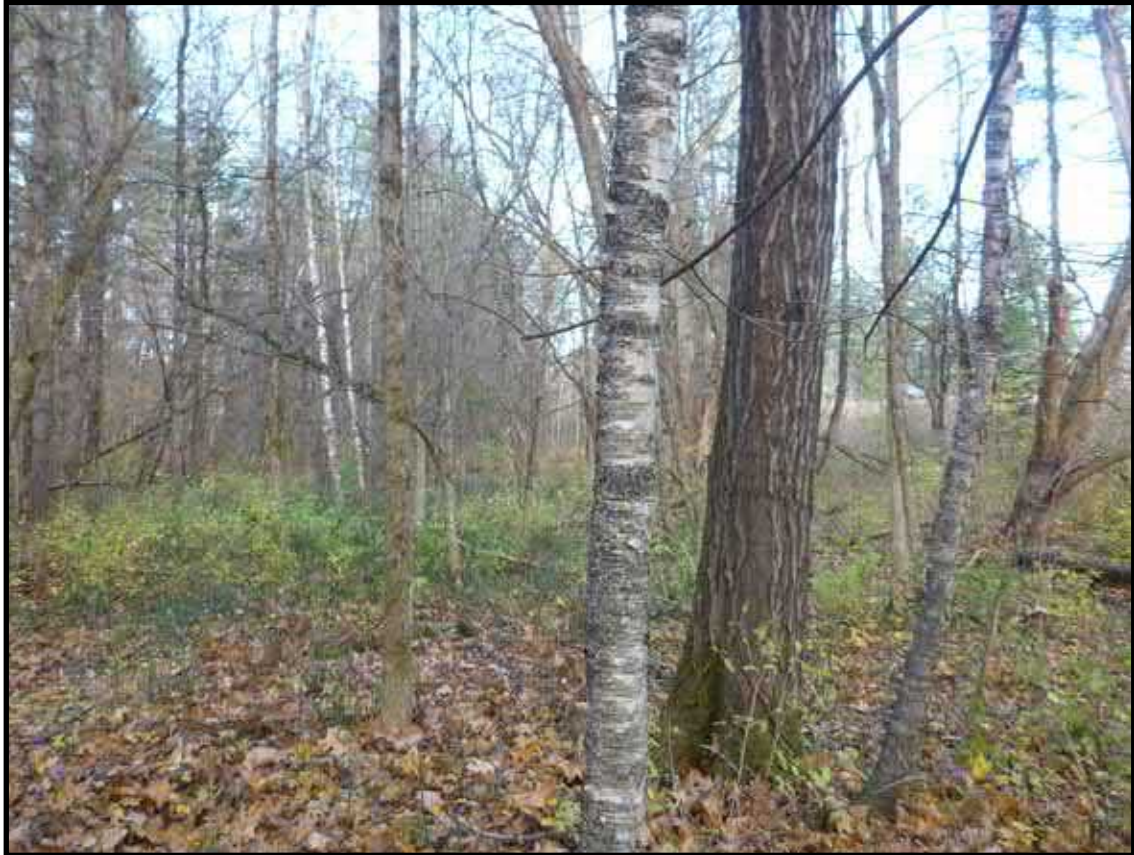
Photograph 6.3. View facing north showing the northern end of the upper Blow-Me-Down Brook area (photographer: James Lee, November 2016) [HRI Neg.#16048/D2-033].

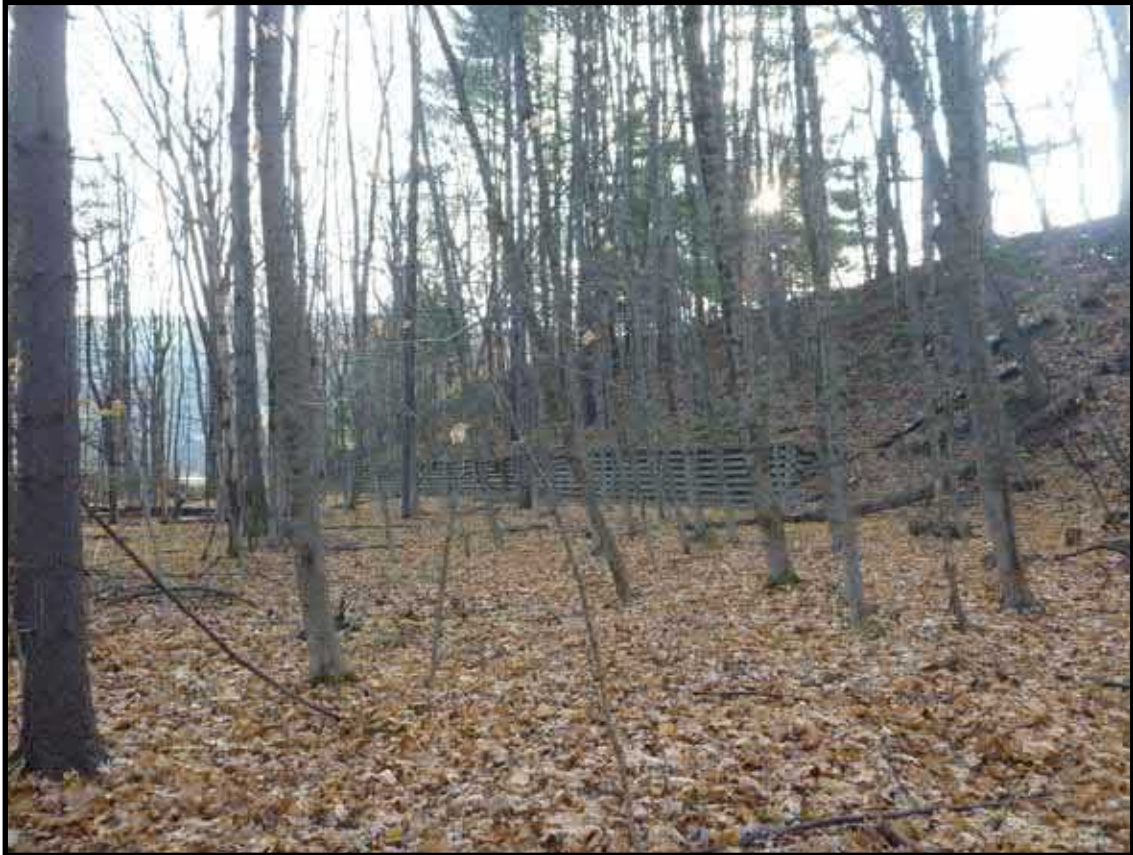
Photograph 6.4. View south showing the southern end of the upper Blow-Me-Down Brook area and the retaining walls along the former route of Wilson Road (photographer: James Lee, November 2016) [HRI Neg.#16048/D2-035].

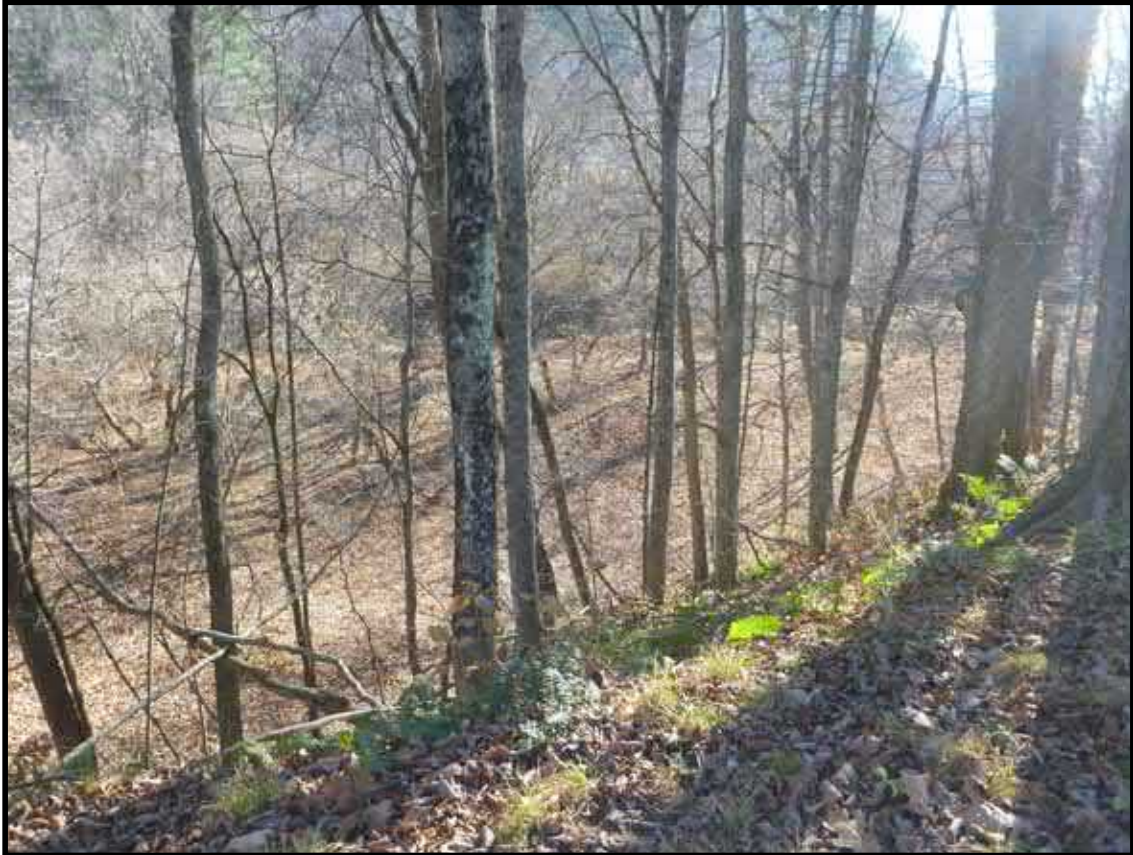
Research 2017). The lower area measures approximately 210 meters long northeast-southwest and is only 40 meters wide. At an elevation of around 310 feet asl, it is still part of the floodplain of Blow-Me-Down Brook and the Connecticut River and evidence of this was observed in the area in the form of rafts of sticks, branches and other buoyant items (plastic bottles, foam, etc.) on the ground surface (Photograph 6.5).

Photograph 6.5. View facing southeast showing the lower Blow-Me-Down Brook area from the promontory area (photographer: James Lee, November 2016) [HRI Neg.#16048/D2-043].

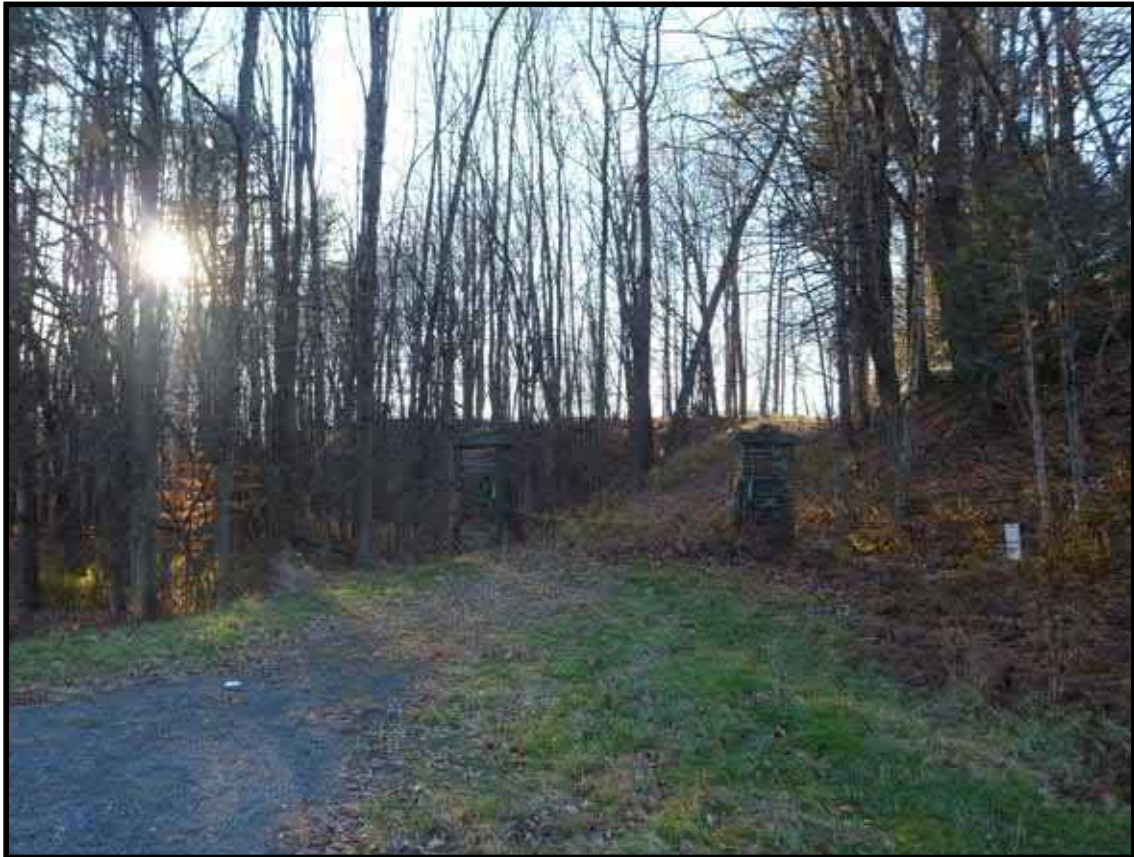
Soils along the lower segment of Blow-Me-Down Brook consisted of a dark humic silty loam overlying a loamy silt at 18 centimeters in Shovel Test 15 and a clayey silt at 110 centimeters in Shovel Test 16. A mottled sand underlay this clayey silt and the test was ended at a stone impasse at 125 centimeters below the ground surface. These soils suggest this area was also subject to the changing channel and flood events of Blow-Me-Down Brook. At the very north end of this lower section of the brook a former driveway entrance with mortared stone gateposts was observed (Photograph 6.6). A chain hung between these posts

Photograph 6.6. View facing west showing the gate posts at the driveway entry to Blow-Me-Down Farm at the north end of the lower BMD Brook area (photographer: James Lee, November 2016) [HRI Neg.#16048/D2-186].

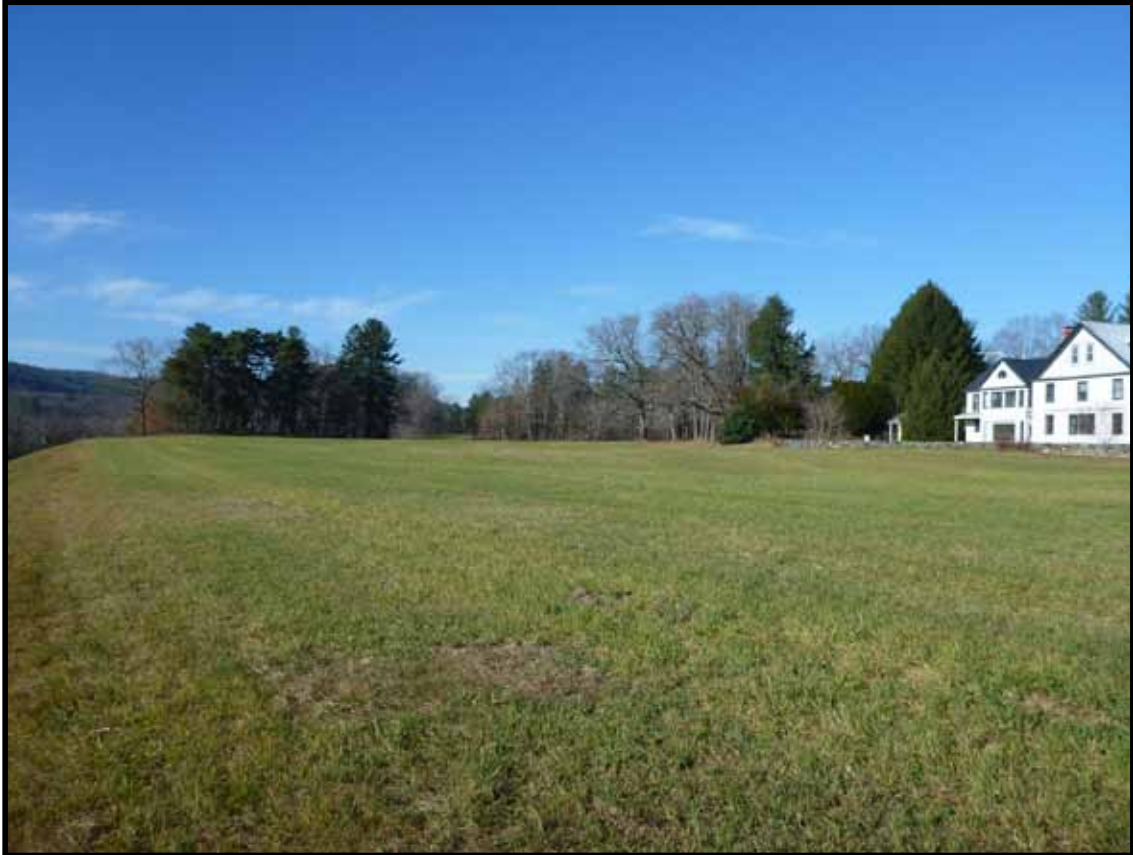
Photograph 6.7. View north showing the upper terrace (photographer: James Lee, November 2016) [HRI Neg.#16048/D2-053].

the central part of this area the B2 horizon was a loamy silt. The fine, homogenous nature of the silt in this area suggests that these soils were aeolian-derived silts, possibly deposited as Glacial Lake Hitchcock receded and winds carried silts up from the river bed, decelerated and then deposited them at the top of this terrace. The stratigraphy of this area has also likely been affected by its historic use as both a grass tennis court and a golf course (Dryfhout 2000:60).

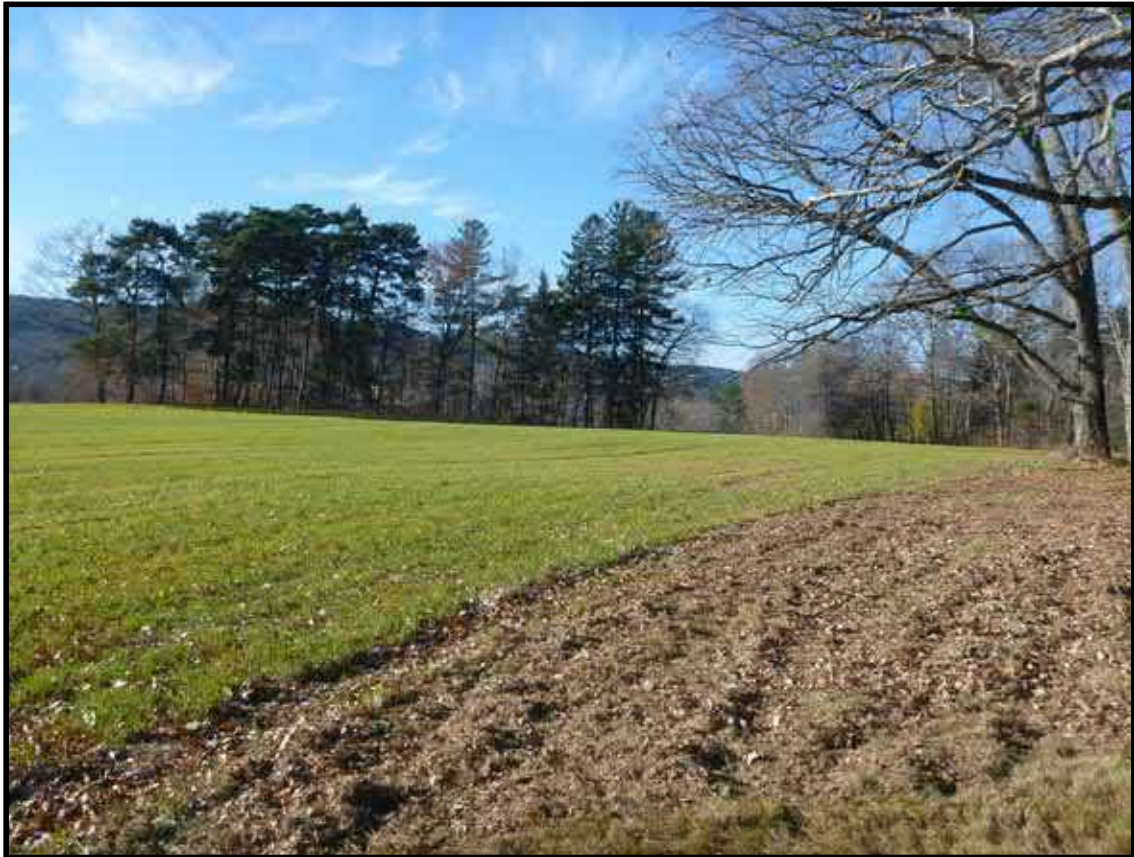
Photograph 6.8. View northwest showing the northern end of the upper terrace (photographer: James Lee, November 2016) [HRI Neg.#16048/D2-141].

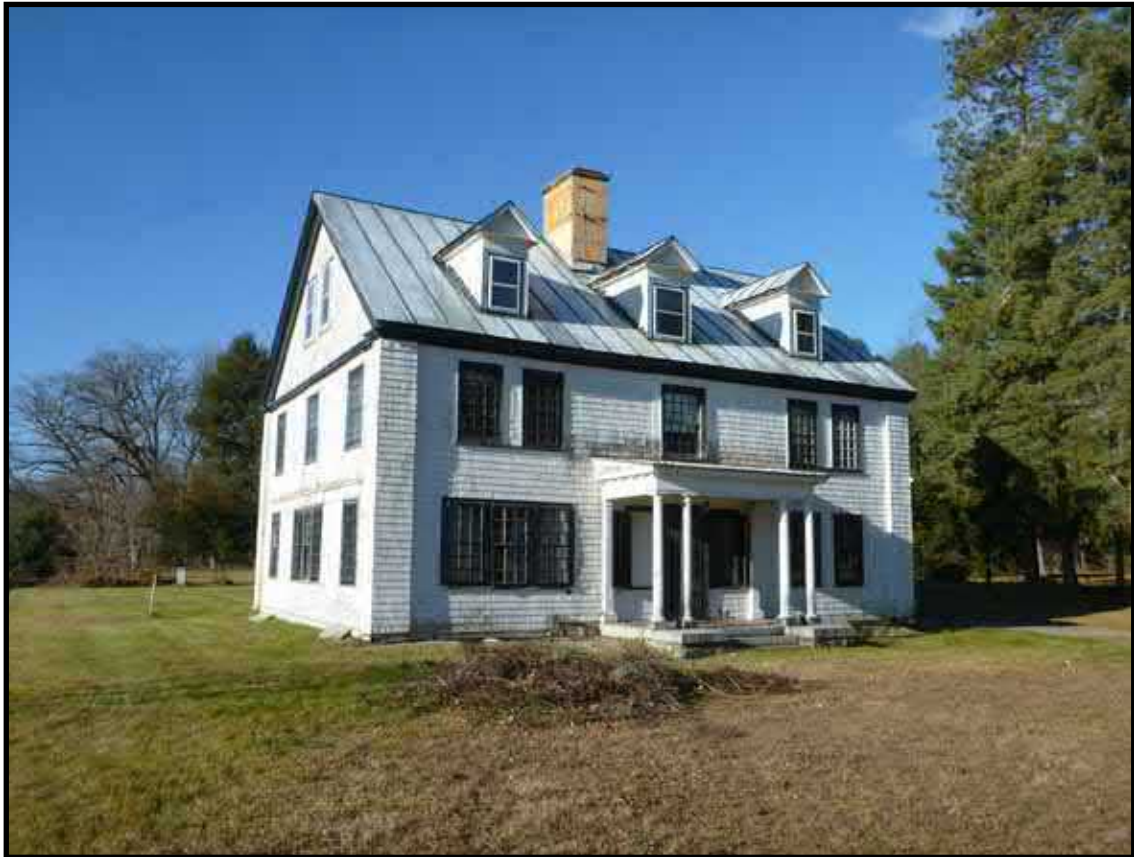
Photograph 6.9. View north showing the Casino building (photographer: James Lee, November 2016) [HRI Neg.#16048/D2-150].

The standing buildings within the farmstead can be divided into three groups. The Casino and Dance Hall are located along the western edge of this area next to the Upper Terrace Area. These buildings were built in the late 19th century and have been heavily modified. The Dance Hall has also been moved from its original location. The Casino Building, built in 1887, by Charles Beaman, supposedly incorporates framing elements from the 18th-century Moses Chase House. This building is a two-and-a-half-story, three-bay frame dwelling with three dormer windows, a central brick chimney and a full cellar (Photograph 6.9). The front door, which faces south, has a small stone porch with classical columns supporting its roof. Soon after this building was erected a rear ell was added to house a ten pin bowling alley. After the primary residence of the property, "Blow-Me-Down," was destroyed by fire in 1926, the Casino was made into a residence. The bowling alley addition was detached, moved and remodeled into the Dance Hall in 1927 and a large two-and-a-half-story addition was added to the Casino (Photograph 6.10). The Dance Hall, now in its current location north of the Casino, was expanded at both ends and porches and a cupola were added (Yokum and Machurat 2014) (Photograph 6.11). This building rests on piers. At some point in the mid-20th century an in-ground pool (recently removed) was built next to the Dance Hall. A line of mature hemlocks extends north from the Dance Hall. These trees were likely started as small shrubs for a garden area (Photograph 6.12). An asphalt driveway runs between these two buildings and is drained by three storm water inlets that connect with underground conduits that run to the southwest (see above, Figure 5.1; Photograph 6.13). Three millstones are set upright as a curb along the edge of this asphalt parking area. A fourth millstone is set directly in front of the Casino around the base of a flagpole (Photograph 6.14). Another feature of note is a 66-meter-long dry-laid stone retaining wall, built in 1890, that runs northwest-southeast to the west of the Casino (Photograph 6.15).

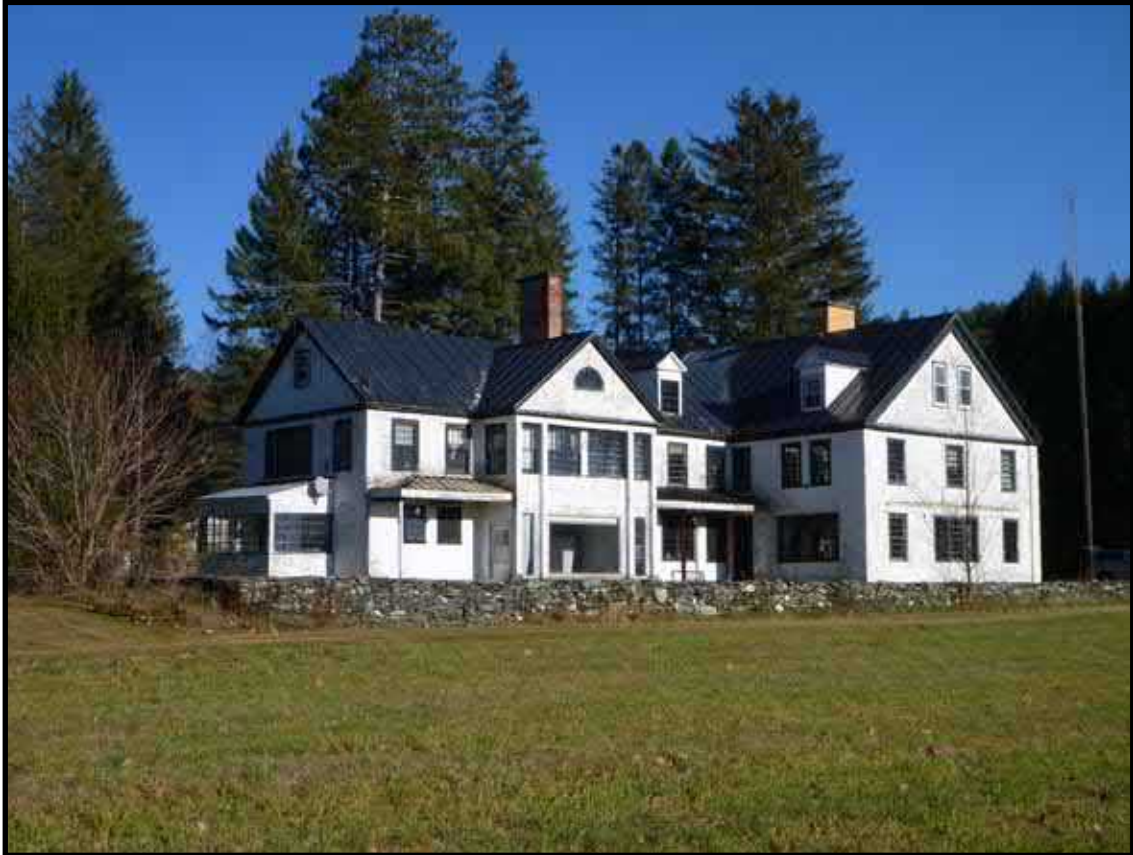
Photograph 6.10. View east showing the Casino (photographer: James Lee, November 2016) [HRI Neg.#16048/D2-145].

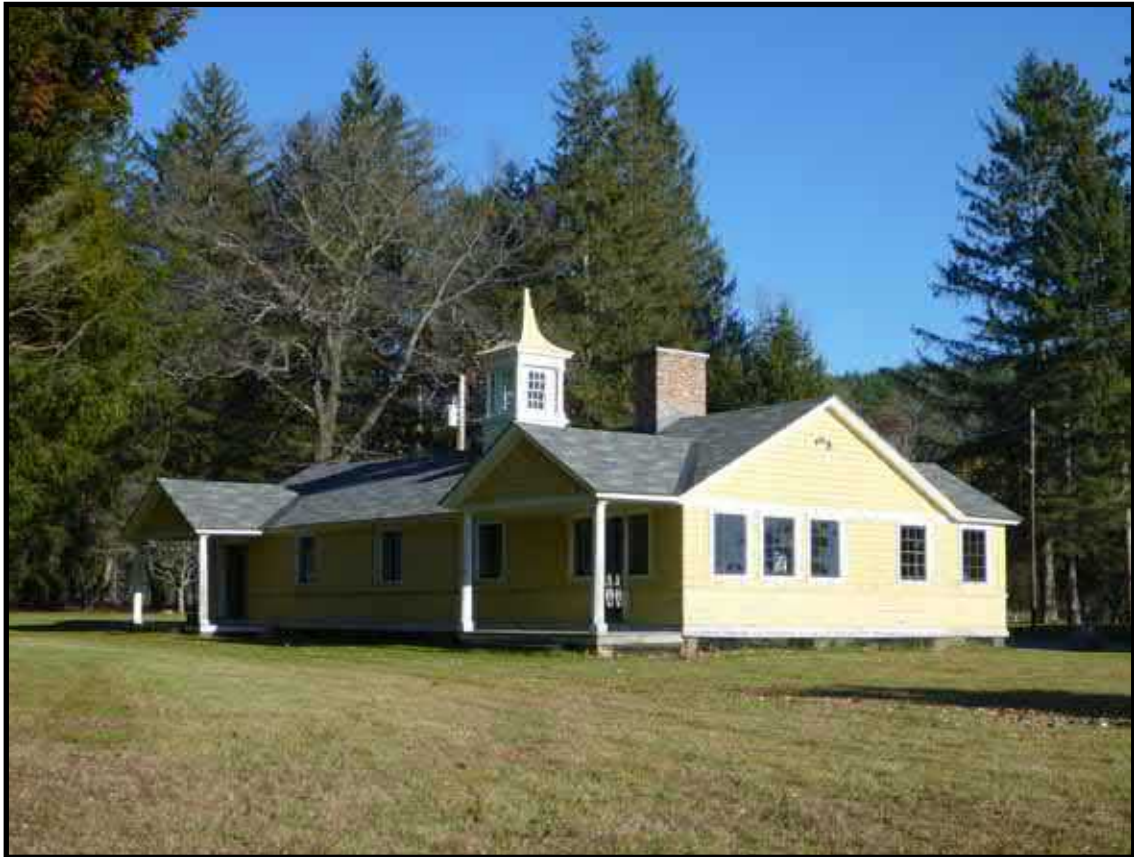
Photograph 6.11. View southeast showing the Dance Hall (photographer: James Lee, November 2016) [HRI Neg.#16048/D2-139].

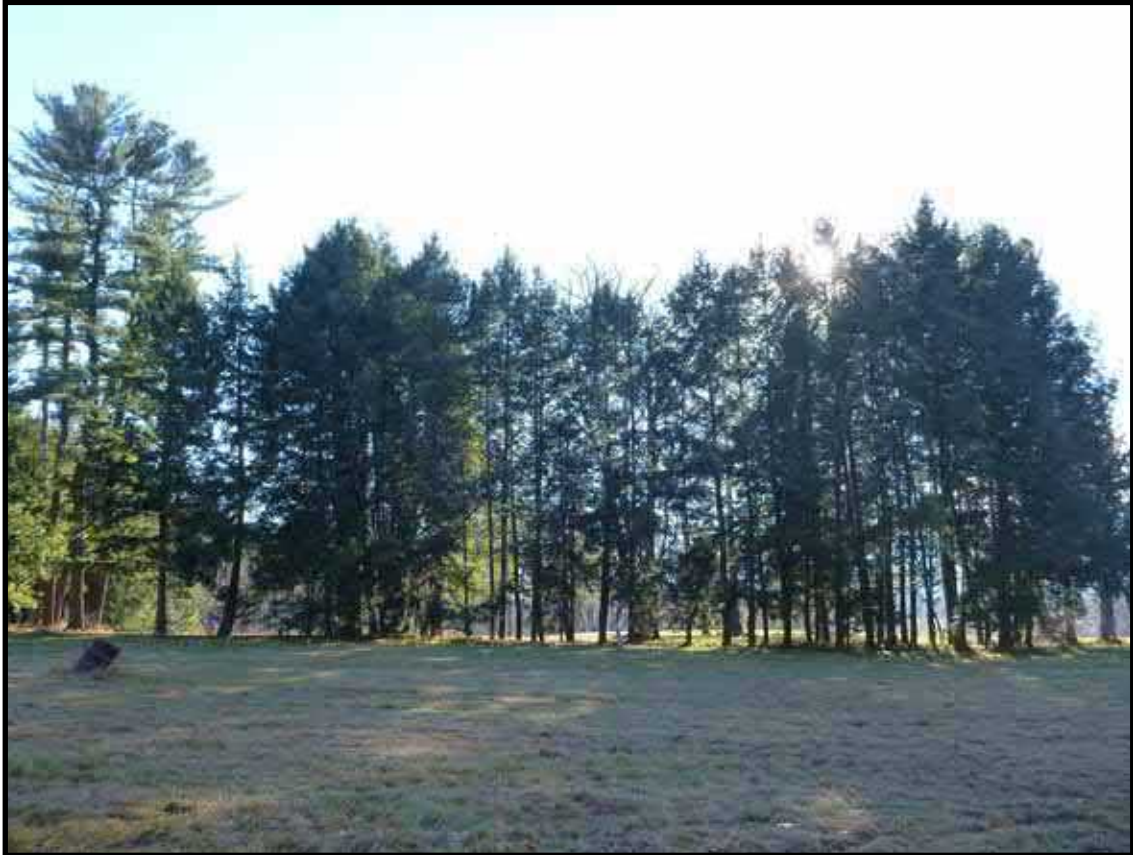
Photograph 6.12. View south showing a line of mature hemlock trees extending north from the Dance Hall (photographer: James Lee, November 2016) [HRI Neg.#16048/D2-150].

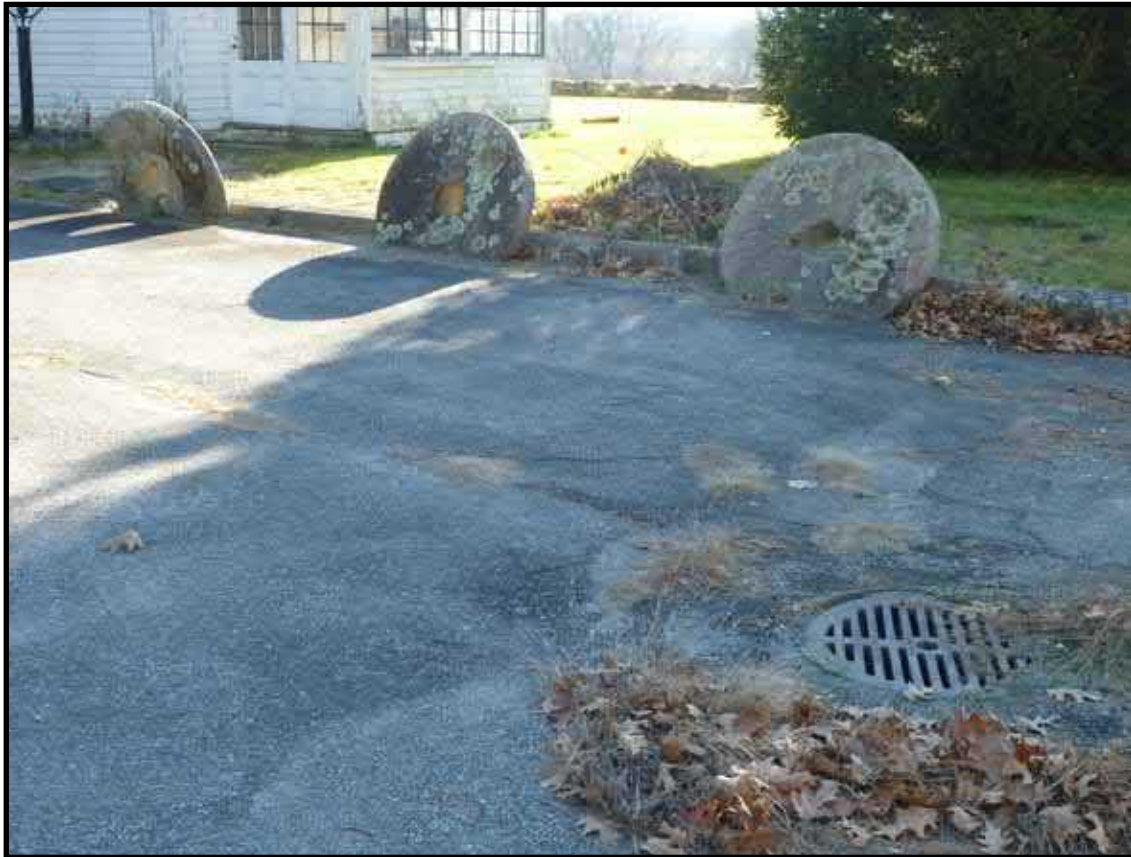
Photograph 6.13. View southwest showing a line of millstones used as curbing between the Casino and Dance Hall. Note the storm drain in the right foreground. This drains via conduits to the west (photographer: James Lee, November 2016) [HRI Neg.#16048/D2-129].

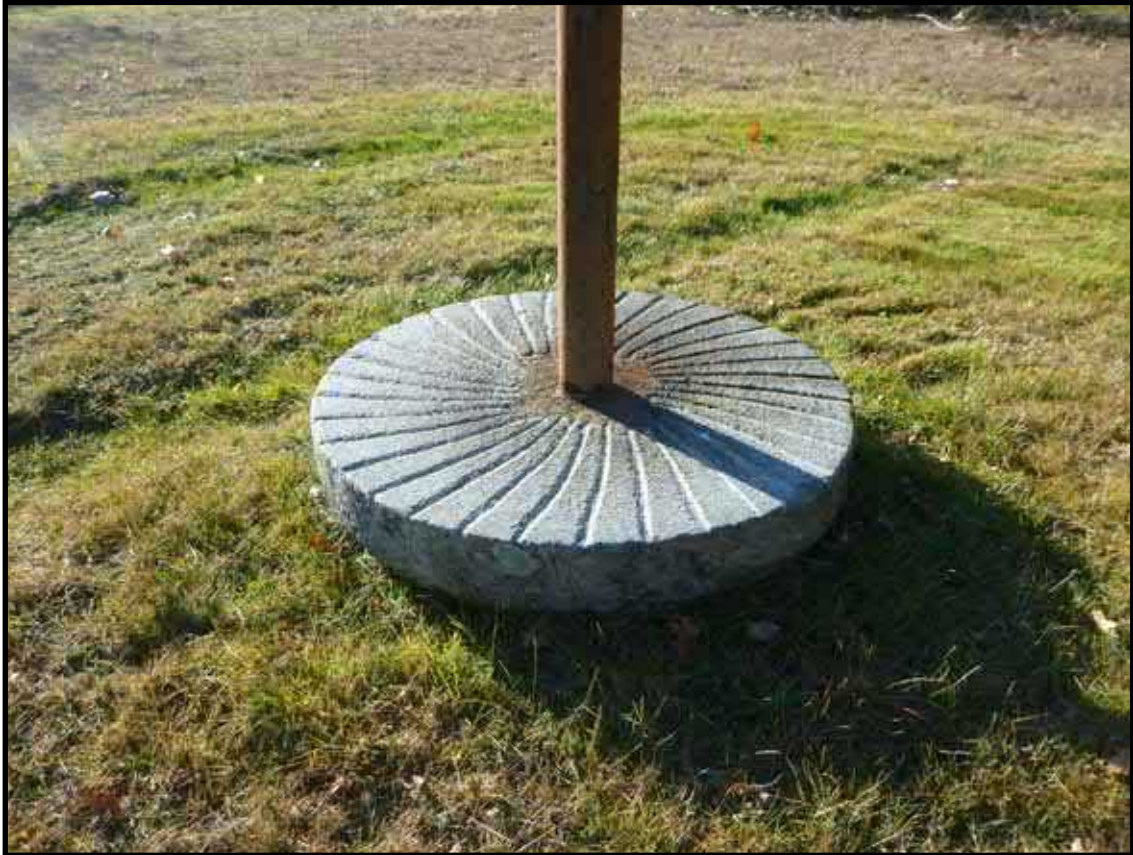
Photograph 6.14. View south showing the millstone around the base of the flag pole south of the Casino (photographer: James Lee, November 2016) [HRI Neg.#16048/D2-158].

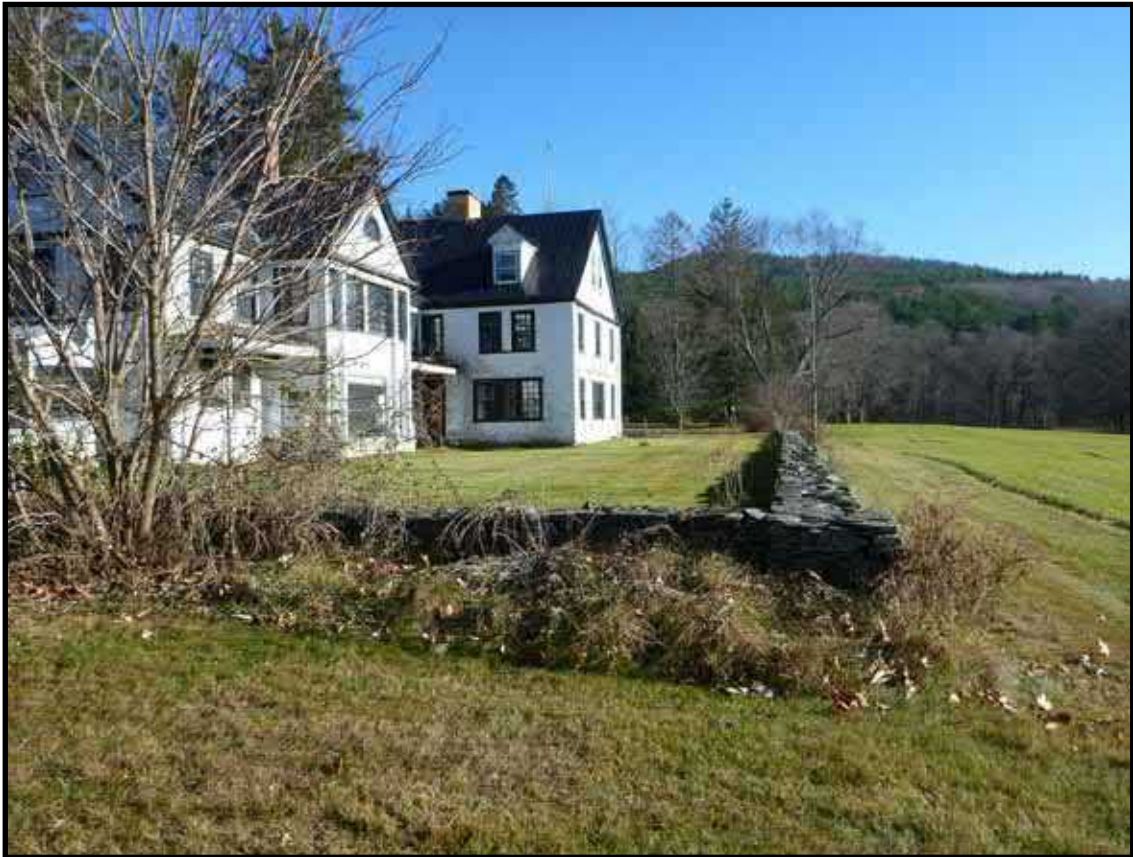
Photograph 6.15. View southeast showing the dry-laid stone retaining wall just west of the casino (photographer: James Lee, November 2016) [HRI Neg.#16048/D2-147].
