**ARCHEOLOGICAL OVERVIEW AND ASSESSMENT  
BLOW-ME-DOWN FARM**

**SAINT-GAUDENS NATIONAL HISTORIC SITE  
CORNISH, NEW HAMPSHIRE**

**James Lee, M.A., Principal Investigator  
Eryn Boyce, M.A., Historian**

**JULY 2017**

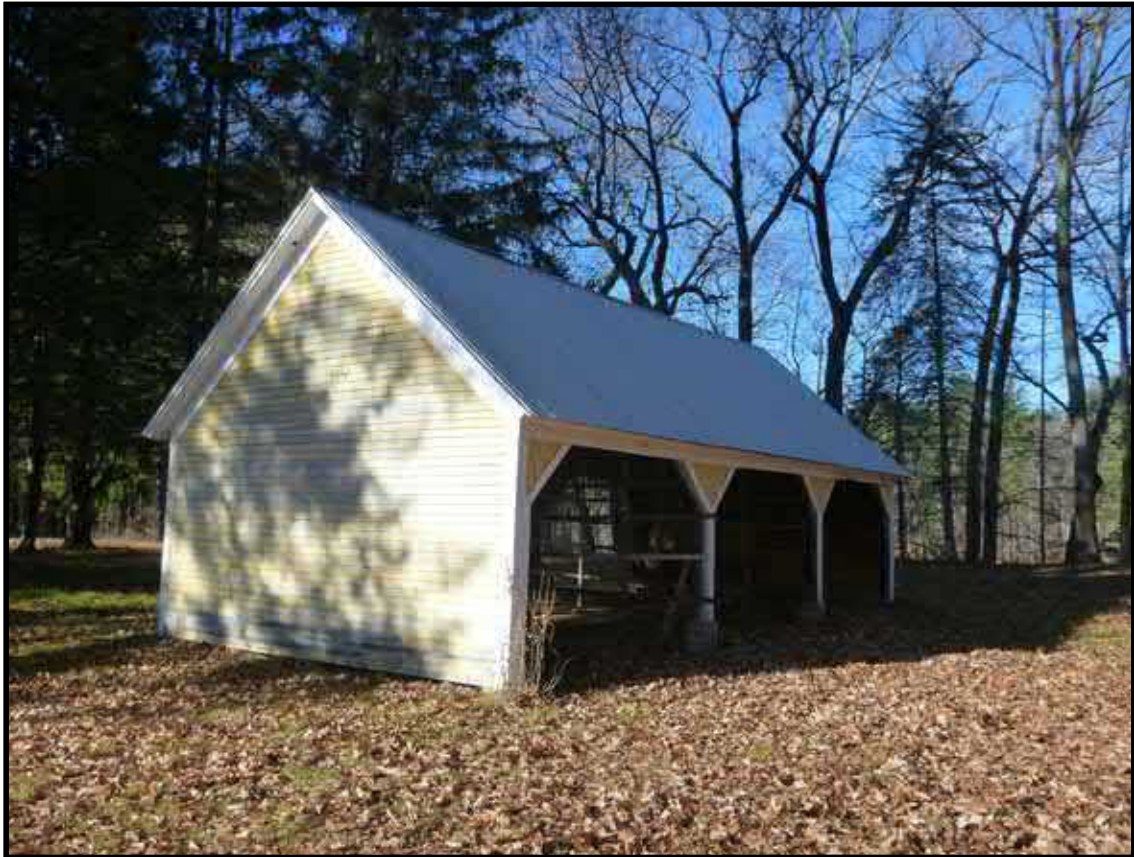
Photograph 6.16. View north showing the Wood Shed (photographer: James Lee, November 2016) [HRI Neg.#16048/D2-113].

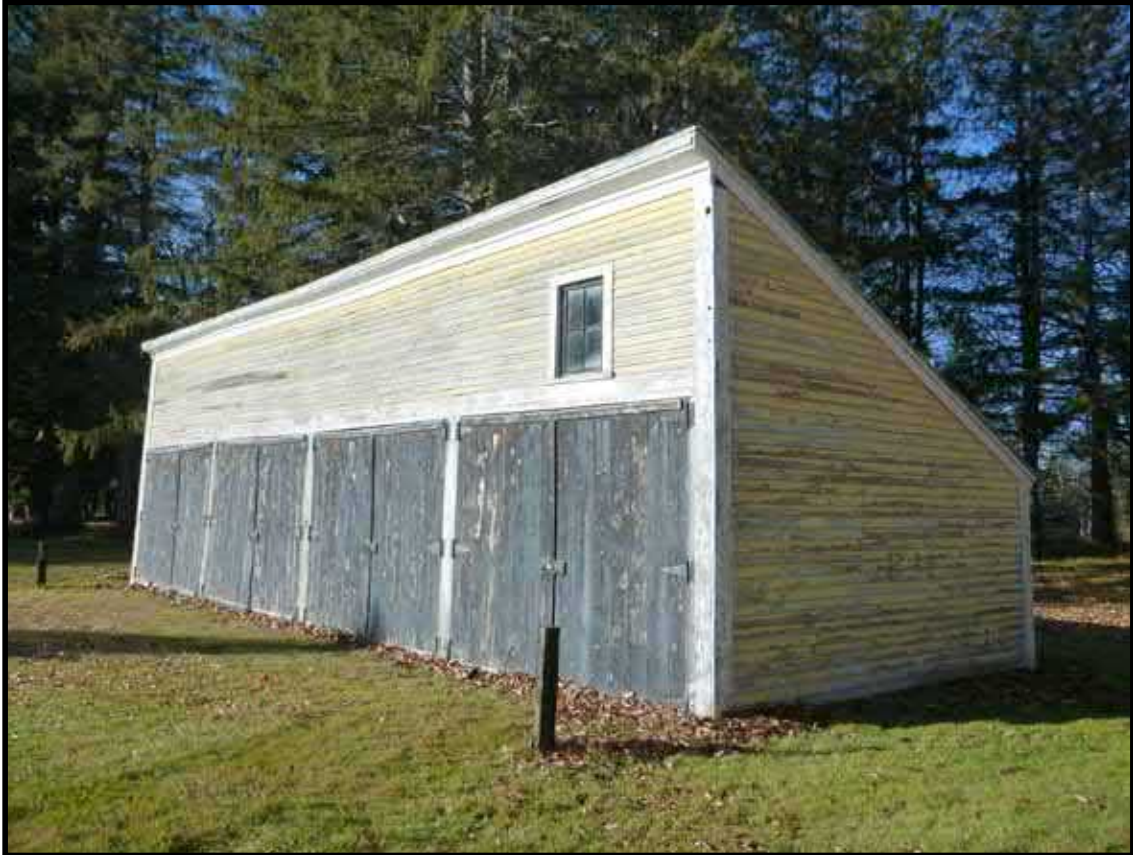
Photograph 6.17. View northwest showing the Carriage House (photographer: James Lee, November 2016) [HRI Neg.#16048/D2-112].

Another group of outbuildings is located east of the Casino and Dance Hall. The northernmost of these is a two-sided structure, known as the Wood Shed, which has three bays open at either end (Photograph 6.16). This one-story frame building is built on piers at its corners, has a gabled metal roof and an earthen floor. The two ends are covered in clapboard siding. It likely served historically as a shelter for carriages. Just south of the wood shed is a four-bay frame outbuilding, known as the Carriage House, which has clapboard siding and four sets of double doors set on hinges (Photograph 6.17). There is also a single door on its western end and a single window facing south above the eastern most bay. This outbuilding has a metal shed-style roof and earthen floor and is set on a simple fieldstone foundation. The insurance report from 1935 also describes it as a garage and states that it served as a horse barn, as well as a carriage house (Insurance Company of America 1935:3).

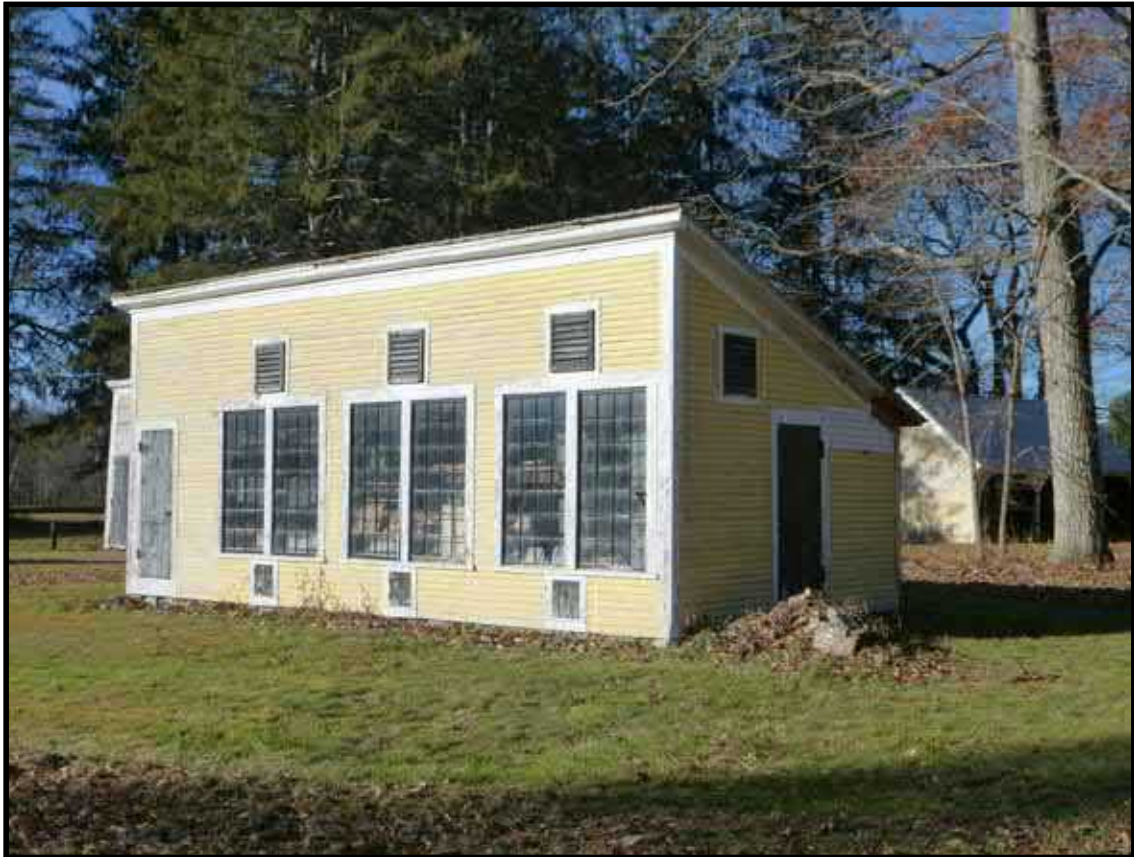
Just southeast of this building is an outbuilding known as the Blacksmith Shop. Labeled as a “Tool House” on the insurance map, it is described as a shed for storing and fixing tools. This outbuilding is also a four-bay, shed-roofed frame building set on a simple fieldstone foundation (Photograph 6.18). It has a metal roof and a wooden floor. A garage door is located on the western end, and simple plank doors on iron strap hinges are located at the western end of the southern façade and in the middle of the eastern façade. Three sets of 28-pane windows (six in all) are also located on the southern façade. A closed chicken chute door is centered below each of these window sets and a louvered vent is located above. A fourth louvered vent is located on the eastern façade. The form of this outbuilding and the lack of any visible hearth chimney or stove pipe strongly suggest that it may originally have been a poultry house.

Photograph 6.18. View northwest showing the Blacksmith Shop or "Tool House" (photographer: James Lee, November 2016) [HRI Neg.#16048/D2-110]

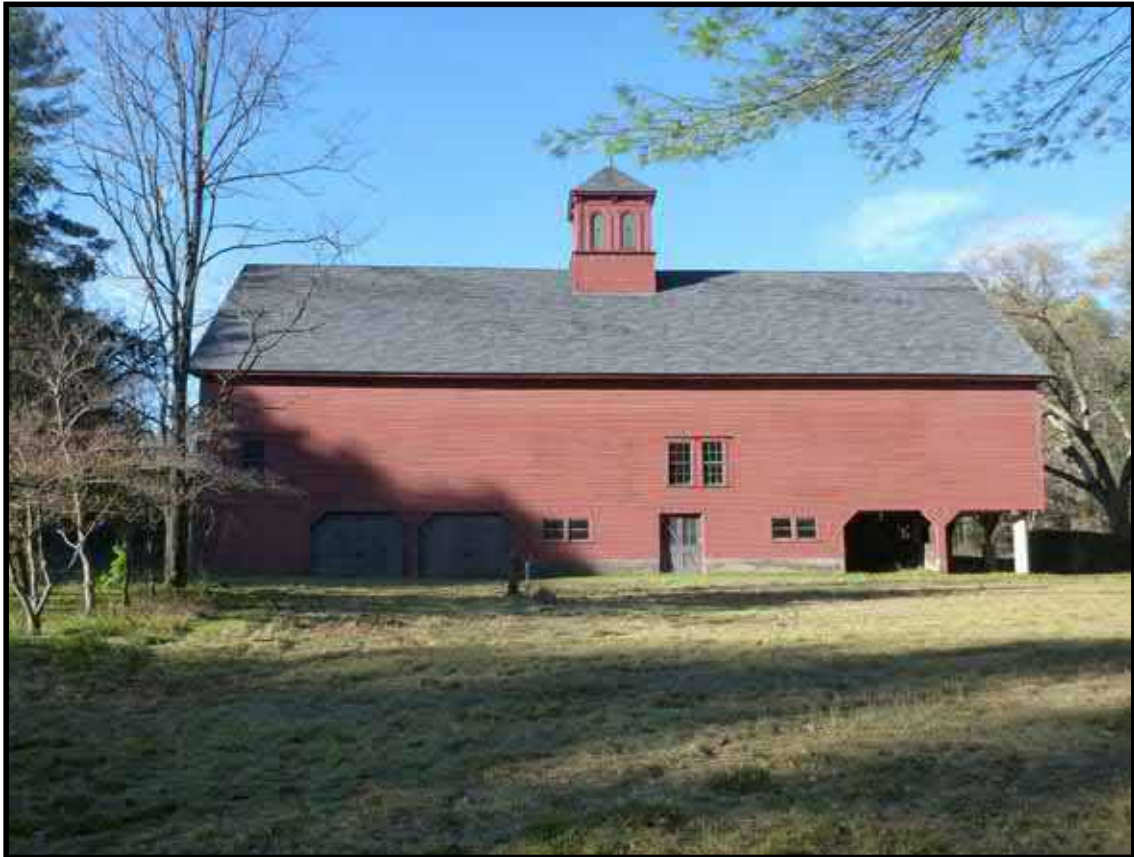
The third group of buildings and building sites center around the Barn. As with the Dance Hall, this building has been the subject of a historic structure report and will not be described in great detail here (Fix 2016) (Photograph 6.20). The Barn is missing a few of its later additions including a timber-frame cow barn that once extended to the south and an addition to the east that formerly connected the barn to a stone and earth ramp (Photograph 6.21). A barnyard was also formed by the frame addition and at least three other no-longer-extant farm buildings that are visible in a historic view of the farm (see above, Photograph 3.5). These buildings likely included the pig pen, stable and possibly the carpenter shop that were said to have been moved to the north in 1899. While no shovel tests were excavated in this immediate area the entire barnyard area south of the standing barn is likely to retain archeological traces of this building complex.

Photograph 6.20. View north showing the Barn (photographer: James Lee, November 2016) [HRI Neg.#16048/D2-95].

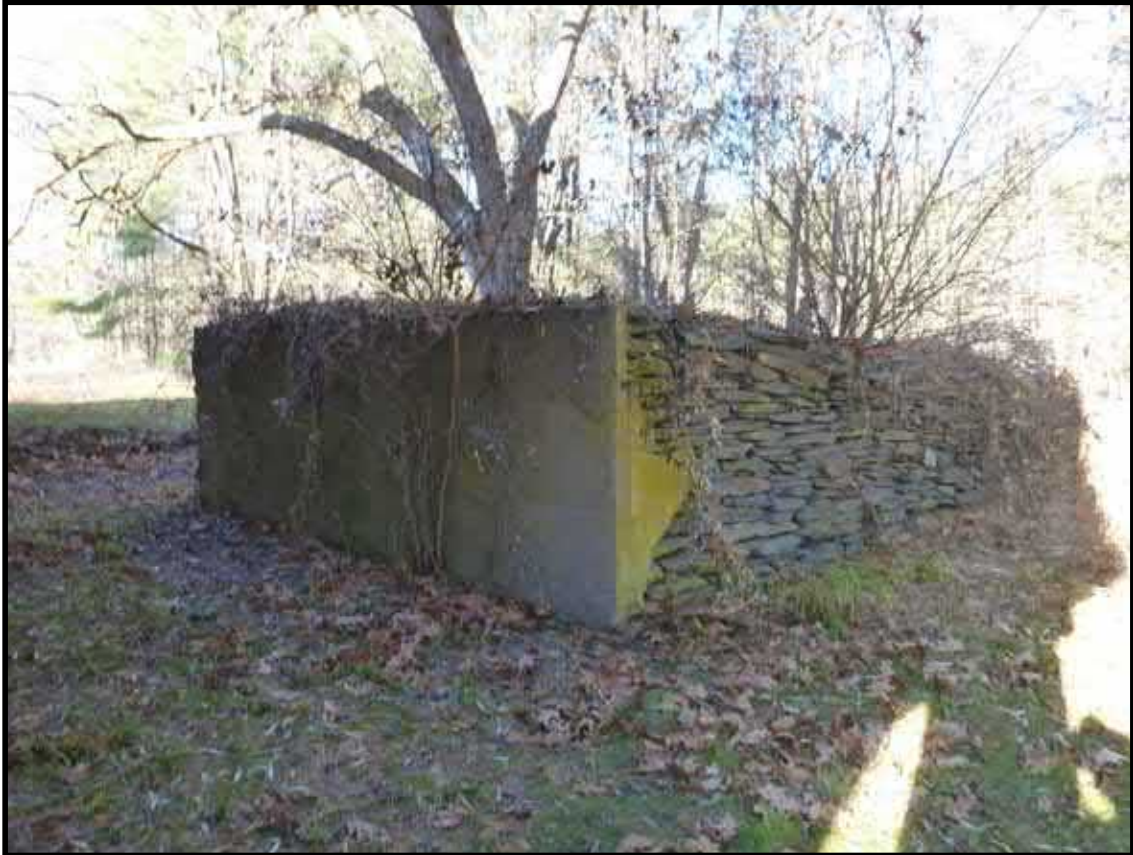
Photograph 6.21. View northeast showing the stone and earthen ramp at the eastern end of the Barn (photographer: James Lee, November 2016) [HRI Neg.#16048/D2-99].

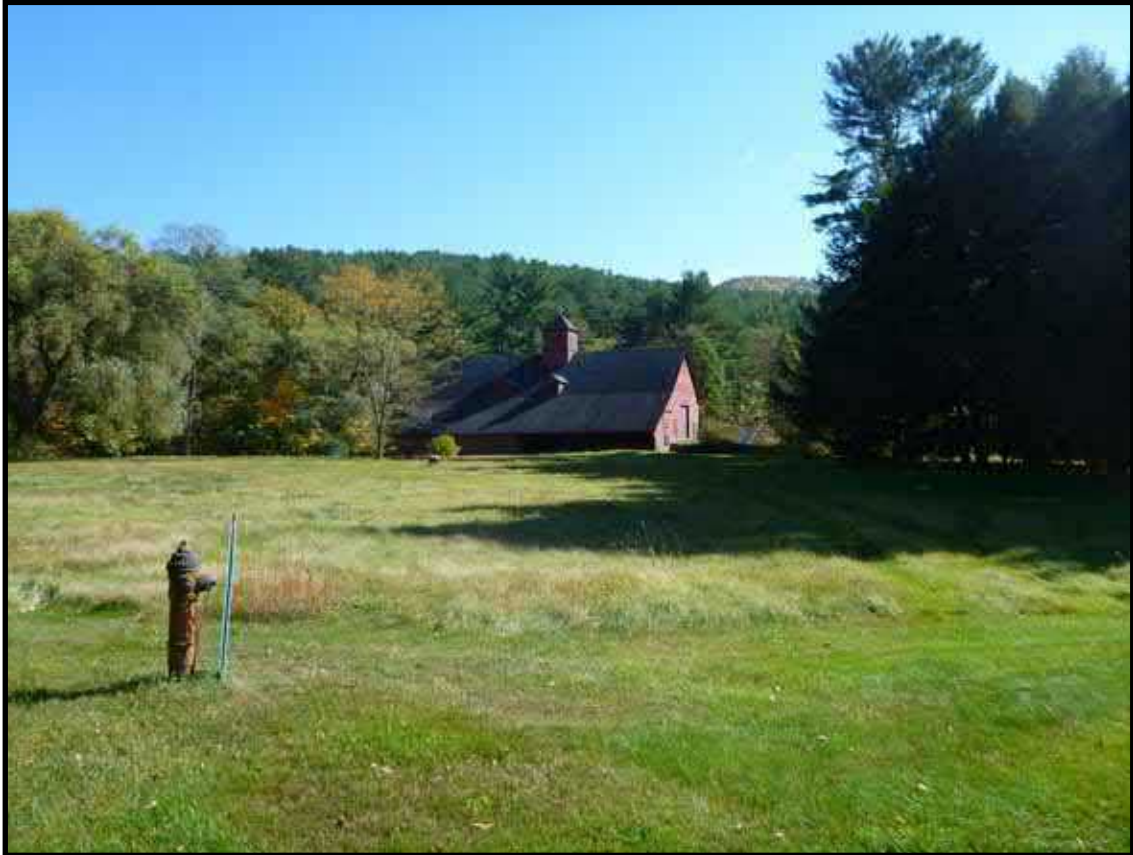
Photograph 6.22. View southeast showing the site of the Farmer's House and associated outbuildings. The Barn is visible in the background and a hydrant is visible in the foreground (photographer: James Lee, October 2016) [HRI Neg.#16048/D1-007].

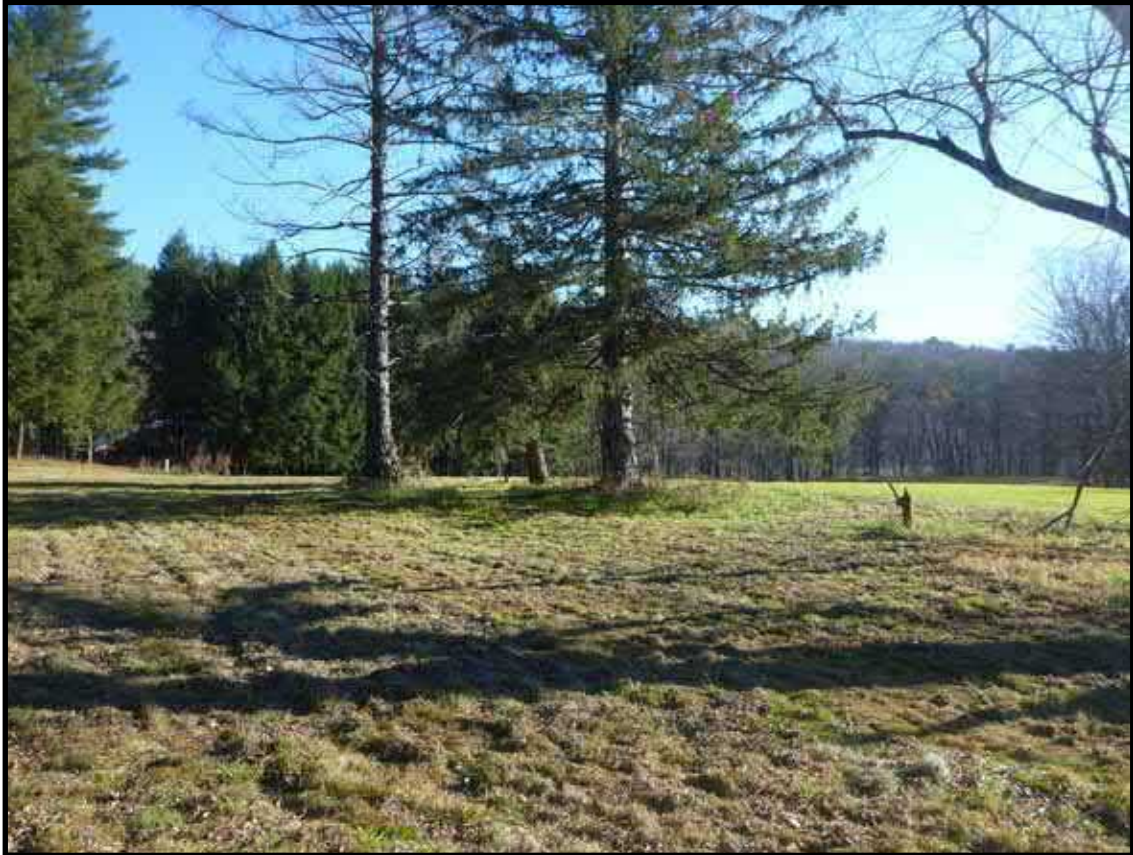
The Blow-Me-Down Cottage Site lies at the southwestern corner of the Blow-Me-Down Farmstead Area (Photograph 6.24). No surface evidence of this 35-room mansion remains, except for several hummocks of soil. A lane that is visible in a few historic photographs of the cottage still runs north-south along the eastern edge of this site, providing a more definitive location for the house, which is not accurately plotted on any of the maps so far identified. This "cottage" was built in 1883-84 and incorporated the foundation of the Pike House, which was built in 1869 and burned down in 1875 (Dryfhout 2000:66). Some sources state that at this time the original 18th-century Moses Chase House was being used as a barn on the property and was later used as part of the Casino (Dryfhout 2000:65). This somewhat unclear developmental history of the Blow-Me-Down Cottage Site is likely to complicate an understanding of its archeology.

Photograph 6.24. View southeast showing the site of the Blow-Me-Down cottage (photographer: James Lee, November 2016) [HRI Neg.#16048/D2-77].

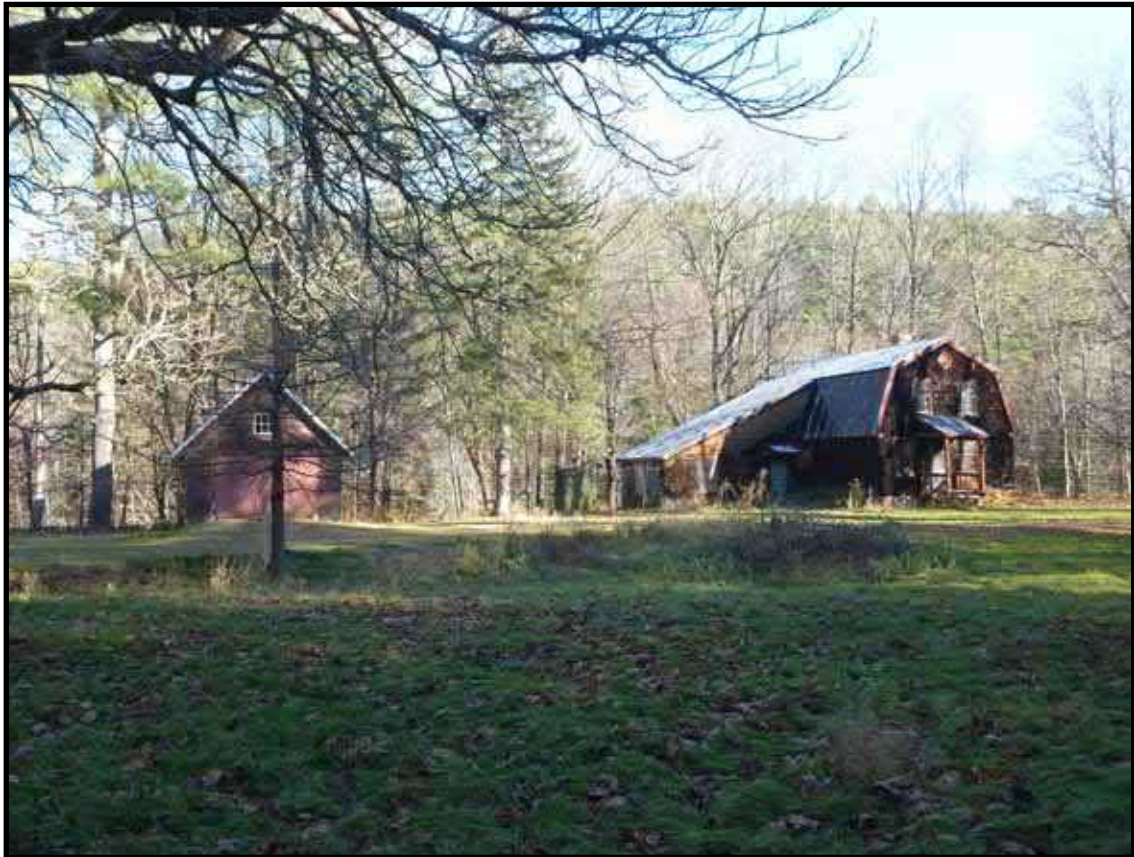
Photograph 6.25. View facing southeast showing the Chauncey Cottage and garage (photographer: James Lee, November 2016) [HRI Neg.#16048/D2-091].

This area is situated along the eastern edge of the project site above Route 12A and includes the immediate surroundings of the cottage and its garage as well as its front yard (Photograph 6.25). The area measures 55 meters to the hemlock-lined driveway to the west and south, 55 meters to the barn to the north, and sits at an elevation of approximately 320 feet asl (Photograph 6.26). Built in 1890, Chauncey Cottage, which is located in the southeast corner of this area, is a frame one-and-a-half-story, two-bay, wood-shingle-sided dwelling with a gambrel metal roof, brick chimney and a shed addition on its northern side. A small, covered porch covers the front door of the house, which is located in its western façade. A second door is located on the western side of the shed addition. In addition to the cottage, a small, one-bay frame garage with similar wood-shingle siding is located just to its north. A driveway runs from the Blow-Me-Down Farmstead Area to the southeast in front of the cottage before turning west and running back to the farm's main driveway. A fire hydrant is located northwest of the cottage in the yard.

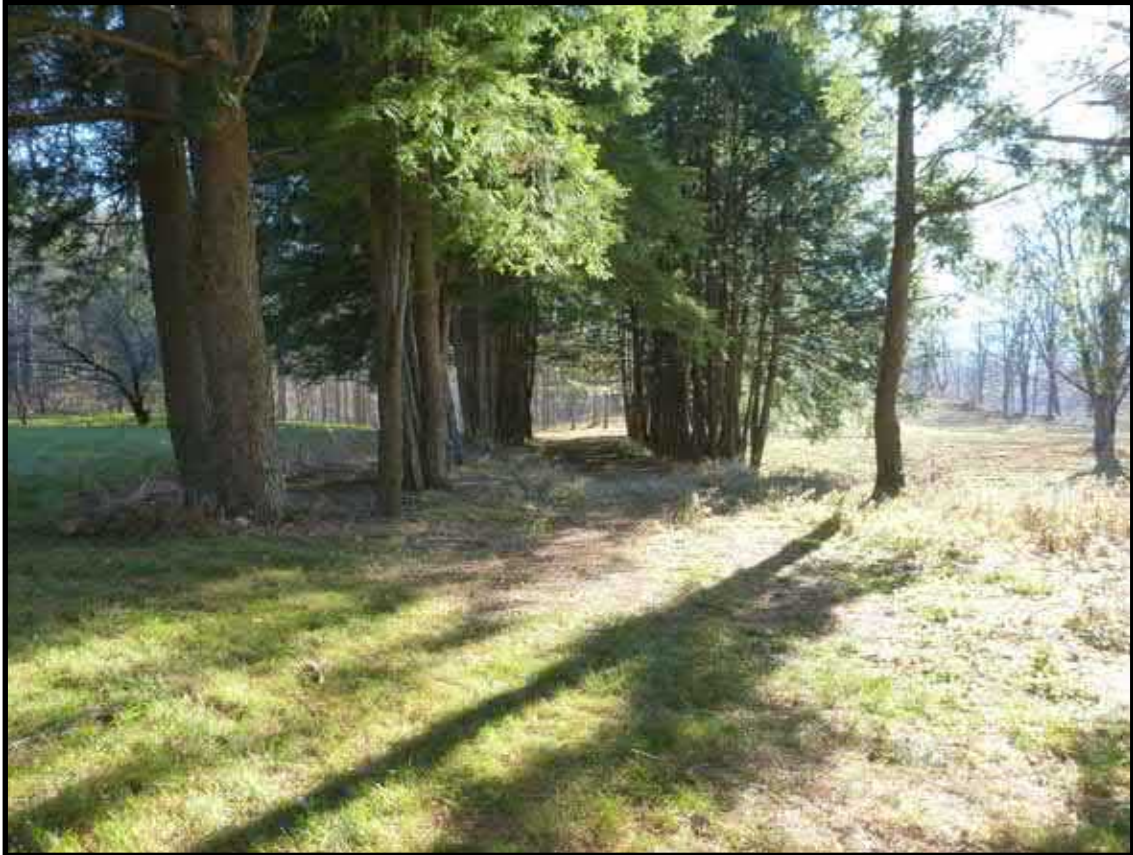
Photograph 6.26. View facing south showing the former driveway lined with overgrown hemlocks. The Chauncey Cottage area is located to the left of the view (photographer: James Lee, November 2016) [HRI Neg.#16048/D2-086].

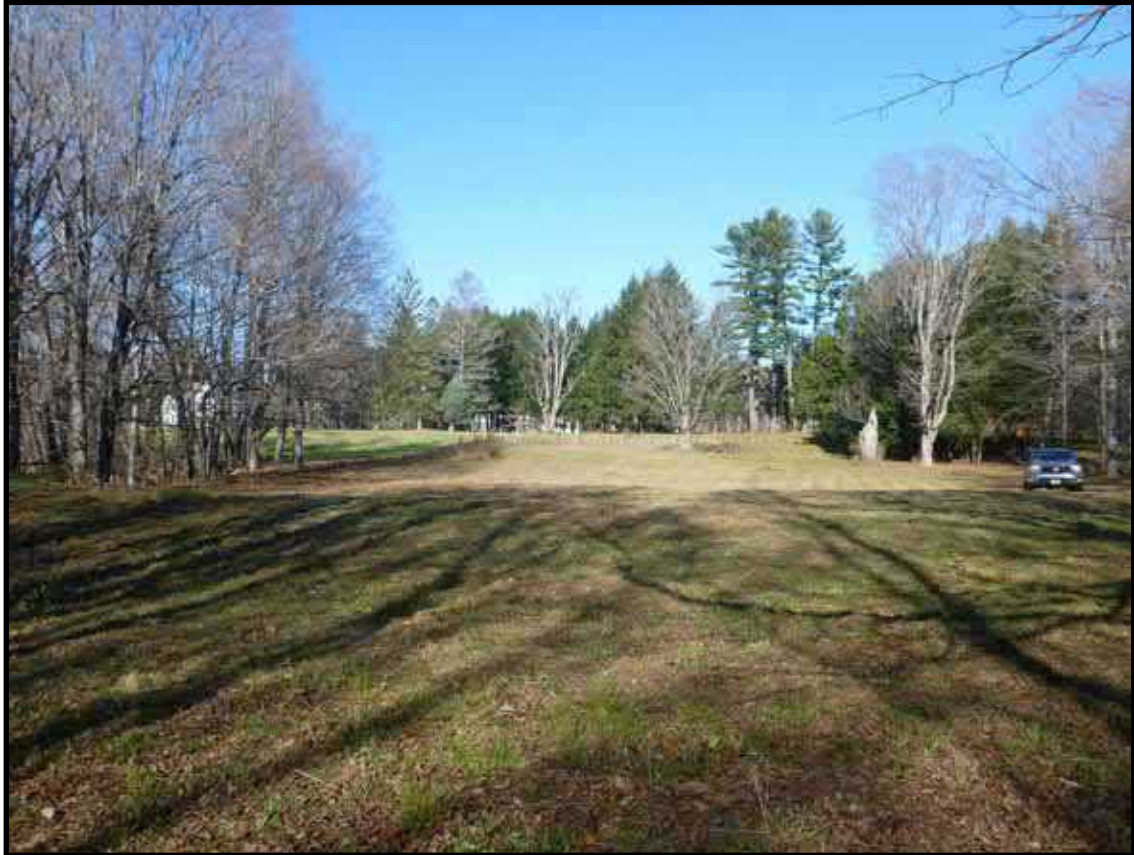
Photograph 6.27. View north showing the Promontory area (photographer: James Lee, November 2016) [HRI Neg.#16048/D2-046].

This area is located south of the Upper Terrace and Blow-Me-Down Farmstead areas and consists of a 95-meter-long and 5-meter-wide undulating, open grassy field (Figure 6.2; Photograph 6.27). This location looks out over Blow-Me-Down Brook to the southeast and its confluence with the Connecticut River to the southwest. A small hill appears to have been built up at the northern end of this area with two large stones and a tree placed at the top of it. At its southern end a farm lane runs down the ridge between the Lower Terrace Area and the lower section of Blow-Me-Down Brook providing access to the southern end of the field on the lower terrace (Photograph 6.28).

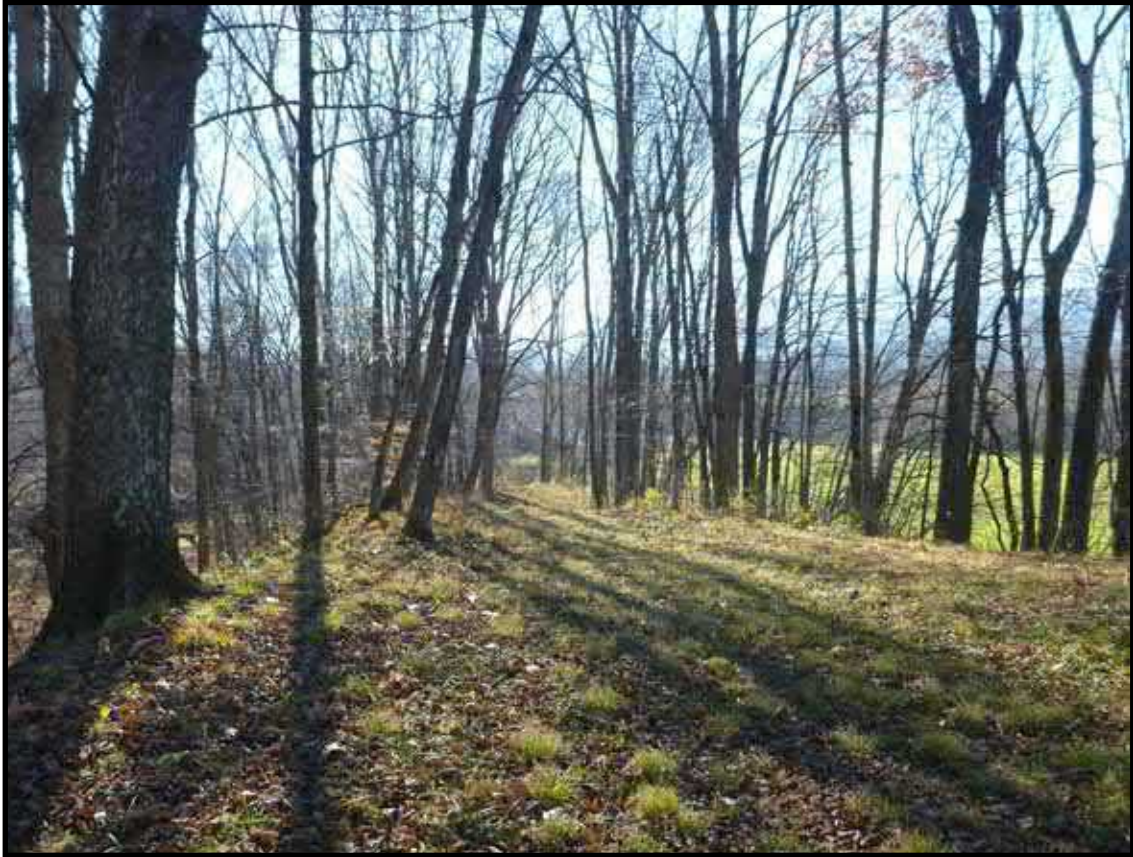
Photograph 6.28. View south showing the lane the leads south downhill from the Promontory to the Lower Terrace (photographer: James Lee, November 2016) [HRI Neg.#16048/D2-042].

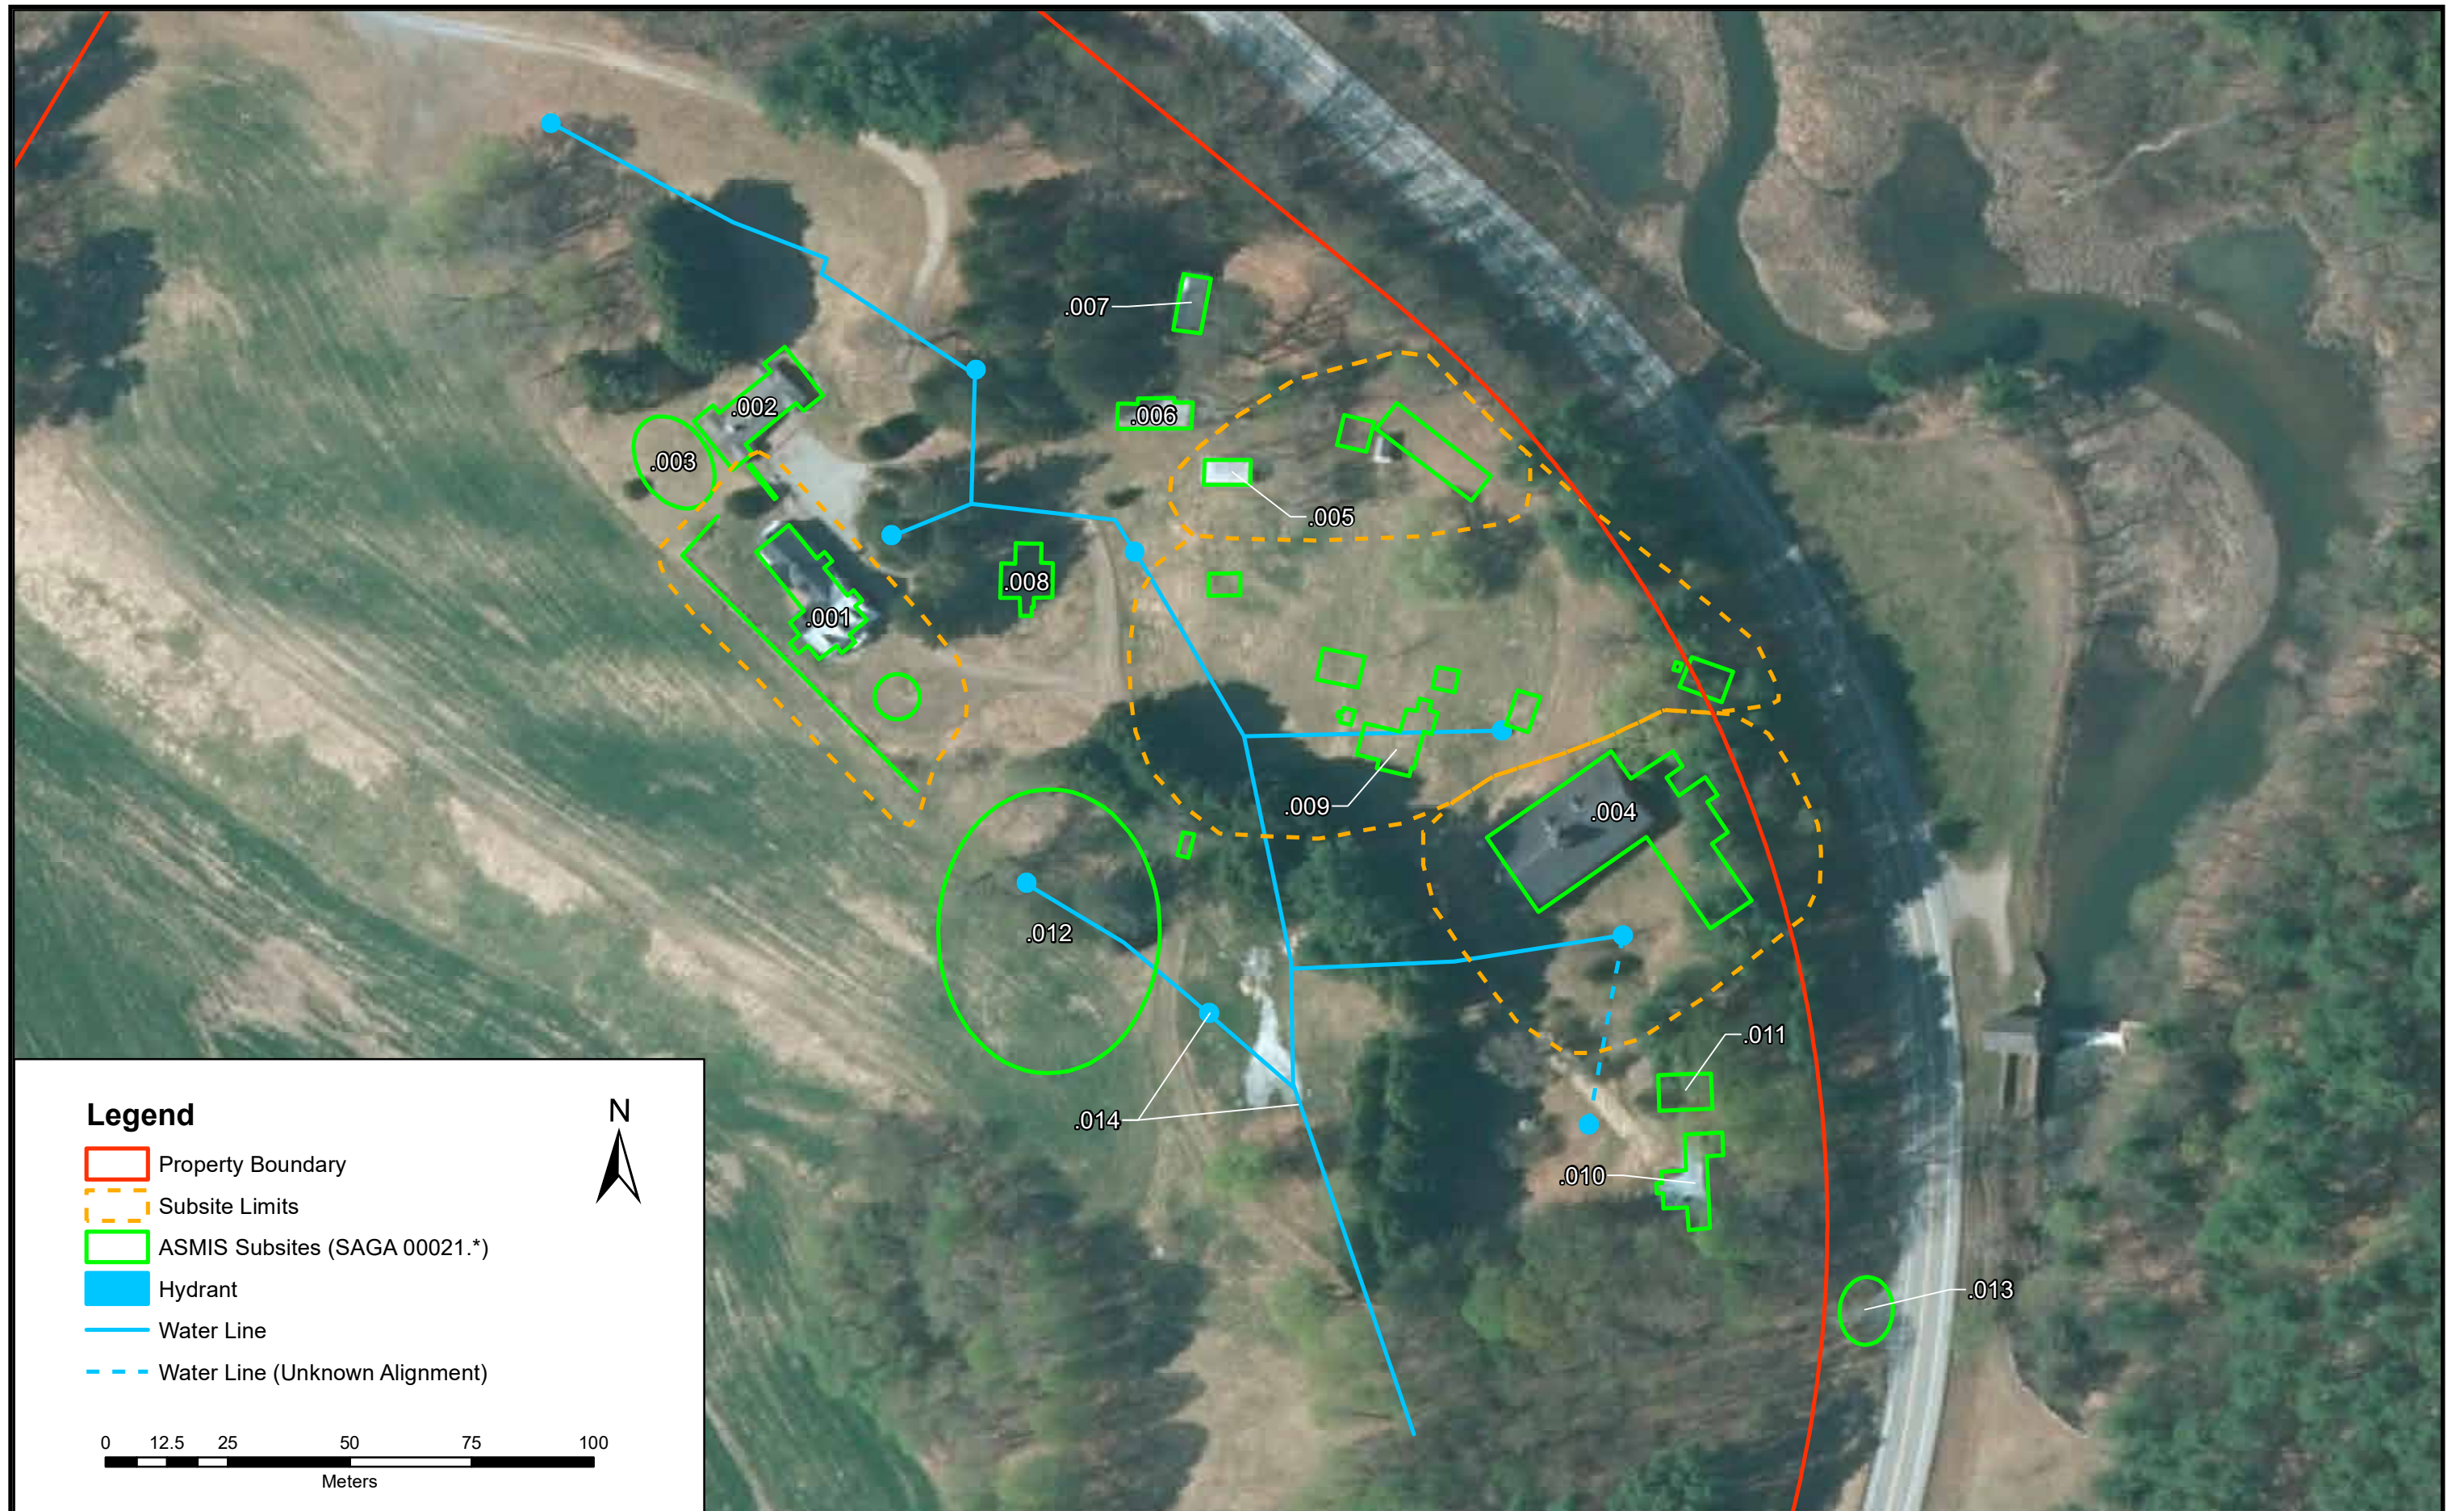
Figure 7.1 Aerial photograph of Blow-Me-Down Farm showing ASMIS subsites.
