**PHASE II ARCHAEOLOGICAL FIELD ASSESSMENT  
PHASE III ARCHAEOLOGICAL DATA RECOVERY  
AND MONITORING**

**BORTON/BALLINGER FARMSTEAD SITE  
[28-BU-949]**

**ROWAN COLLEGE AT BURLINGTON  
CAMPUS EXPANSION PROJECT  
MOUNT LAUREL TOWNSHIP**

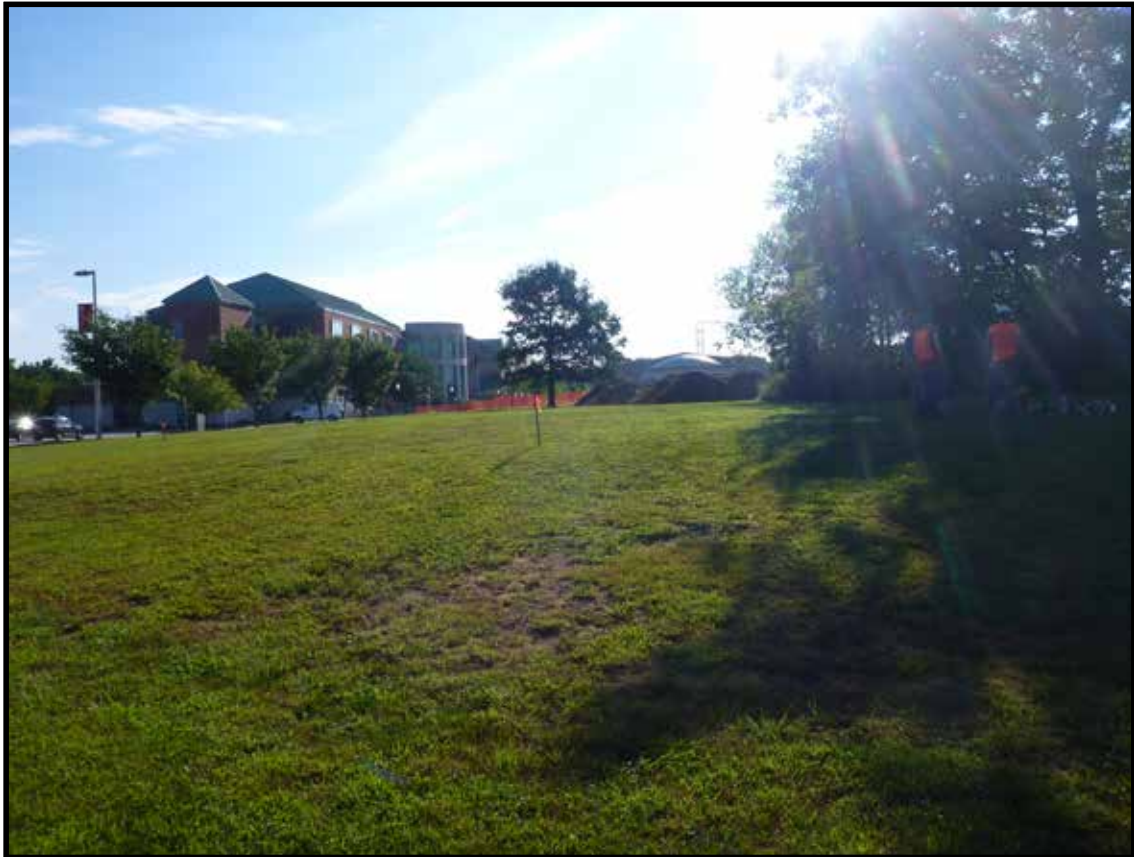
Photograph 3.1. View looking southeast of Borton/Ballinger Farmhouse Area prior to the start of excavation (Photographer: Joshua Butchko, August 2016) [HRI Neg. #16034/D1:003].

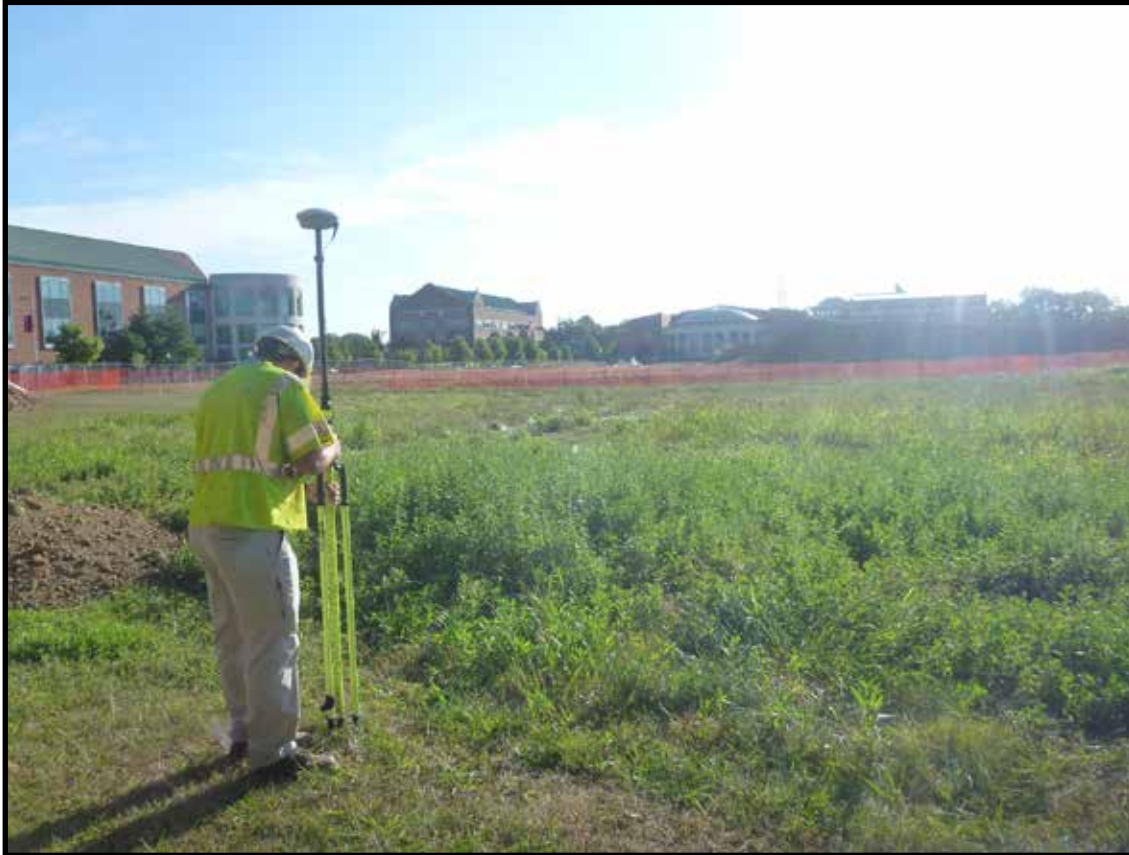
Photograph 3.2. View looking northeast of Borton/Ballinger Farmyard Area prior to the start of excavation. GIS specialist Evan Mydlowski is pictured plotting the location of test trenches (Photographer: Joshua Butchko, August 2016) [HRI Neg. #16034/D1:202].

A review of historic aeriels identified five to six possible outbuildings (numbered 1 through 6) east of the Borton/Ballinger Farmstead farm lane (Figure 3.1; Photograph 3.2). Using georeferenced historic aeriels, the approximate footprints of these buildings were plotted and trenches were mechanically excavated in these areas with the specific goal of identifying the extent, character and integrity of any remaining archaeological features (outbuilding 1 was not investigated because it falls outside of the project's proposed limit of disturbance). These buildings were removed at the same time that the Borton/Ballinger Farmhouse was demolished and some ground disturbance was expected. Modern aerial photographs give some indication of the extent of ground disturbance caused by these activities.

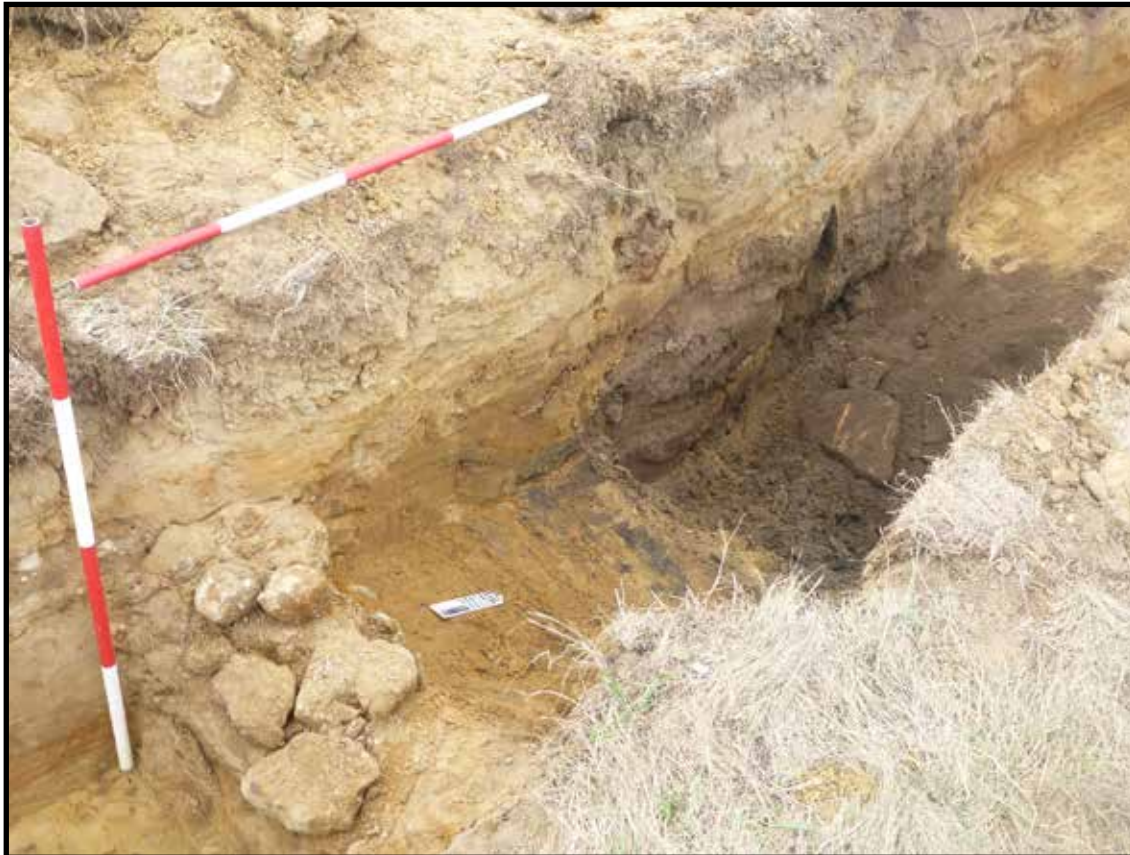
Photograph 3.3. View looking northwest showing partial west profile for Trench 103 (Photographer: Joshua Butchko, September 2016) [HRI Neg. #16034/D1:312].

This 50-foot-long trench was positioned running north-south across the site of outbuilding 2, which is identifiable in aerial photographs as a large barn (Figures 3.1, 3.2 and 3.3; Photographs 3.3. and 3.4). A mortared fieldstone foundation [122] running east-west was identified almost immediately after starting this trench. A southern foundation wall [118] was also identified in this trench 33 feet to the south. The trench was extended to ensure that no other features existed further to the south. The northern end of the trench was expanded to the east and west, forming a “T”, to “chase” the northern foundation in order to identify its northern corners. The remnants of the northwest corner were identified although the western foundation wall was only fragmentary. A possible interior rubble-stone wall footing [126] was identified running south from the northern foundation wall towards the southern end of the projected footprint and a possible northeastern corner was identified 43 feet east of the northwestern corner, making a roughly 43 by 33-foot barn foundation with a 10-foot wide (interior dimensions) bay running north-south. Concrete debris was identified at the projected northeastern corner of the barn and stratigraphy in this area suggested it had been disturbed by modern construction activities. Only the bottom few courses of stone of the mortared masonry foundations were identified in these trenches. A large block of dumped concrete, probably a Portland-type, was also identified along the northern foundation wall that appeared to represent a modern foundation repair episode. This concrete appears to have been used elsewhere to repair the foundation during the 20th century. Artifacts from this trench primarily consisted of unidentifiable ferrous metal fragments. A fragment of large mammal bone was recovered from the backdirt pile.

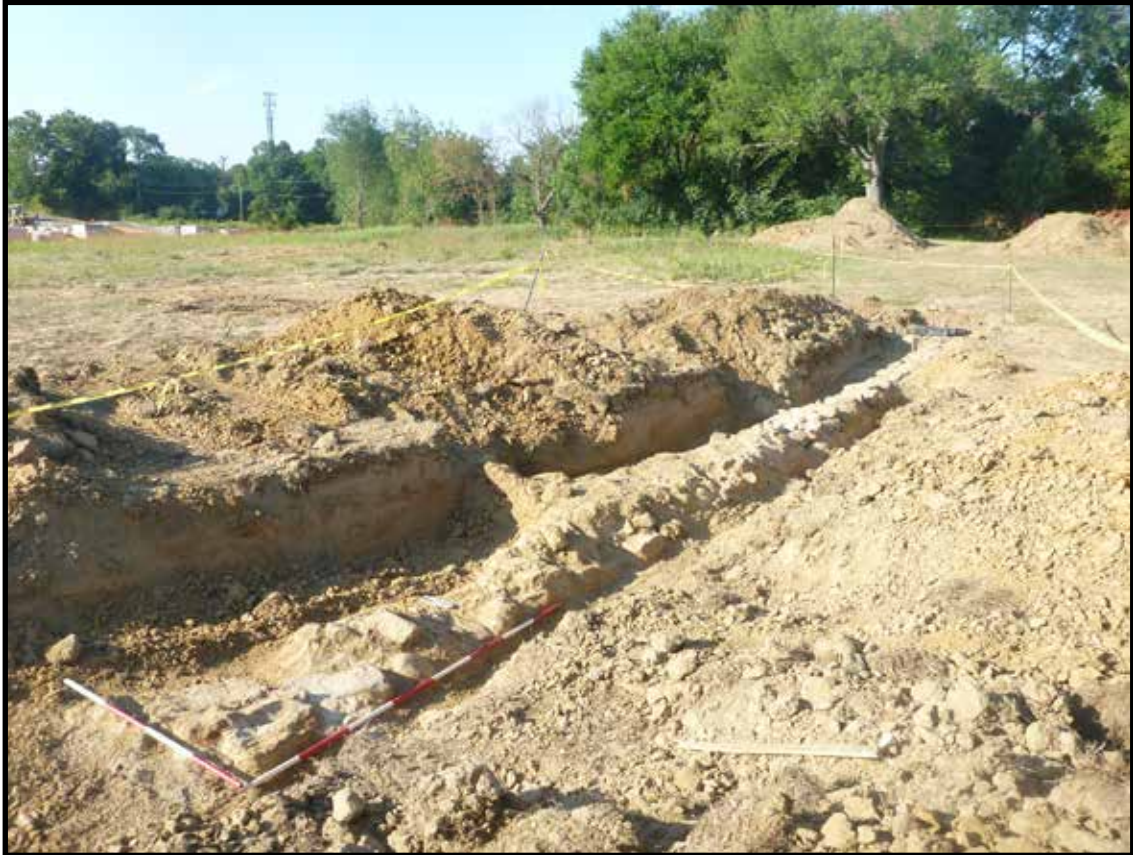
Photograph 3.4. View looking southwest showing north extent of barn foundation exposed in Trench 103 (Photographer: Joshua Butchko, September 2016) [HRI Neg. #16034/D2:165].

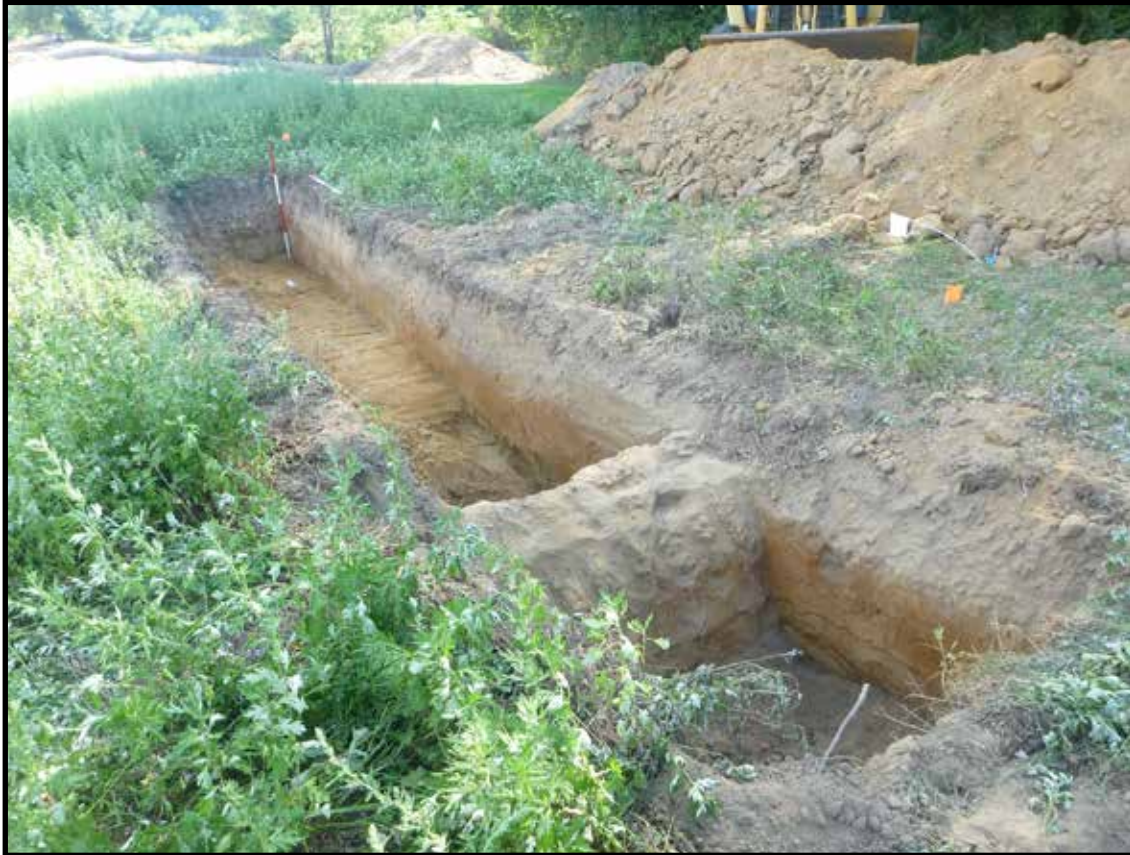
Photograph 3.5. View looking southwest showing partial west profile for Trench 104 (Photographer: Joshua Butchko, September 2016) [HRI Neg. #16034/D1:220].

This 32-foot long north-south trench was situated to identify the remains of outbuilding 6 (Figures 3.1 and 3.4; Photograph 3.5). A shallow mortared fieldstone foundation [128] was identified running east-west at the north end of the trench in the approximate location where the georeferencing indicated that the northern edge of the building’s footprint would be (Figure 3.1). Despite continuing the trench to the south beyond the projected southern edge of the outbuilding no other foundation remains were identified. The northern end of the trench was expanded 9 feet to the west, and a possible northwest corner (turning south) was identified, although the foundation remains were fragmentary after having apparently been damaged during the building’s demolition. The absence of a southern foundation wall could be a result of the gentle slope down to the south in this area. The southern foundation may have projected further above ground to keep the building level and was removed because of this. It could also indicate that the outbuilding was three sided, as are many tractor sheds and some livestock pens. Small fragments of redware, creamware and shell were collected from the backdirt pile associated with this trench along with a small numbered metal tag and a modern plastic flower tag for chrysanthemums.

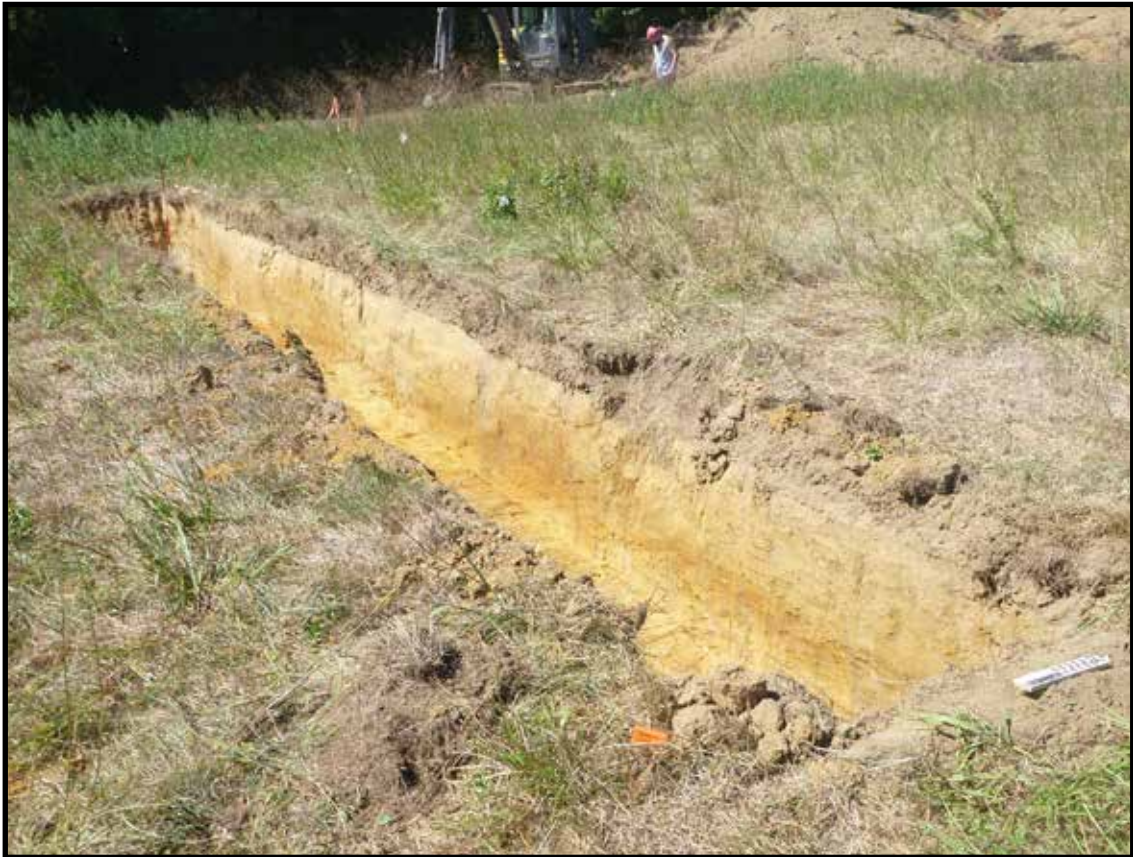
Photograph 3.6. View looking northwest showing final view of Trench 105 (Photographer: Joshua Butchko, September 2016) [HRI Neg. #16034/D2:031].

Trench 105 was excavated east-west across the projected locations of outbuildings 5 and 4 starting just southeast of the southern end of Trench 104 and extending 45 feet (Figure 3.1; Photograph 3.6). It is unclear if these outbuildings were permanent structures or if the objects from the aerial photographs were large trailers or wagons. Two features with rounded bottoms were observed in the southern profile 6.5 feet apart towards the western end of the trench (Figure 3.5). They fall roughly within the projected center of outbuilding 5 and may have held posts or piers that

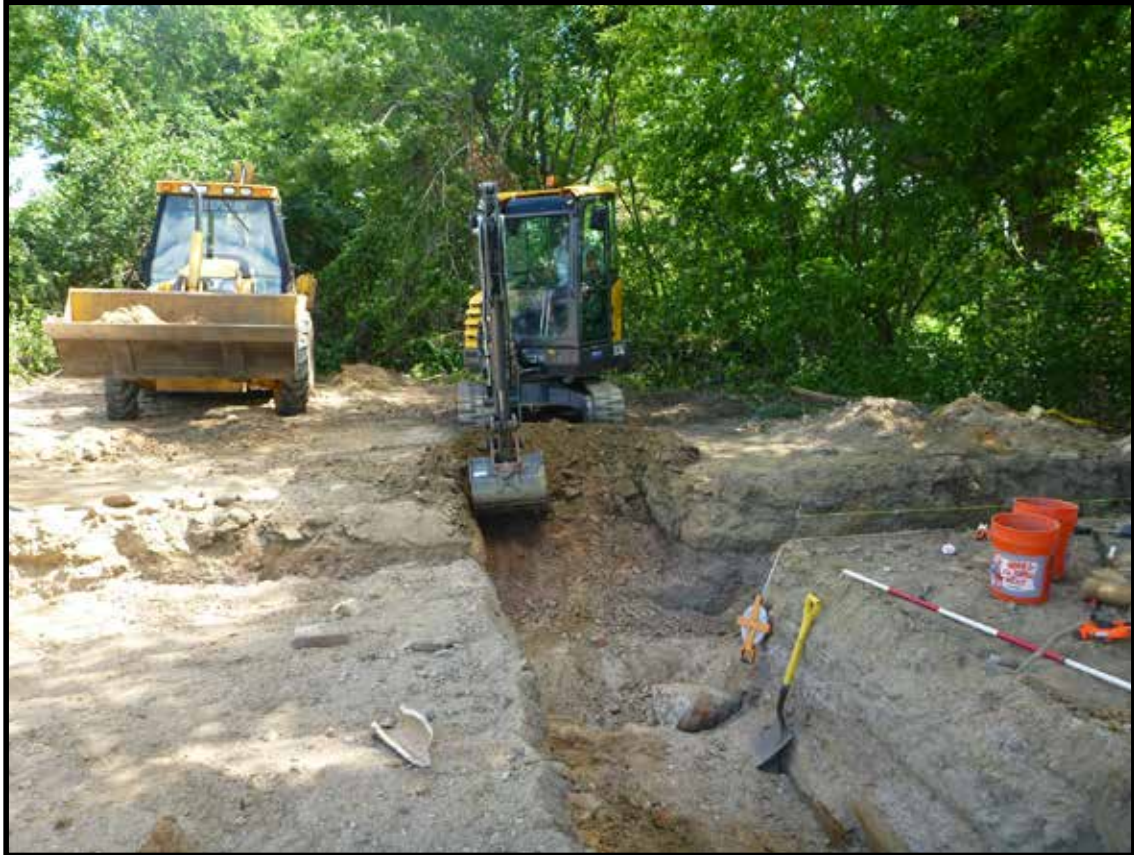
Photograph 3.7. View looking southeast during machine excavation of Trench 102 (Photographer: Joshua Butchko, August 2016) [HRI Neg. #16034/D1:045].

Trench 102 was oriented northwest-southeast, perpendicular to Trench 101, and measured 65 feet long by 5 feet wide (Figures 3.6 and 3.8). As with Trench 101 it was placed to identify the limits of the farmhouse's foundation. This trench, again mechanically excavated, uncovered more of the northern foundation wall [23] of the house but did not locate the southern foundation wall, which was eventually located 6 feet beyond the end of this trench (Figure 3.8; Photograph 3.7). The northern foundation wall within this trench was significantly disturbed by both the installation of modern utilities (a modern pvc sewer pipe [113]) and the subsequent demolition of the house, which had

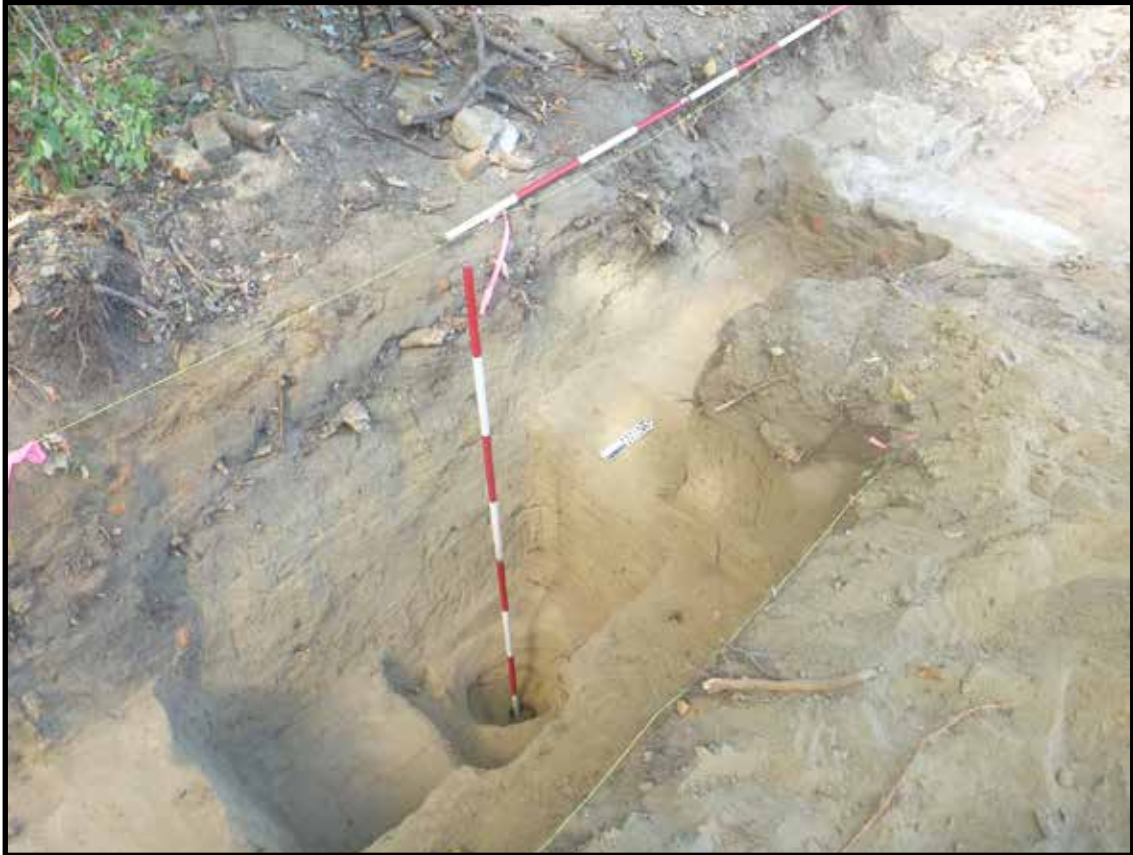
Photograph 3.8. View facing northwest showing western profile of Trench 106 (Photographer: Joshua Butchko, September 2016) [HRI Neg. #16034/D2:231].

Trench 106 extended 40 feet south of the southwestern corner of the house's foundation [39], which had been identified as part of the open area excavation of the foundation discussed in detail below (Figure 3.6). This trench, which was initially excavated mechanically, shovel tested at 10-foot intervals and then internally subdivided into hand-dug excavation units, was located to delineate a historic midden described in the Phase II report. Excavation identified a substantial lens of material [5] apparently associated with the demolition of a structure, but not from the modern demolition of the Borton/Ballinger Farmhouse, as it largely lacked modern artifacts (Figure 3.9; Photograph 3.8). It relates to an earlier demolition/reconstruction episode. A buried historic yard surface [62] was identified underlying this demolition deposit, which was sampled and found to contain 18th- through 19th-century artifacts (Figure 3.9). These items were not found in sufficient quantity or concentration to be considered part of a historic trash midden and are likely part of a general scatter of artifacts broadcast around the historic ground surface. This surface overlay a thick lens of upcast subsoil [55] that, in turn, overlay a truncated subsoil [63]. This upcast material had very few artifacts and is most likely derived from the cellar excavation for the construction of the foundation [39]. Finally, a narrow builder's trench [61/60] was identified between the foundation [39]

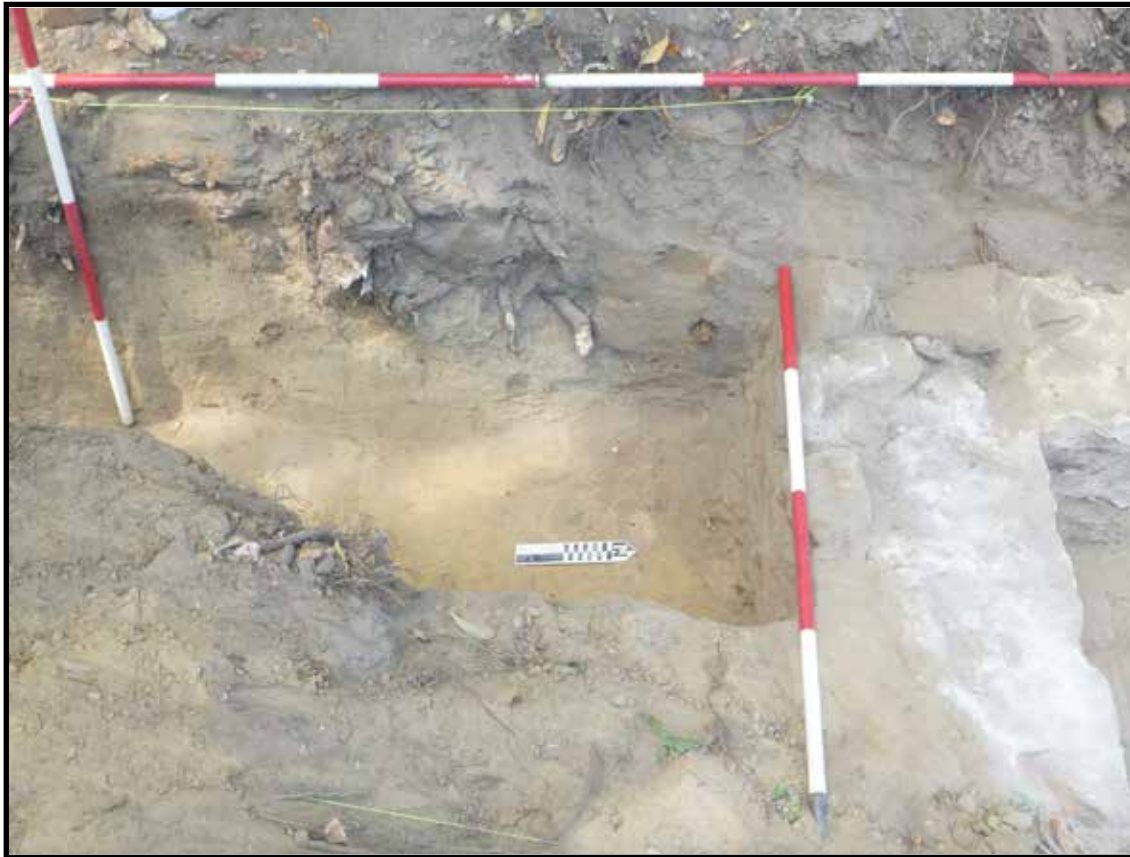
Photograph 3.9. View west showing the builder's trench identified in Trench 106 (Photographer: Joshua Butchko, September 2016) [HRI Neg. #16034/D2:224].

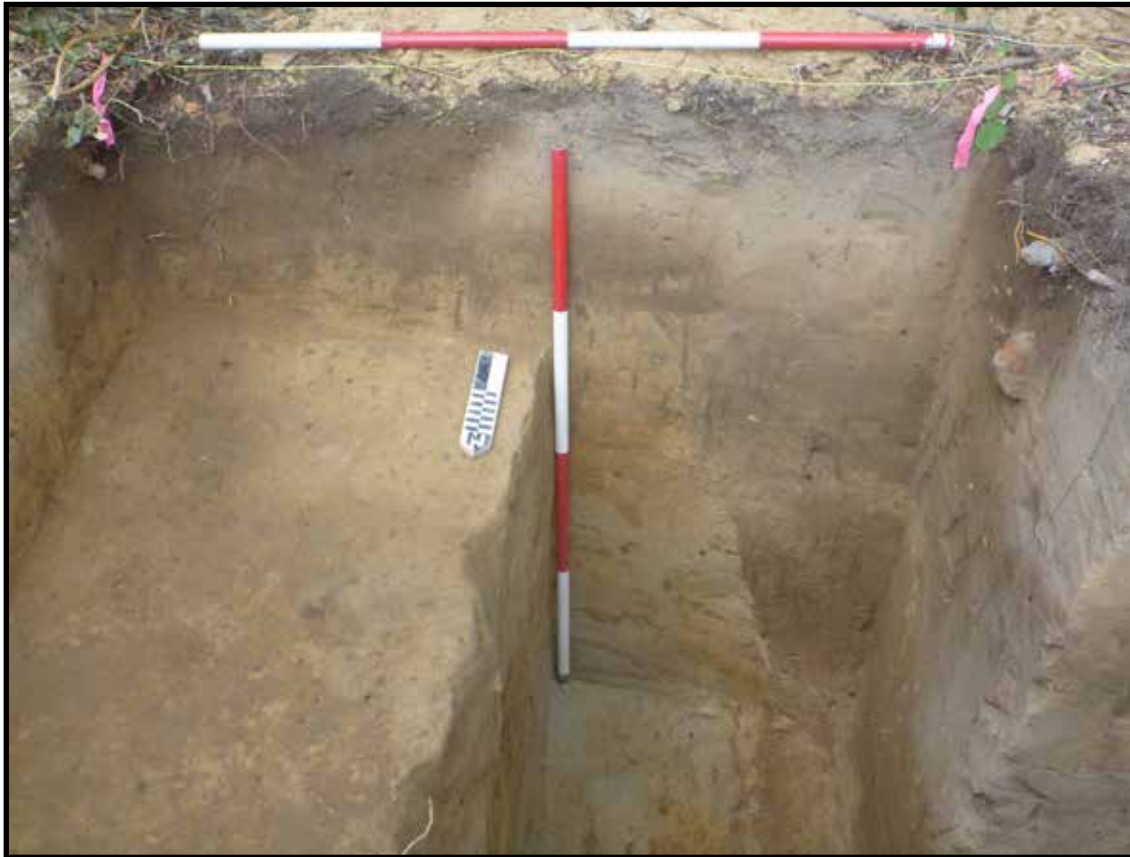
Photograph 3.10. View looking south showing final profile view of Excavation Unit 114 (Photographer: Andrew Martin, September 2016) [HRI Neg. #16034/D3:193].

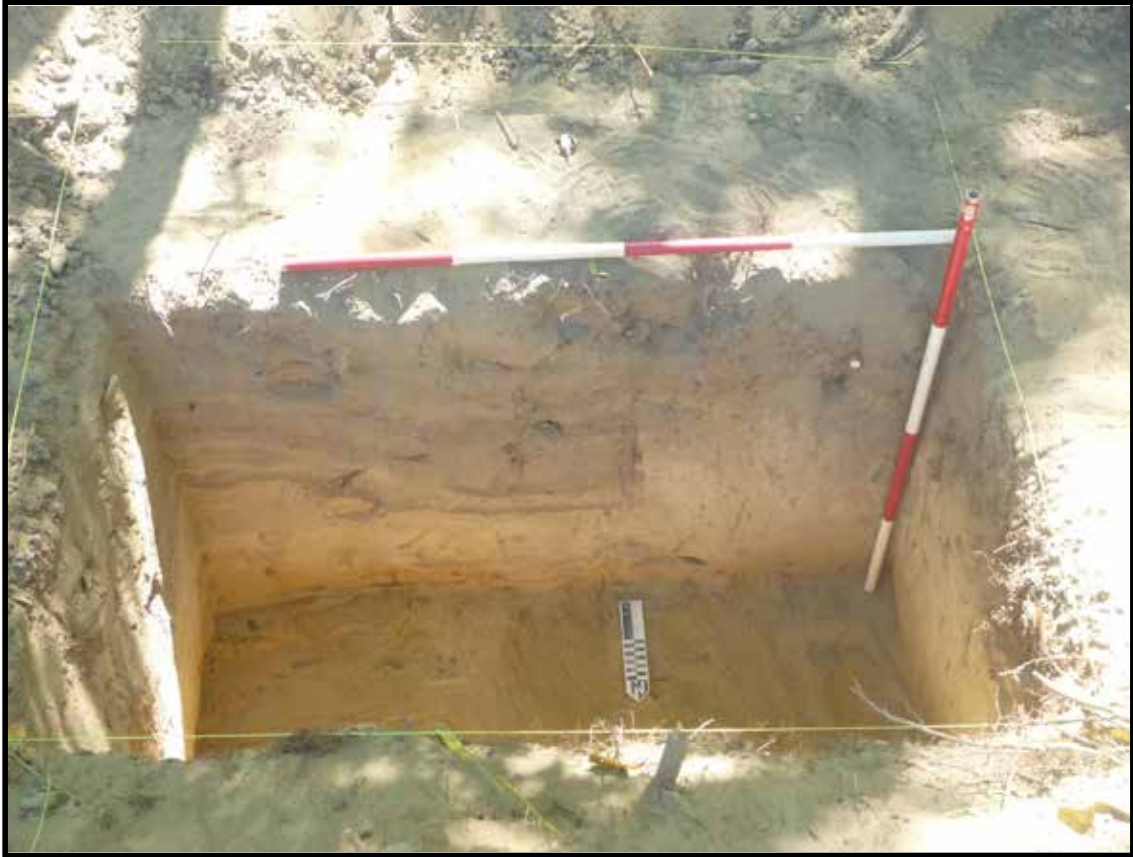
Photograph 3.11. View facing south showing the Phase II unit within the southern profile of Excavation Unit 113 (Photographer: Joshua Butchko, September 2016) [HRI Neg. #16034/D2:241].

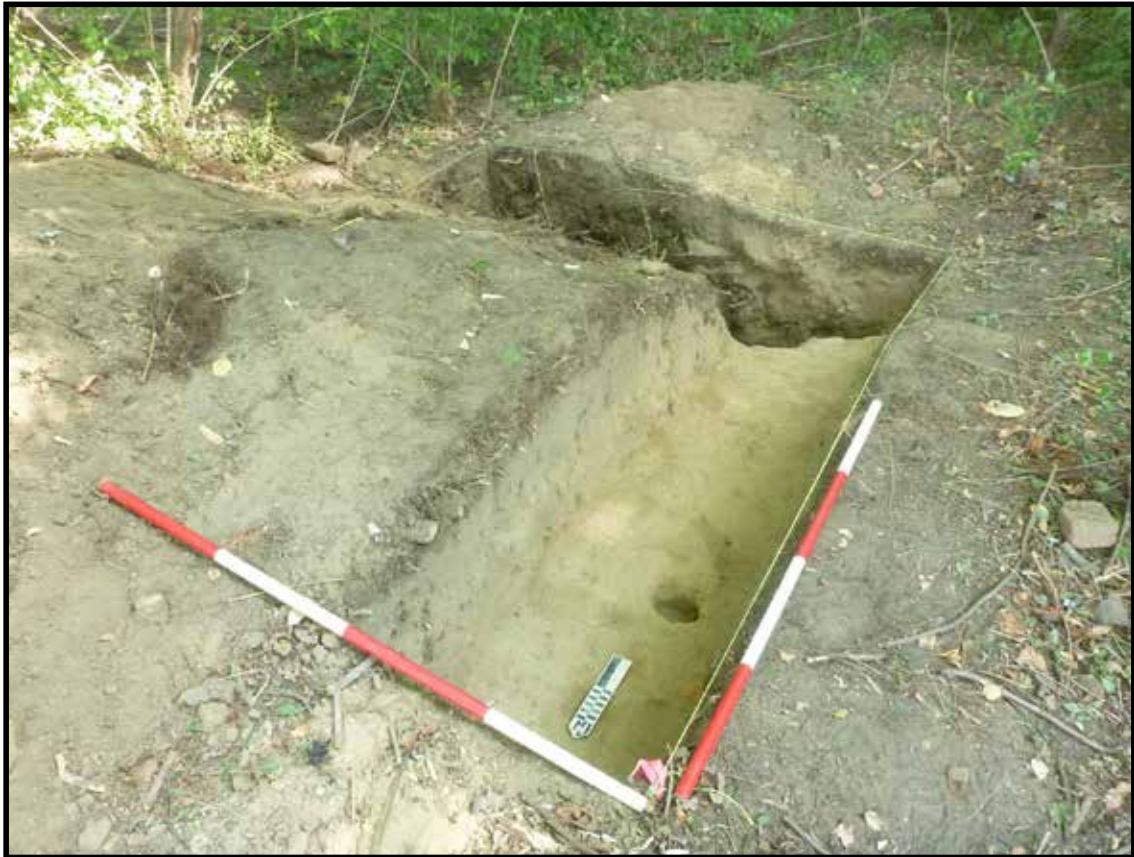
Photograph 3.12. View looking southeast showing final excavation view of Excavation Units 101 and 102 (Photographer: Dorothy Both, September 2016) [HRI Neg. #16034/D1:251].

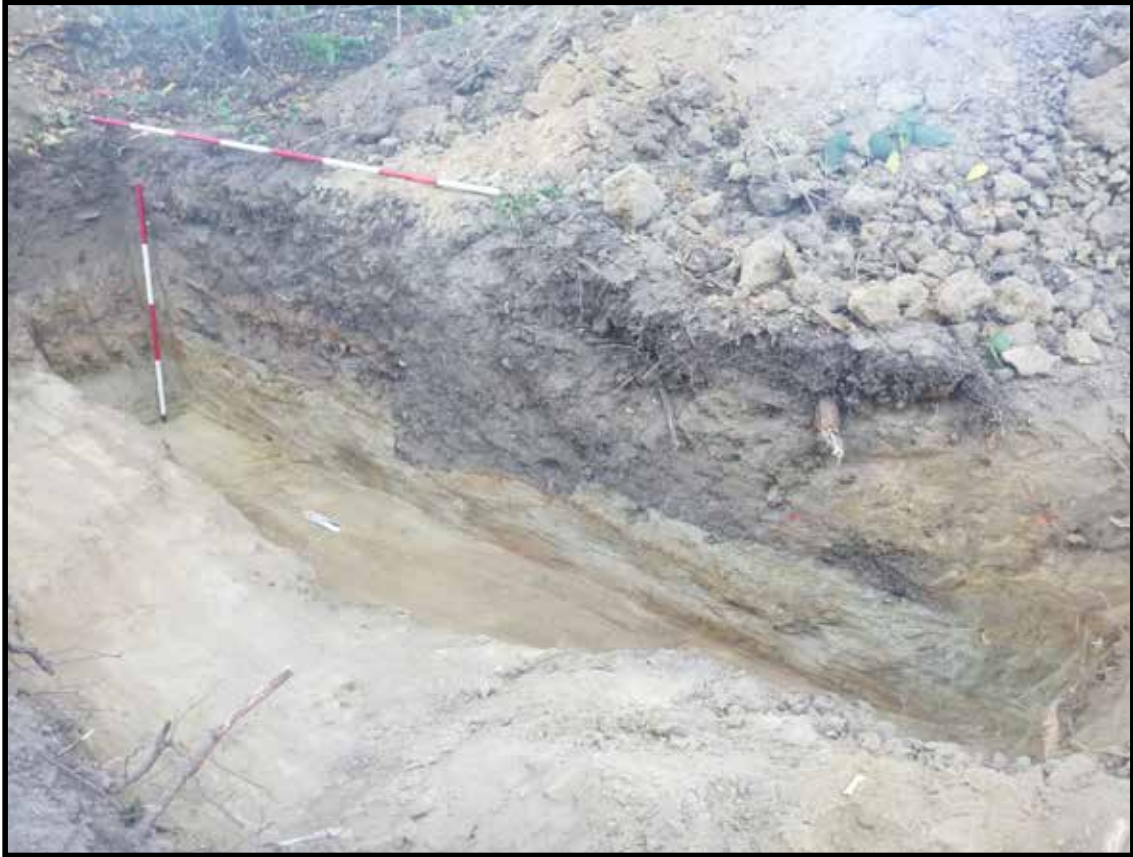
Photograph 3.13. View looking northeast showing final excavation view of Excavation Units 101 and 102 and Trench 109 (Photographer: Joshua Butchko, September 2016) [HRI Neg. #16034/D2:336].

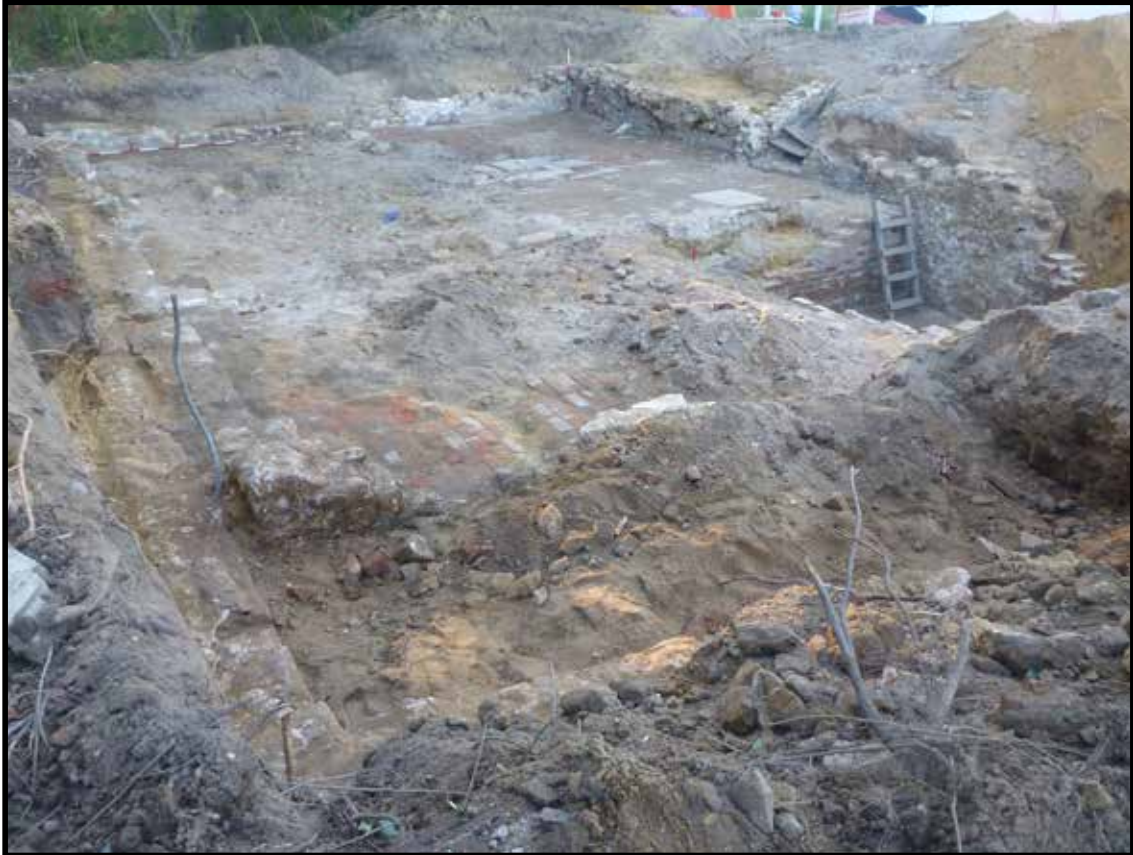
Photograph 3.14. View looking northwest showing final view of the Borton/Ballinger Farm House basement floor plan (Photographer: Joshua Butchko, September 2016) [HRI Neg. #16034/D3:363].

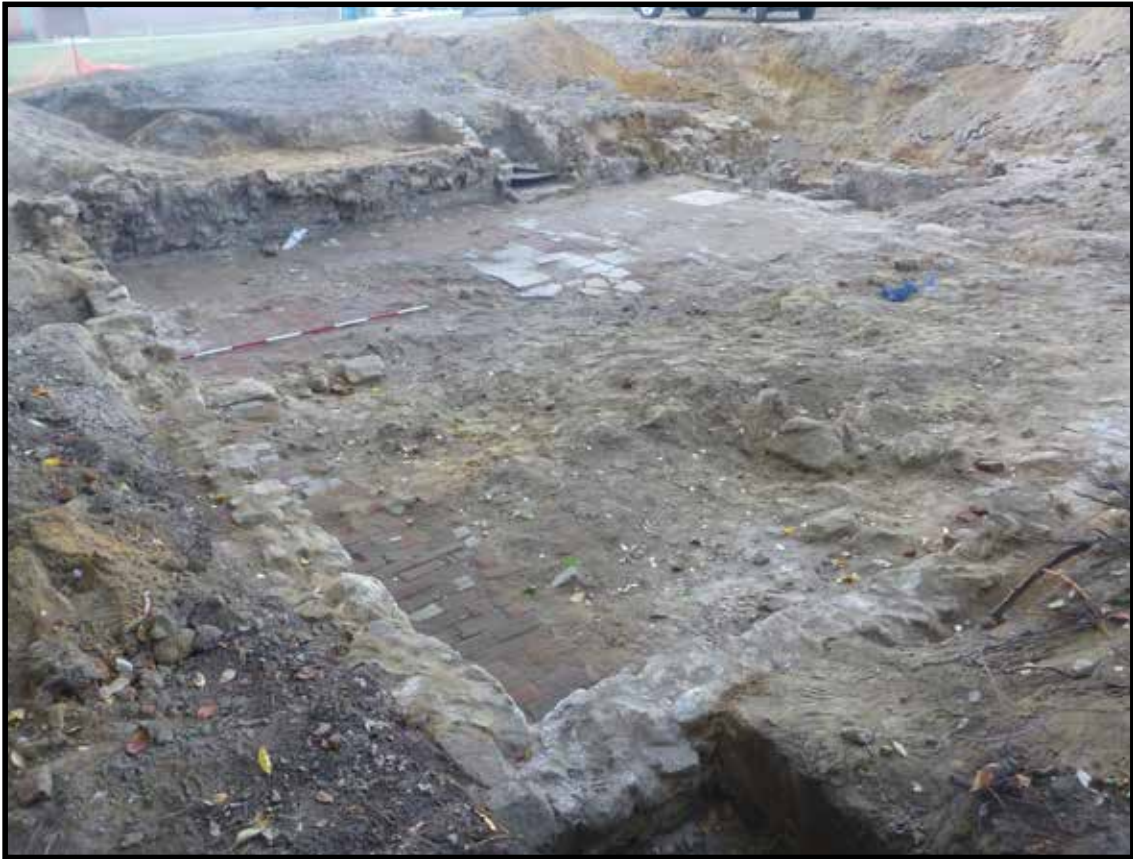
Photograph 3.15. View looking northeast showing final view of the Borton/Ballinger Farm House basement floor plan (Photographer: Joshua Butchko, September 2016) [HRI Neg. #16034/D3:384].

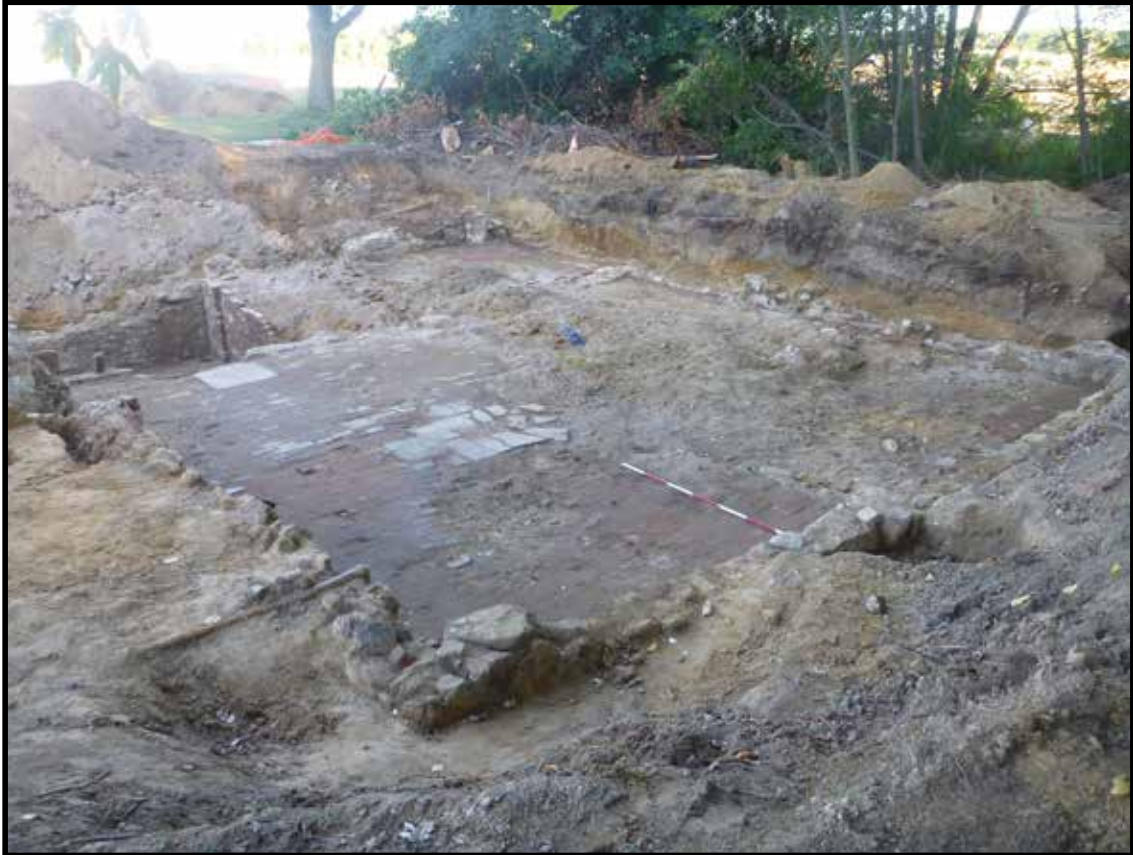
Photograph 3.16. View looking southeast showing final view of the Borton/Ballinger Farm House basement floor plan (Photographer: Joshua Butchko, September 2016) [HRI Neg. #16034/D3:377].

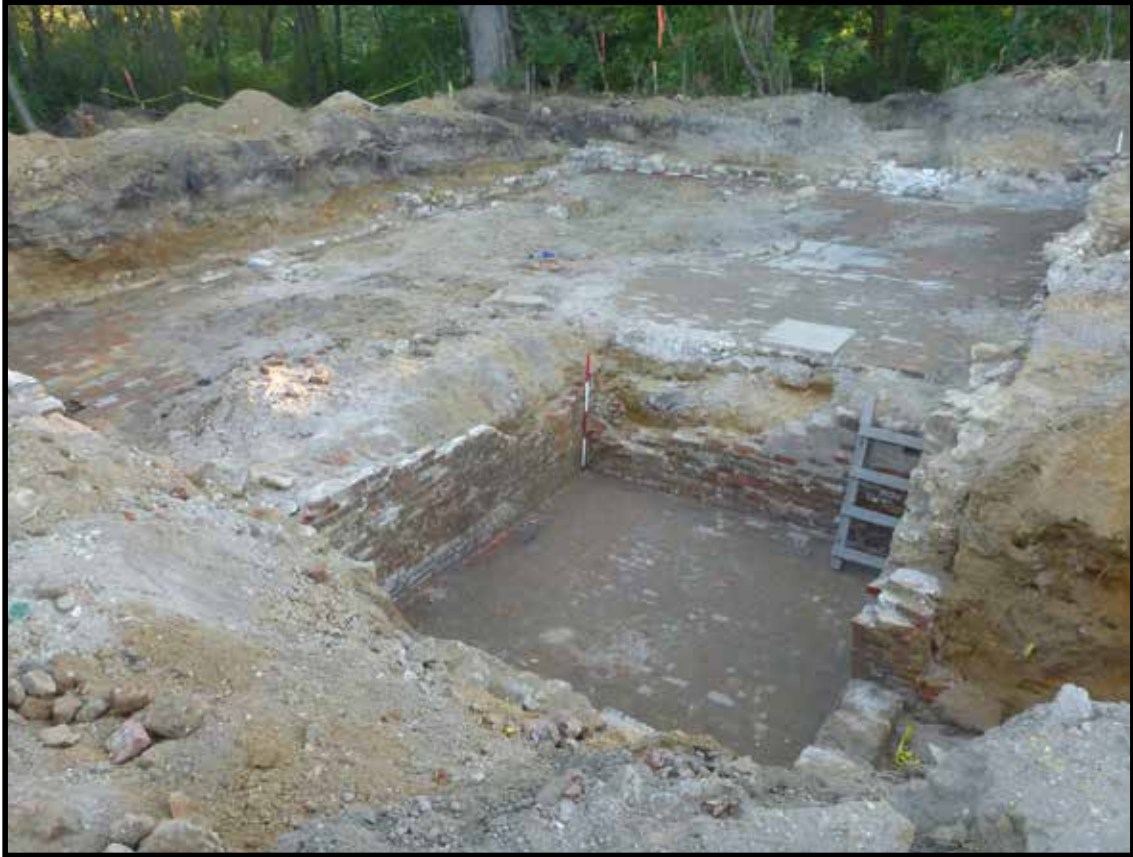
Photograph 3.17. View looking southwest showing final view of the Borton/Ballinger Farm House basement floor plan (Photographer: Joshua Butchko, September 2016) [HRI Neg. #16034/D3:365].

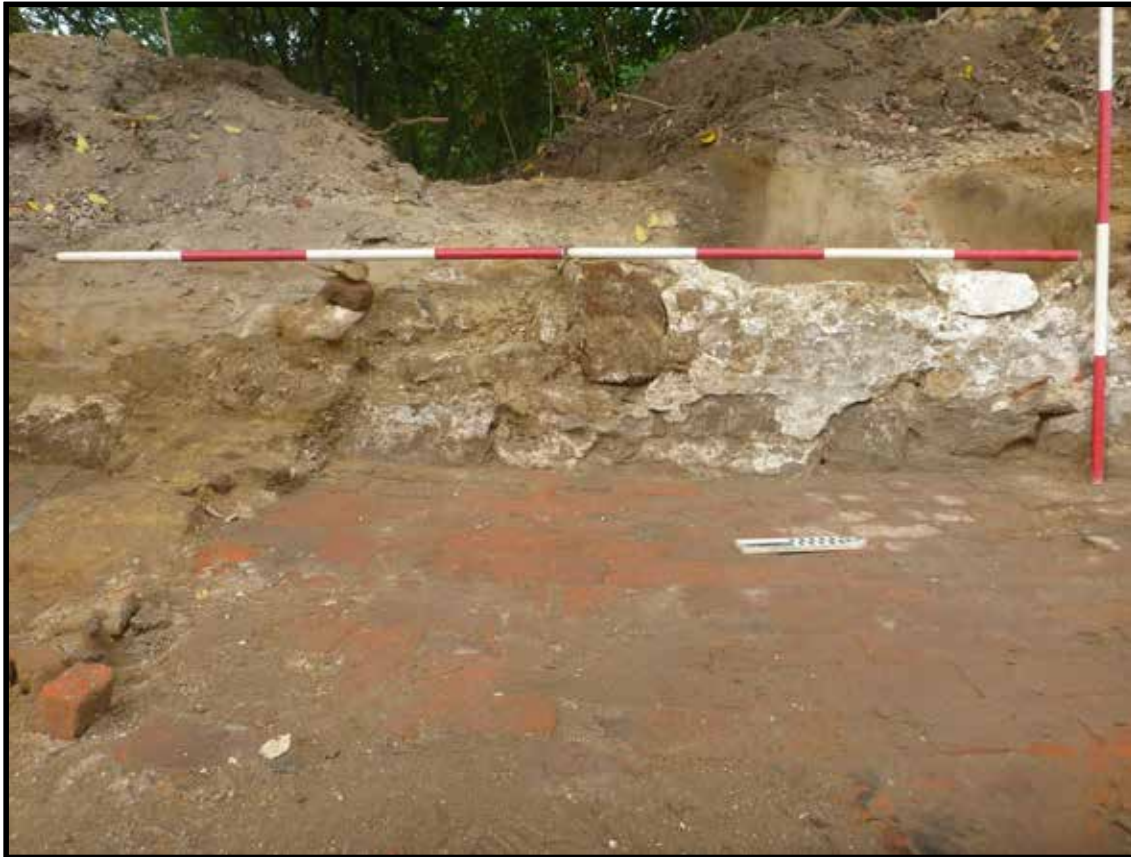
Photograph 3.18. View looking west showing abutment of Contexts 86 and 7 along the west extent of the Borton/Ballinger Farm House basement foundation (Photographer: Joshua Butchko, September 2016) [HRI Neg. #16034/D3:146].

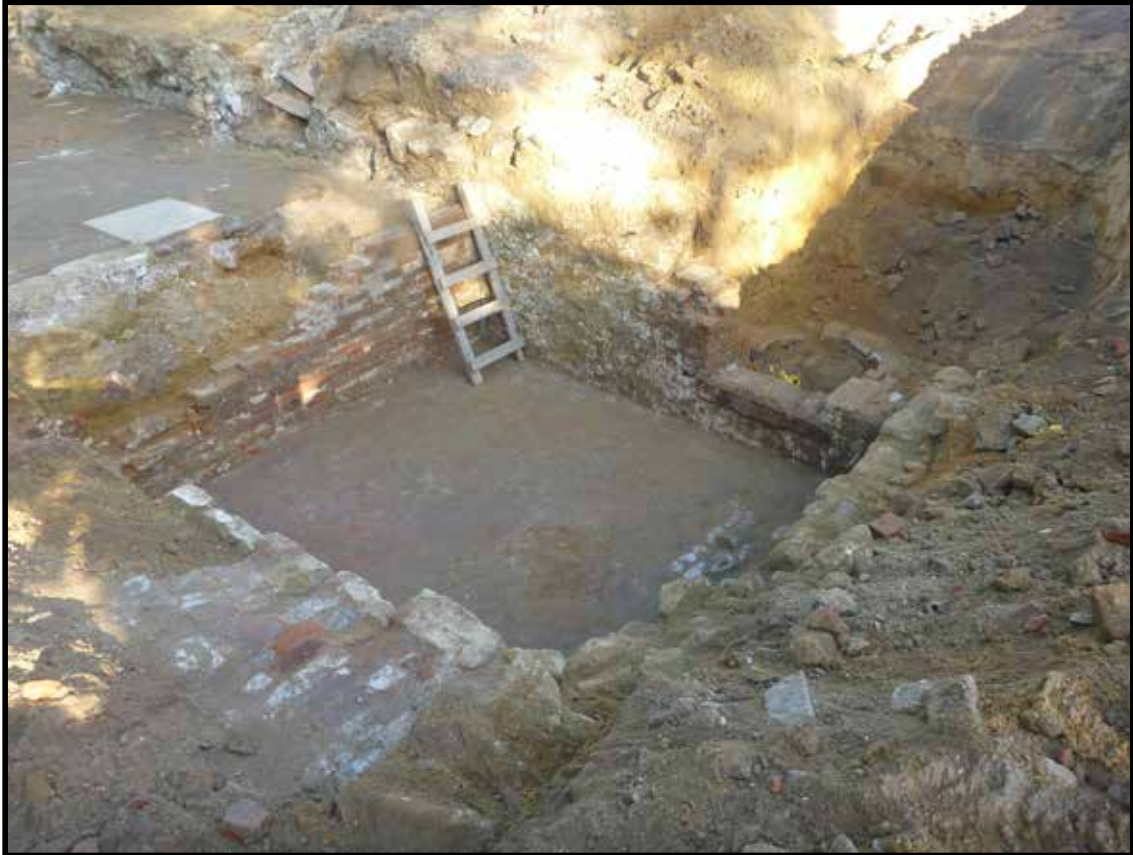
Photograph 3.19. View looking northwest showing final view of the subcellar in the northeast corner of the Borton/Ballinger Farm House basement (Photographer: Joshua Butchko, September 2016) [HRI Neg. #16034/D3:285].

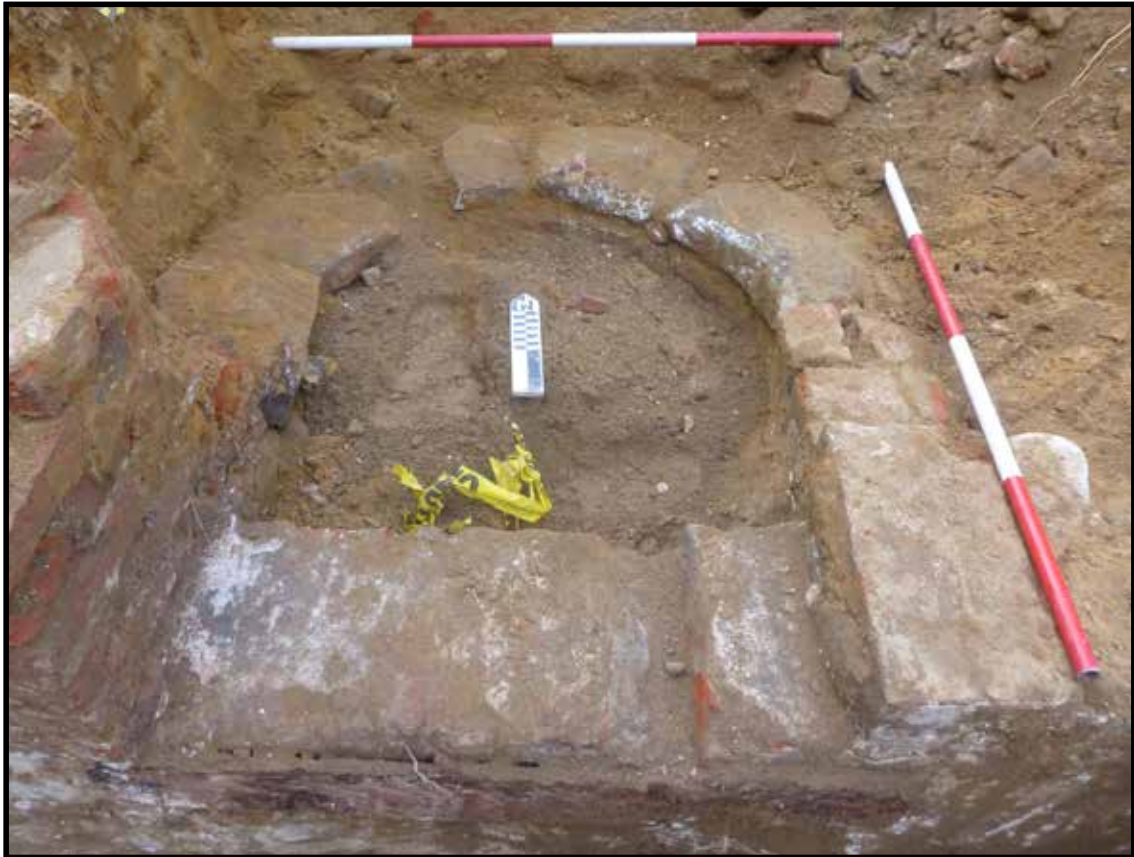
Photograph 3.20. View looking north showing detail of well shaft feature extending north of the main footprint from the subcellar of the Borton/Ballinger Farm House (Photographer: Joshua Butchko, September 2016) [HRI Neg. #16034/D3:242].
