**PHASE II ARCHAEOLOGICAL FIELD ASSESSMENT  
PHASE III ARCHAEOLOGICAL DATA RECOVERY  
AND MONITORING**

**BORTON/BALLINGER FARMSTEAD SITE  
[28-BU-949]**

**ROWAN COLLEGE AT BURLINGTON  
CAMPUS EXPANSION PROJECT  
MOUNT LAUREL TOWNSHIP**

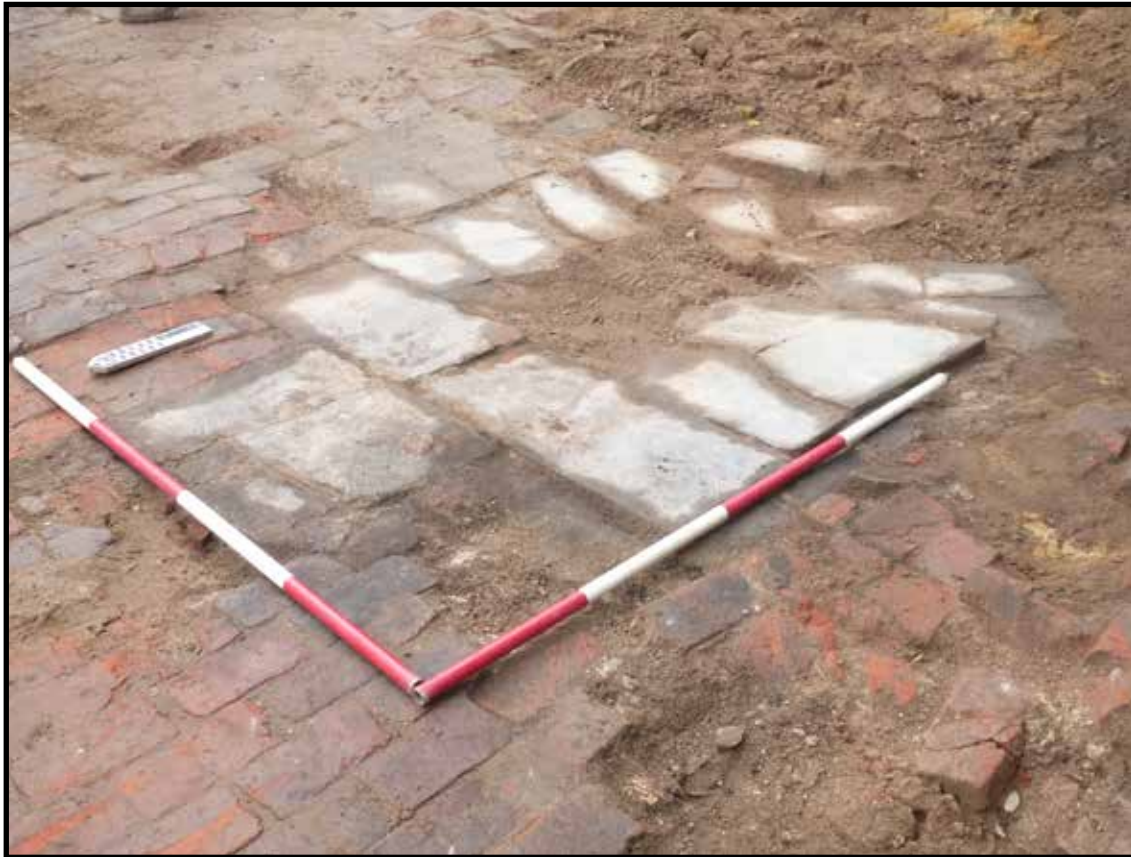
Photograph 3.21. View looking southeast showing Context 87, a slate floor surface, in the northwest chamber of the main basement level in the Borton/Ballinger Farm House (Photographer: Joshua Butchko, September 2016) [HRI Neg. #16034/D3:113].

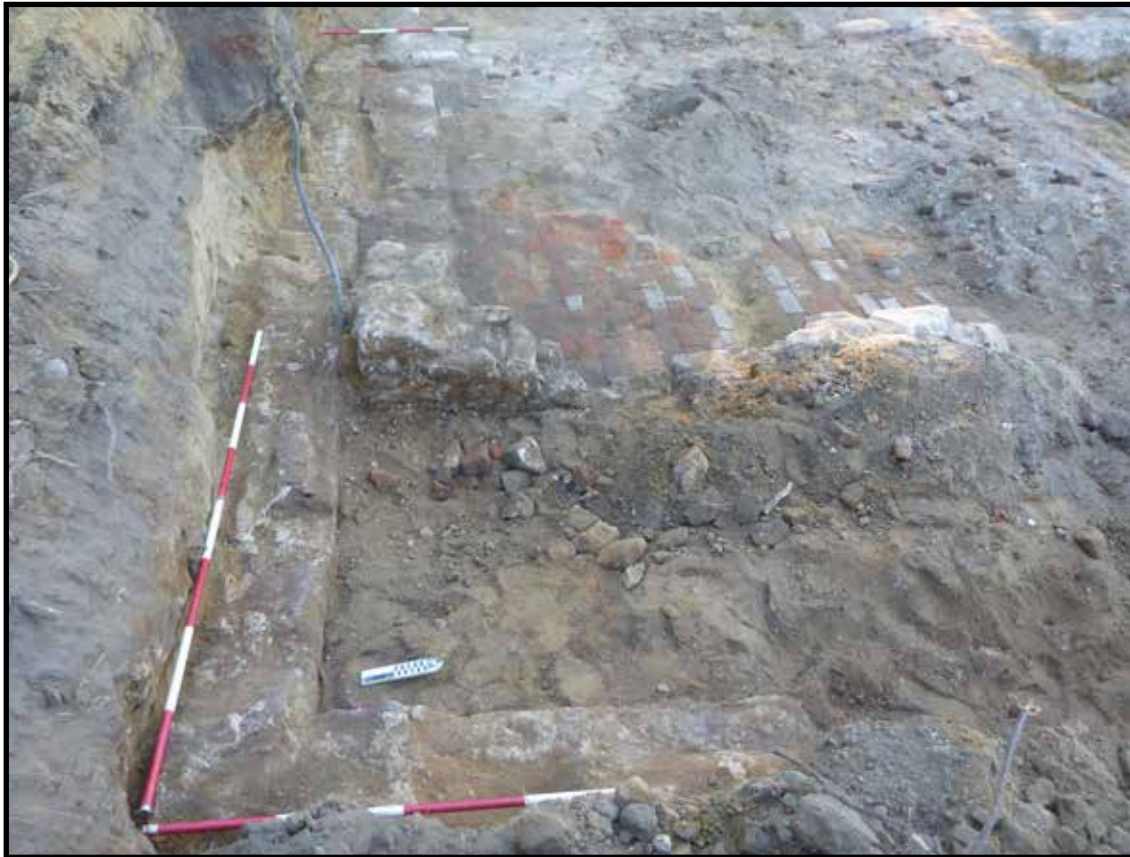
Photograph 3.22. View looking west showing foundations of possible earlier structure truncated by the original house foundation (Photographer: Joshua Butchko, September 2016) [HRI Neg. #16034/D3:358].

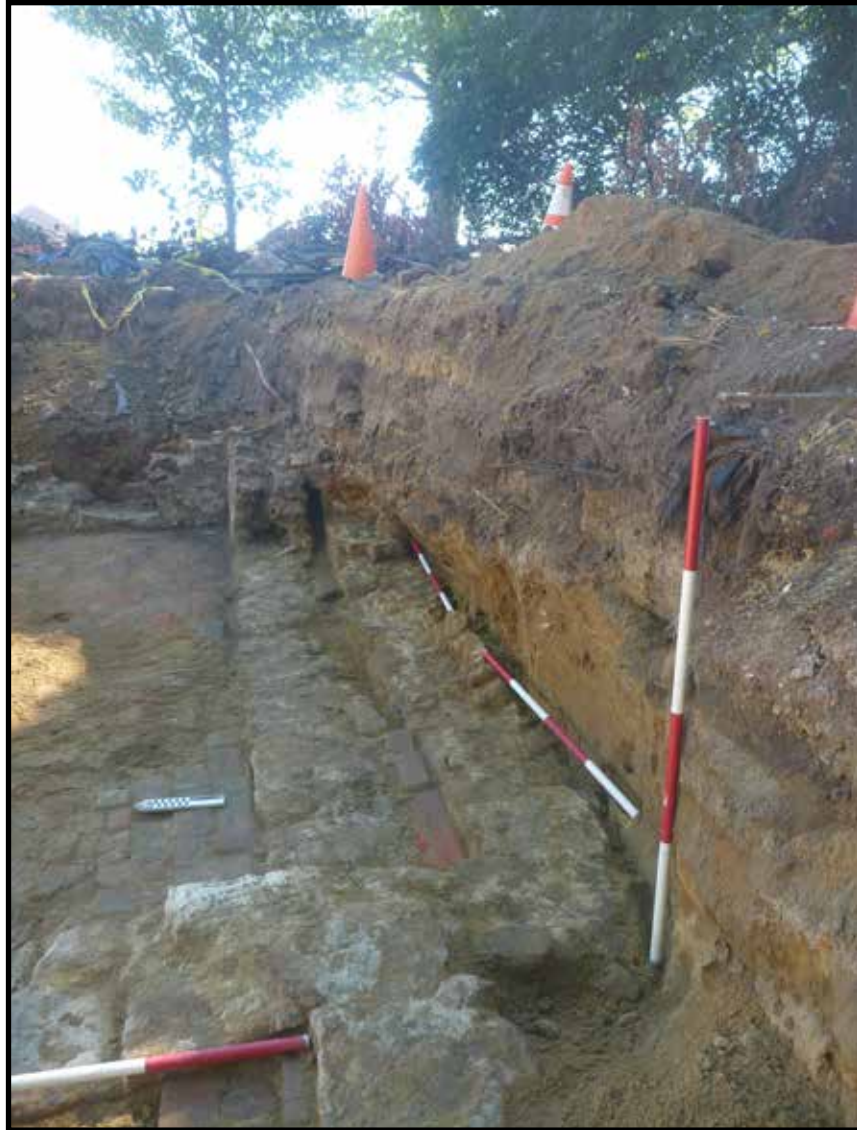
Photograph 3.23. View looking west showing foundations of possible earlier structure truncated by the original house foundation (Photographer: Joshua Butchko, September 2016) [HRI Neg. #16034/D3:310].

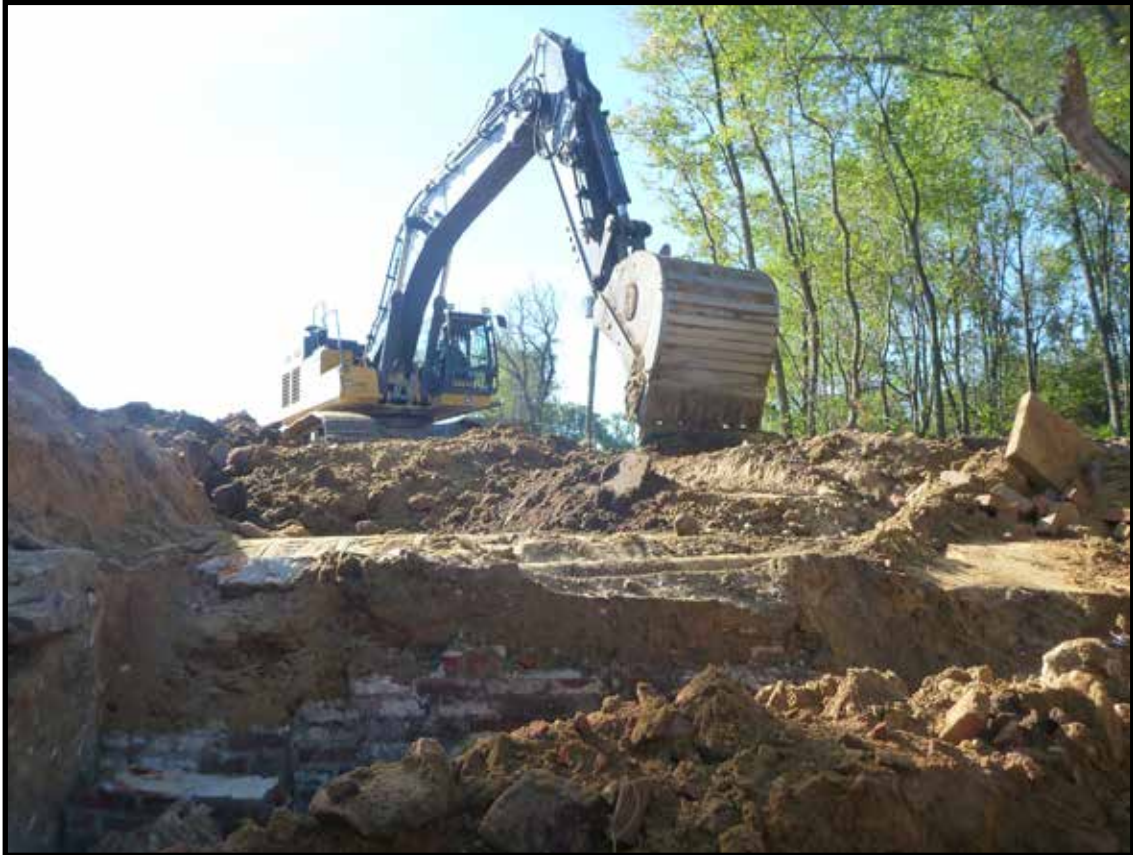
Photograph 3.24. View looking south showing mechanical grading of Borton/Ballinger Farm House Site observed during archaeological monitoring program of new construction (Photographer: Joshua Butchko, October 2016) [HRI Neg. #16034/D4:046].

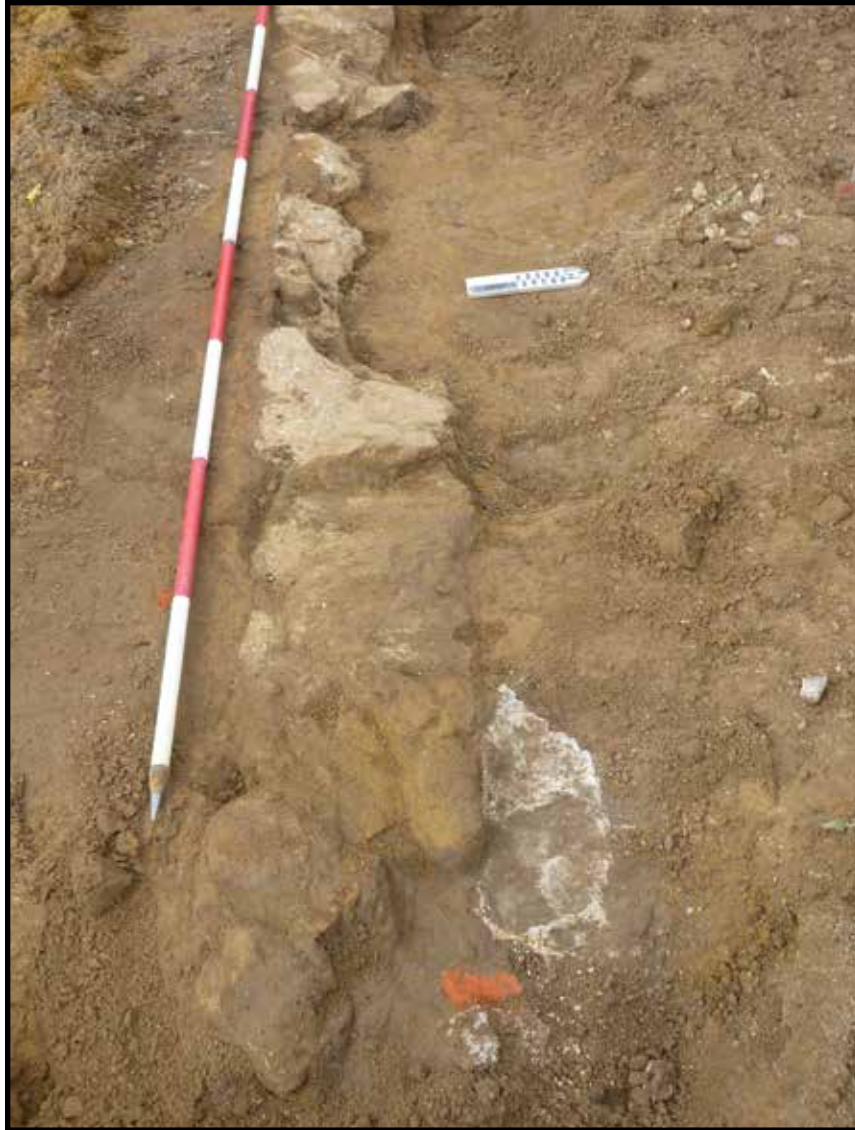
Photograph 3.25. View looking west showing northern addition footings (Contexts 147 and 148) of Borton/Ballinger Farm House Site observed during archaeological monitoring program of new construction (Photographer: Joshua Butchko, October 2016) [HRI Neg. #16034/D4:079].

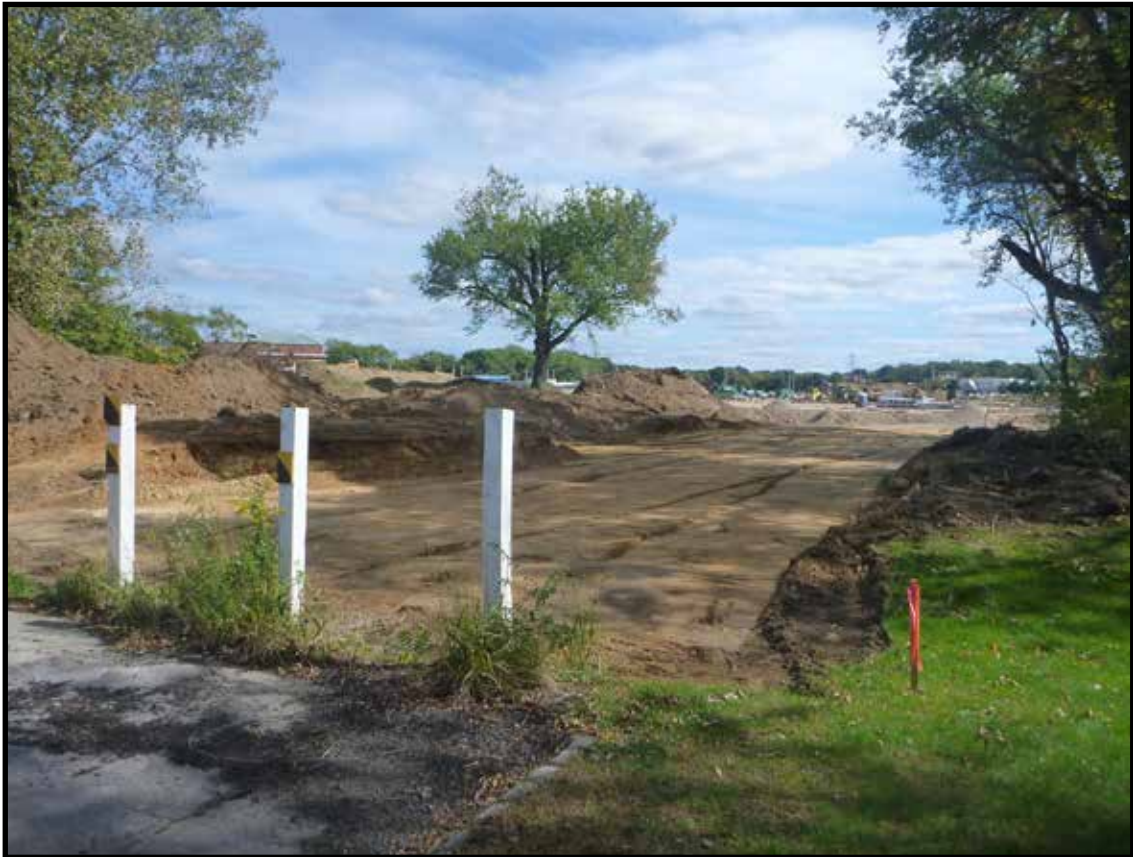
Photograph 3.26. View looking east-southeast showing final grade for proposed road at Borton/Ballinger Farm House Site observed during archaeological monitoring program of new construction (Photographer: Joshua Butchko, October 2016) [HRI Neg. #16034/D4:094].

natural subsoils (Photograph 3.26). Once this grade was reached across the site, the contractors performed narrower machine excavation within the construction footprint to facilitate installation of new utility pipes along what was expected to become the west edge of the proposed road alignment (Photograph 3.27). At the close of excavation this western extent was situated approximately 4 feet east of the two historic osage orange trees identified by the earlier surveys. The utility pipe trenching generally extended along the bottom of this western limit of excavation measuring 5 feet wide and approximately 8 to 10 feet below the original grade. As the new utilities were installed, the monitor was able to photograph in detail the western profile including the intact cultural deposits that were investigated during the data recovery (Photograph 3.28). Monitoring was completed at the north end of the Borton/Ballinger Farmstead site boundary where new surface outlets were installed along the east edge of the proposed road alignment connecting utilities to the extant campus system (Photograph 3.29).

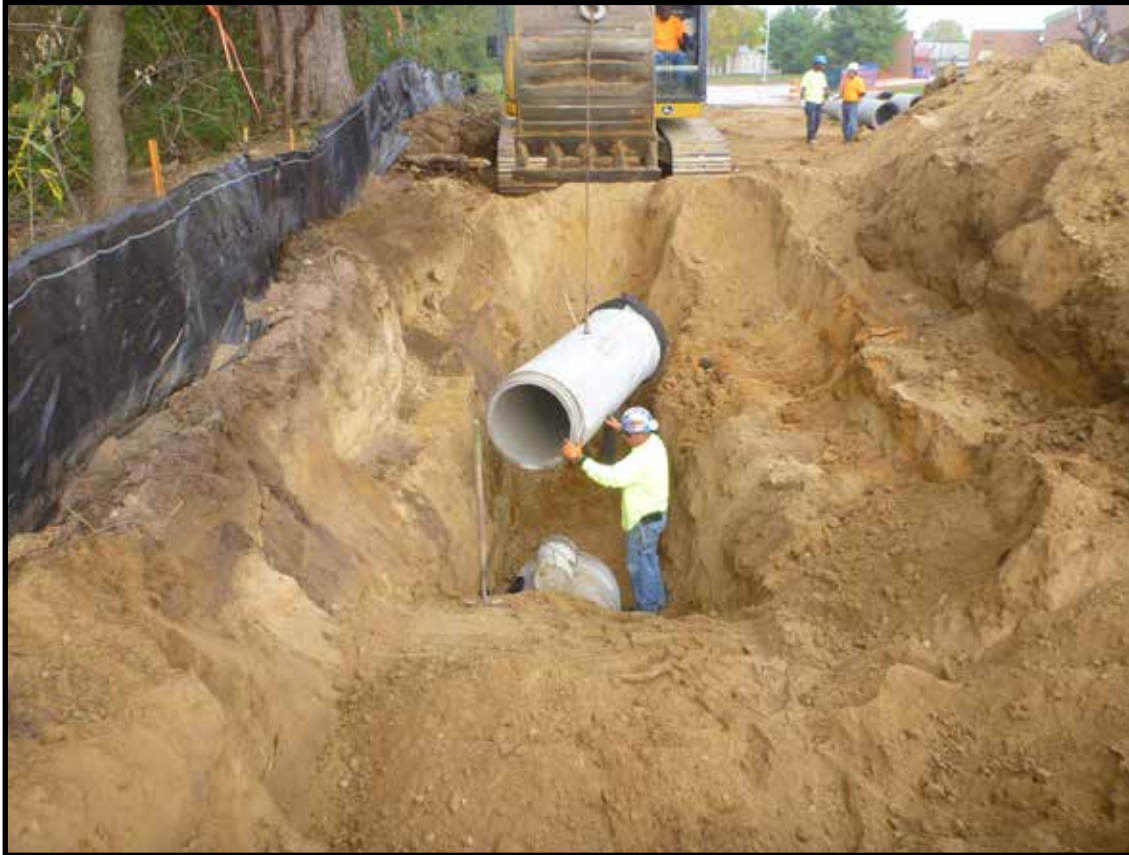
Photograph 3.27. View looking northwest showing installation of new pipeline along west edge of proposed road across Borton/Ballinger Farm House Site observed during archaeological monitoring program of new construction (Photographer: Andrew Martin, October 2016) [HRI Neg. #16034/D5:010].

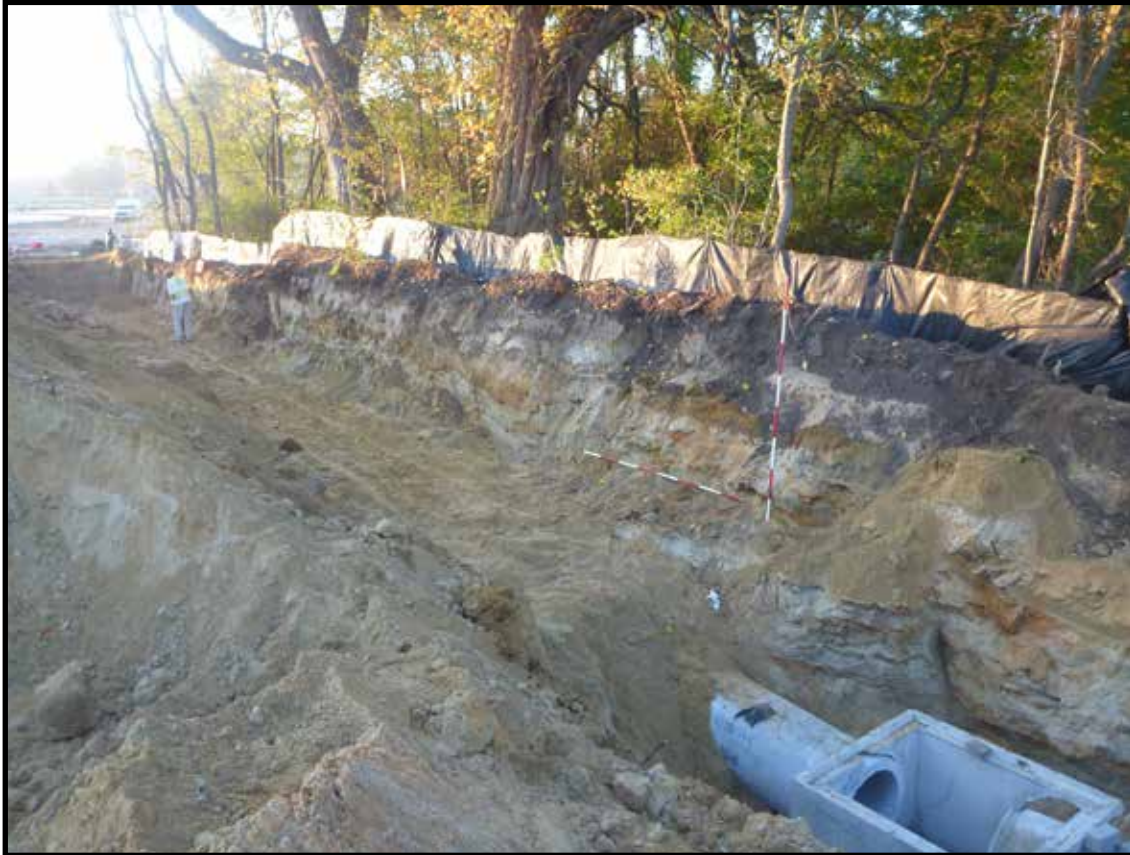
Photograph 3.28. View looking south showing partial west profile of pipe trench excavation observed during archaeological monitoring program of new construction (Photographer: Joshua Butchko, October 2016) [HRI Neg. #16034/D6:035].

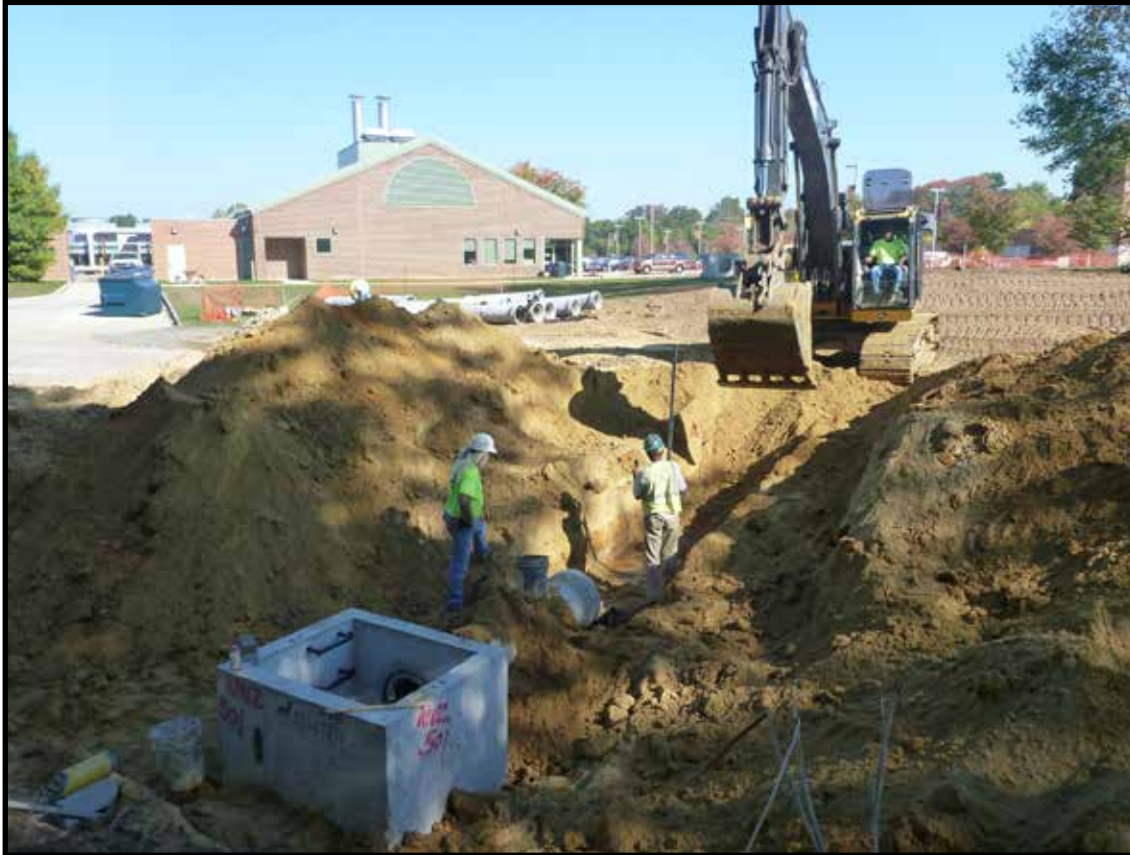
Photograph 3.29. View looking north-northeast showing pipe trench excavation continuing beyond northern limit of project area observed during archaeological monitoring program of new construction (Photographer: Joshua Butchko, October 2016) [HRI Neg. #16034/D6:064].

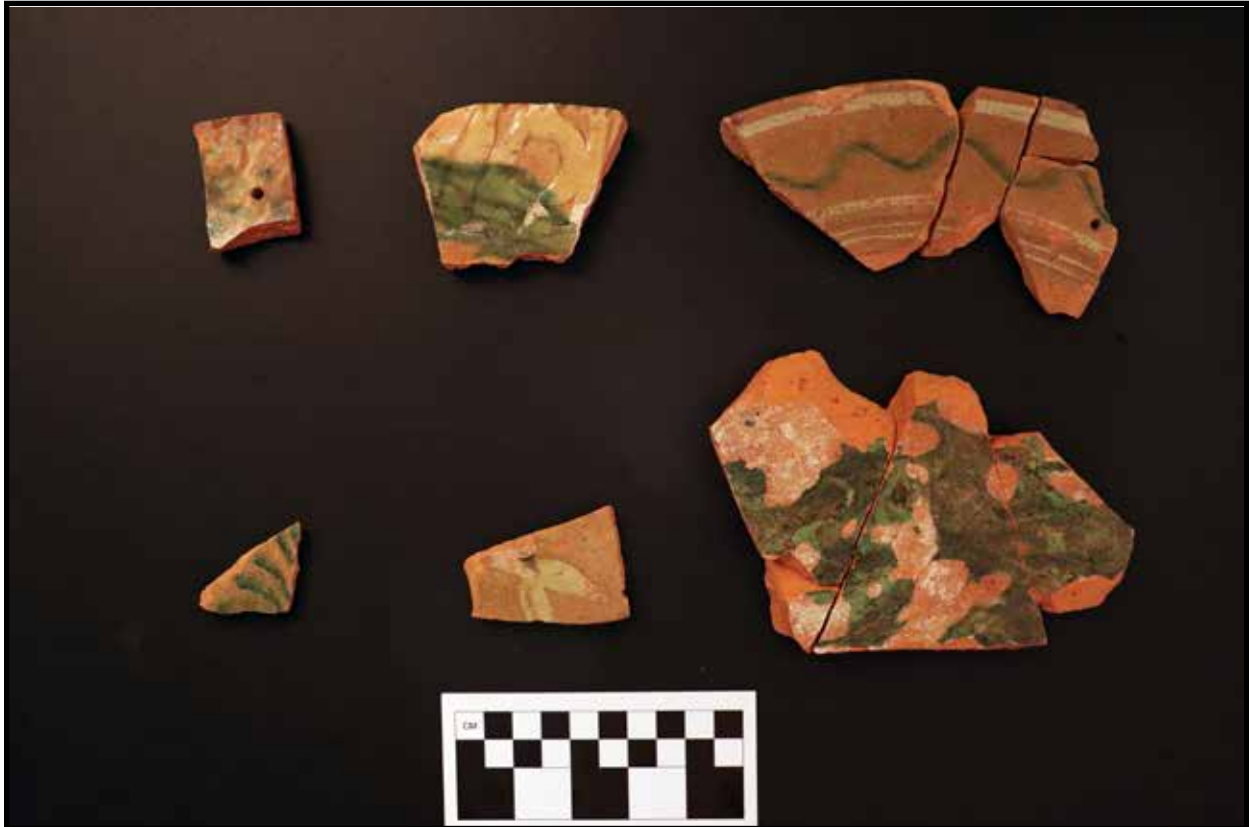
Photograph 4.1. Selected red-bodied earthenware sherds from the Borton/Ballinger Farmhouse Site decorated with variations of slip-trail, copper oxide mottling and pie crust rims. These wares can probably be associated with Pennsylvania German potters, operating out of Philadelphia during the 18th century. All of these selections were recovered from Excavation Unit 105, Context 5. *Top row, left to right:* Plate sherd with piecrust rim and repair hole [Catalog #34.12] Plate sherd with piecrust rim [Catalog #34.14] Mended plate sherds with piecrust rim and repair hole [Catalog #34.17]. *Bottom row, left to right:* Plate sherd [Catalog #34.11] Plate sherd [Catalog #34.11] Mended hollowware sherds [Catalog #34.15] (Photographer: Alexis Alemy, July 2018) [HRI Neg. #16034/D7:008].

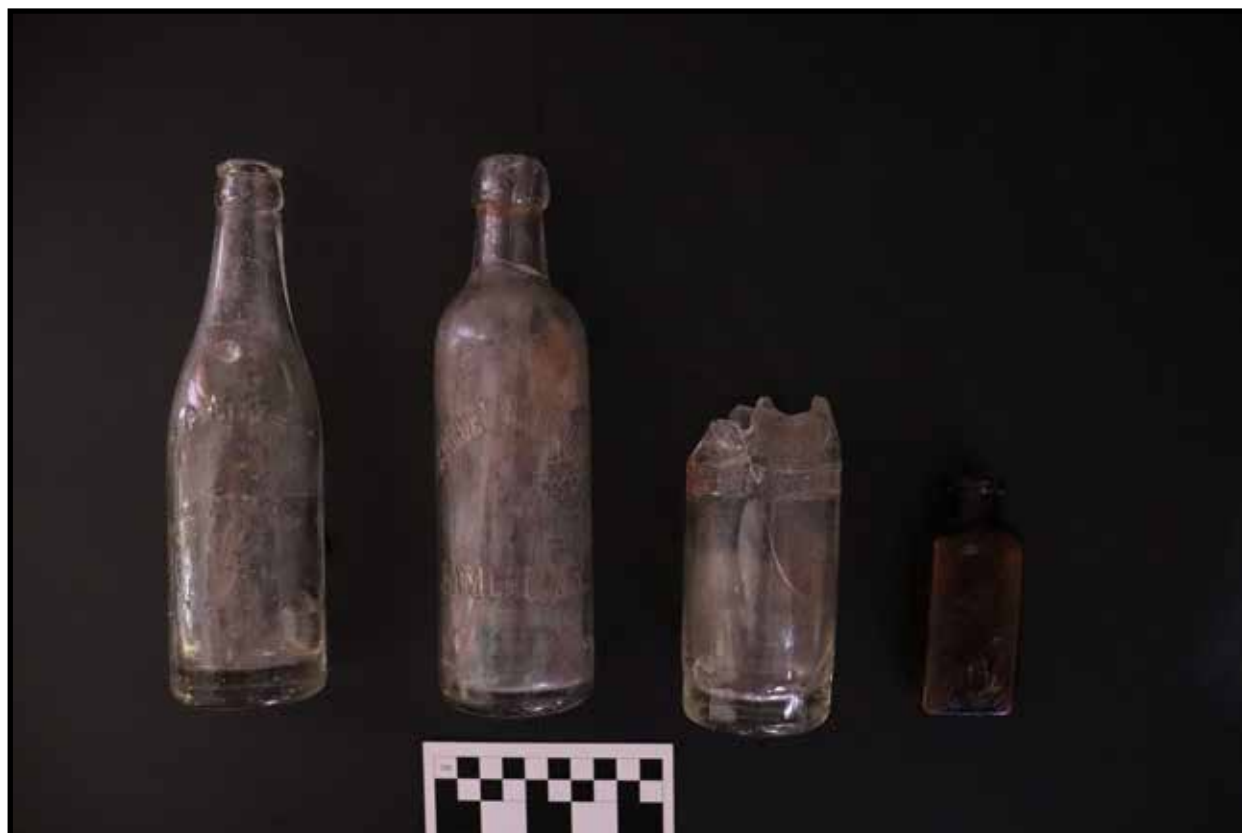
Photograph 4.2. Selected glass vessels from the 20th century trash midden at the Borton/Ballinger Farmhouse Site. All of these selections were recovered from Excavation Unit 102, Context 47. *Left to right:* Beverage bottle, mold seam with crown finish, embossed “CAPACITY 9 OZ BELL BOTTLING CO 1711 S ORIANA ST PHILADA PA” [Catalog #26.145] Beverage bottle, mold seam with one part stopper finish, embossed “CAMDEN BOTTLING CO. CAMDEN, NJ” [Catalog #26.144] Partial beverage bottle, mold seam, embossed on base “JOHN BLAUFUSS RIVERSIDE NJ” [Catalog #26.188]. Pharmaceutical bottle, mold seam with patent finish, embossed on base “2956” [Catalog #26.139] (Photographer: Alexis Aley, July 2018) [HRI Neg. #16034/D7:002].

A trash midden associated with the very late 19th- and 20th-century occupation of the site was identified due west of the farmhouse foundation and excavated during this investigation (Excavation Units 101 and 102, Trench 109) (see above, Figures 3.12 and 3.13).

clear/uncolored (74), aqua (26), brown (7), milk (6) and cobalt blue (2). A variety of vessel forms was identified, chiefly beverage bottles (68). Most of the legible embossed manufacturers' marks are attributed to Philadelphia-based bottlers who operated from the late 19th to at least the early 20th century. At least one bottle was produced locally; a Hutchinson-style soda bottle embossed "JOHN BLAUFUSS RIVERSIDE NJ" (Photograph 4.2). Other forms identified included: drinking vessel, jar/jug, lamp chimney, canning lid, bottle stopper, and punch bowl.

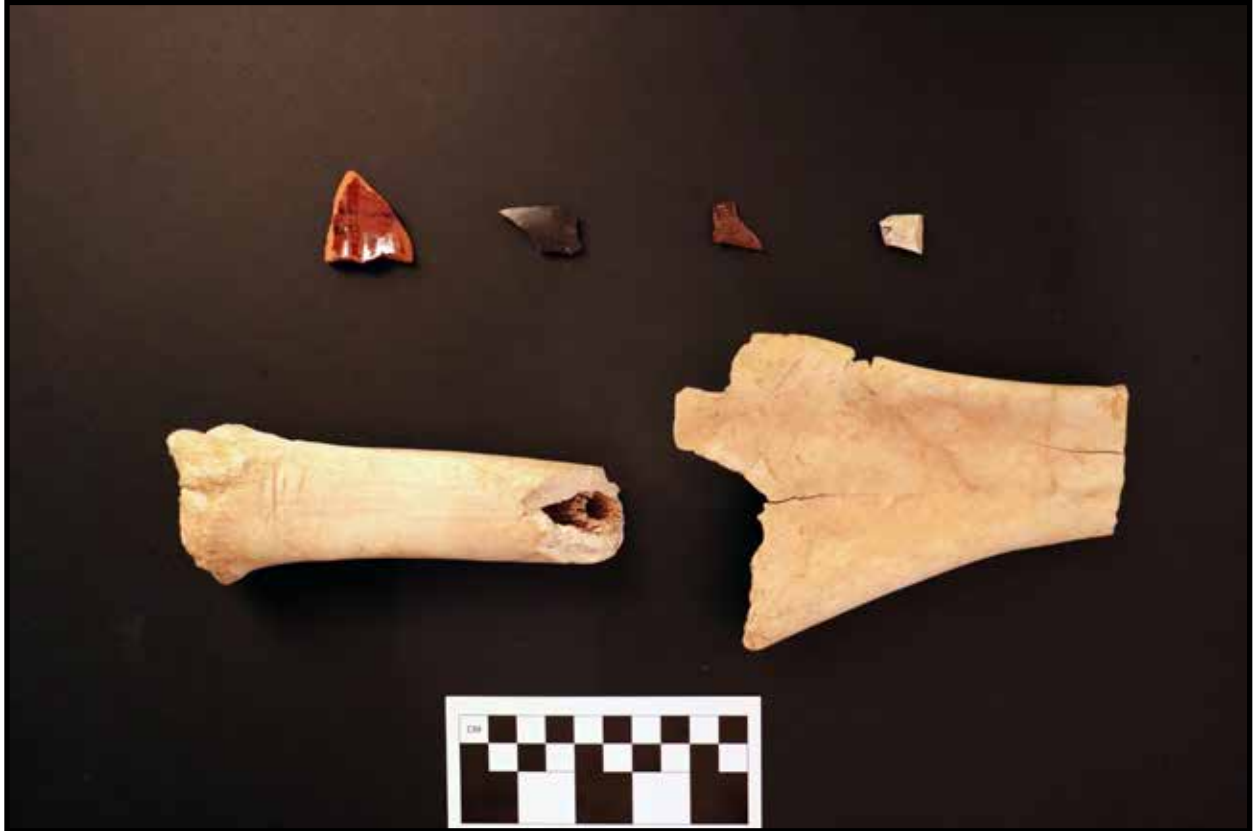
Photograph 4.3. Selected historic artifacts from Context 55 at the Borton/Ballinger Farmhouse Site. Context 55 was interpreted as the upcast fill soil associated with the 18th-century expansion of the house. *Top row, left to right:* Redware hollowware body sherd with mottled lead and manganese decoration [Catalog #36.7] Redware hollowware body sherd with Jackfield-type glaze (19th century reproduction) [Catalog #40.3] Engine-turned redware hollowware body sherd with incised decoration (late 18th to late 19th century)[Catalog #16.2] Pearlware hollowware base fragment with black transfer printed pattern (1785-1864) [Catalog #40.8]. *Bottom row, left to right:* Butchered mammal long bone, probable cow or pig [Catalog #36.1] Butchered mammal scapula, probable cow or pig [Catalog #36.2] (Photographer: Alexis Aley, July 2018) [HRI Neg. #16034/D7:009].

Forty-eight historic artifacts were retained from Context 55, which was interpreted as the upcast fill soil associated with the 18th-century expansion of the house. A selection of finds from this deposit is pictured in this report (see above, Figure 3.9; Photograph 4.3).

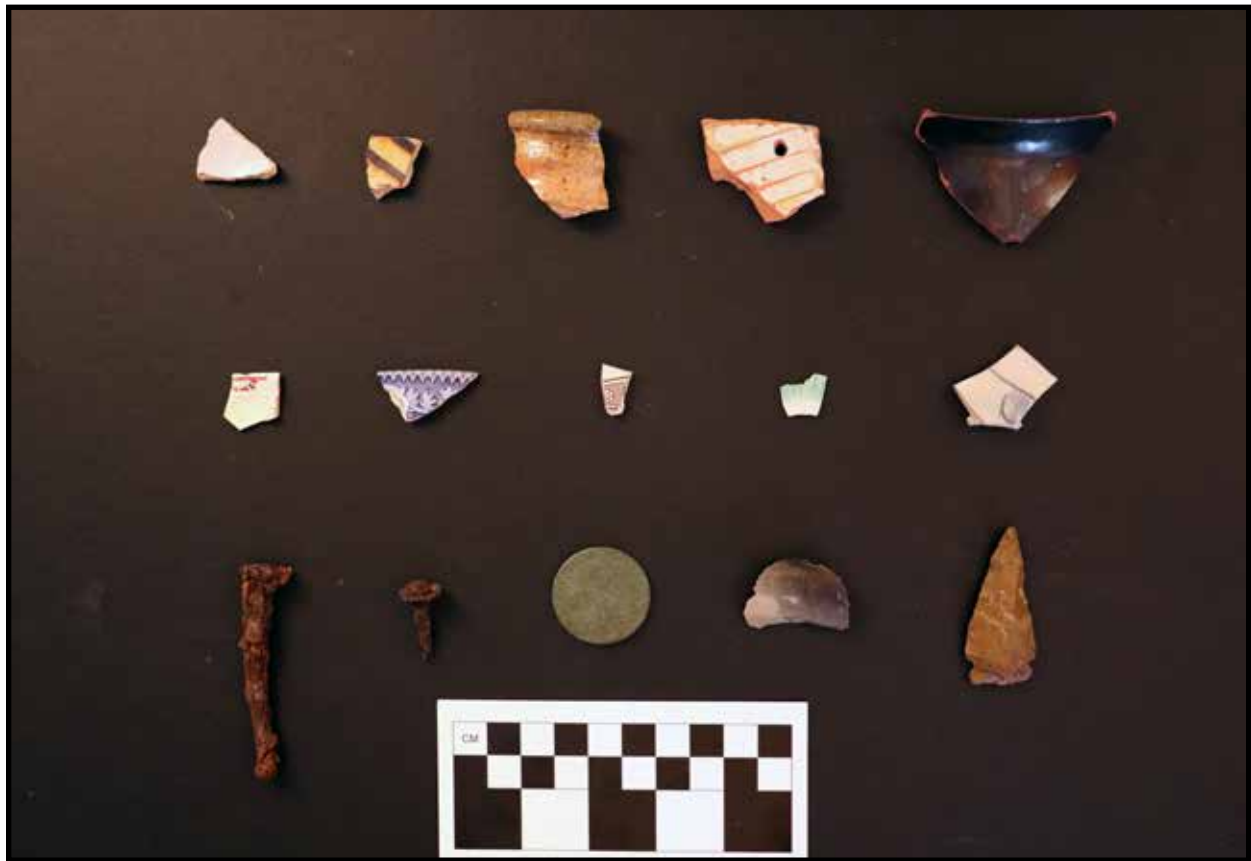
Photograph 4.4. Selected historic and prehistoric artifacts from Context 62 at the Borton/Ballinger Farmhouse Site. Context 62 was interpreted as a late 18th- to early 19th-century A horizon that should predate the mid-19th-century expansion of the house. *Top row, left to right:* Delftware hollowware sherd with pinkish tint (17th to early 18th century) [Catalog #38.15] Buff-bodied hollowware sherd with Staffordshire glaze (1670-1775) [Catalog #38.12] North Devon hollowware rim sherd, possible pipkin (17th to early 18th century)[Catalog #38.41] Redware plate sherd with white slip trail, piecrust rim and repair hole [Catalog #38.23] Redware hollowware body sherd with Jackfield-type glaze (19th-century reproduction) [Catalog #38.17]. *Center row, left to right:* Pearlware dish rim sherd with underglaze red hand painted pattern (1830-1860) [Catalog #38.44] Pearlware teacup rim sherd with blue transfer printed floral pattern (1784-1867)[Catalog #13.5] Whiteware hollowware sherd with black transfer printed pattern (1785-1864) [Catalog #38.47] Pearlware plate rim sherd with green Shell Edge pattern (1800-1840) [Catalog #38.45] White salt-glazed stoneware basal sherd with Scratch Blue floral pattern (1745-1780) [Catalog #38.53]. *Bottom row, left to right:* Whole cut nail [Catalog #41.32] Whole roofing nail [Catalog #13.14] Copper alloy U.S. one cent piece embossed with the year 1800 and Liberty facing to the right on the obverse and “UNITED STATES OF AMERICA ONE CENT” embossed on the reverse [Catalog #38.65] English gunflint fragment [Catalog #38.74] Prehistoric jasper projectile point [Catalog #38.72] (Photographer: Alexis Alemy, July 2018) [HRI Neg. #16034/D7:016].

Context 62 yielded 485 artifacts. This deposit was interpreted as a late 18th- to early 19th-century A horizon that should predate the mid-19th-century expansion of the house (see above, Figure 3.9). Of the few prehistoric artifacts recovered during this investigation, two were retained from this deposit: one piece of thermally altered sandstone and the jasper projectile point ( Photograph 4.4).

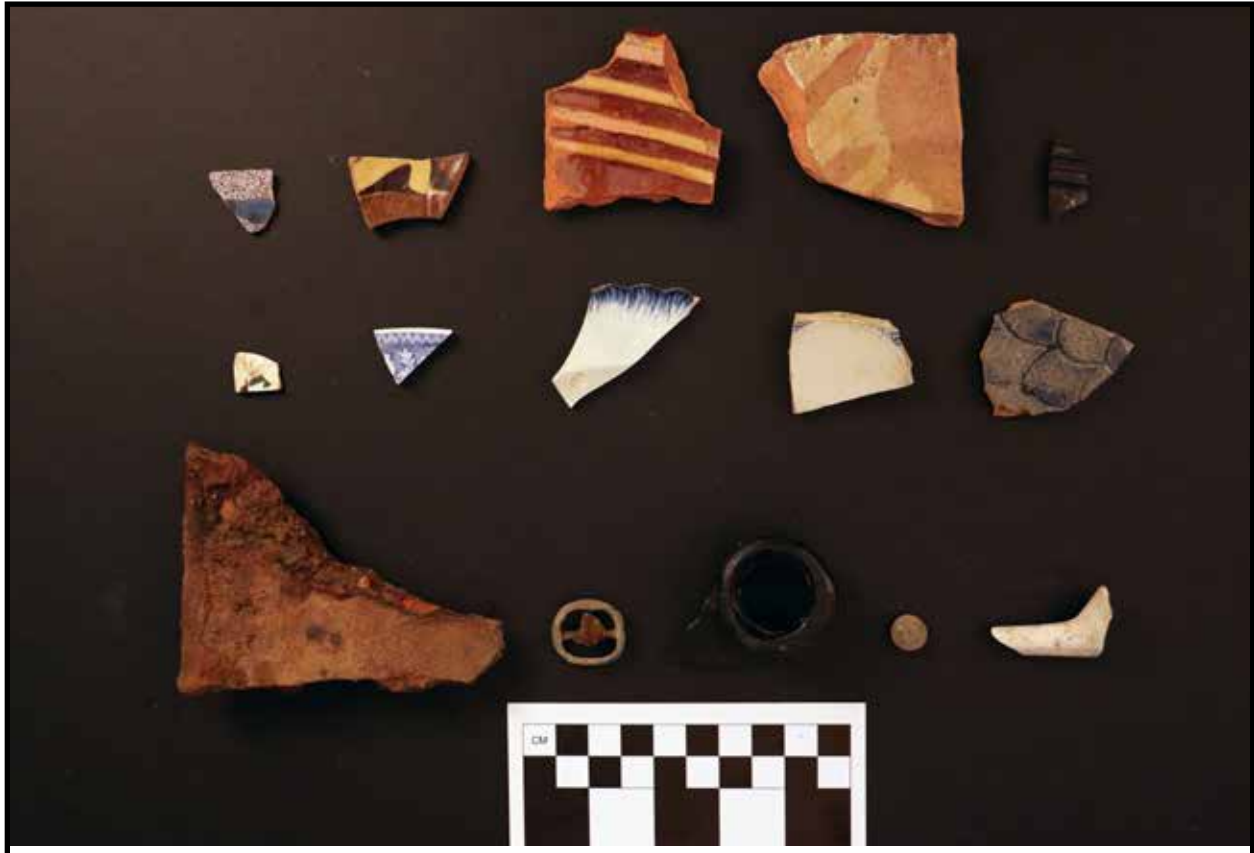
Photograph 4.5. Selected historic artifacts from Context 5 at the Borton/Ballinger Farmhouse Site. Context 5 was interpreted as a demolition/grading deposit attributed to the mid-19th century expansion of the house. *Top row, left to right:* Delftware hollowware sherd with blue and purple hand painted decoration (17th to early 18th century) [Catalog #44.3] Buff-bodied hollowware sherd with Staffordshire glaze (1670-1775) [Catalog #35.49] Red-bodied slipware hollowware sherd with white slip trail decoration [Catalog #44.4] Red-bodied slipware rim sherd with pie crust rim and white slip trail decoration [Catalog #34.26] Jackfield hollowware sherd with molded design (1740-1770) [Catalog #34.56]. *Center row, left to right:* Pearlware dish rim sherd with Annular decoration (late 18th to late 19th century) [Catalog #35.60] Pearlware plate rim sherd with blue transfer printed pattern (1784-1867) [Catalog #48.31] Pearlware plate rim sherd with blue Shell Edge pattern (1800-1840) [Catalog #48.34] White salt-glazed stoneware basal sherd with Scratch Blue linear pattern (1745-1780) [Catalog #35.56] Buff-bodied stoneware hollowware sherd with exterior salt glaze, cobalt blue and incised scale-like decoration [Catalog #44.34]. *Bottom row, left to right:* Cast iron kettle fragment [Catalog #35.75] Copper alloy watch buckle [Catalog #44.42] Olive green bottle fragment with applied irregular flanged finish [Catalog #34.81] Glass and copper alloy button fragment [Catalog #48.1] White clay tobacco pipe bowl and stem fragment [Catalog #34.74] (Photographer: Alexis Alemy, July 2018) [HRI Neg. #16034/D7:014].

sherds) and smaller amounts of bowl (16), milk pan (8), dish (4), flower pot (2) and saucer (1). A sampling of these and other interesting small finds from this deposit are pictured in Photograph 4.5.

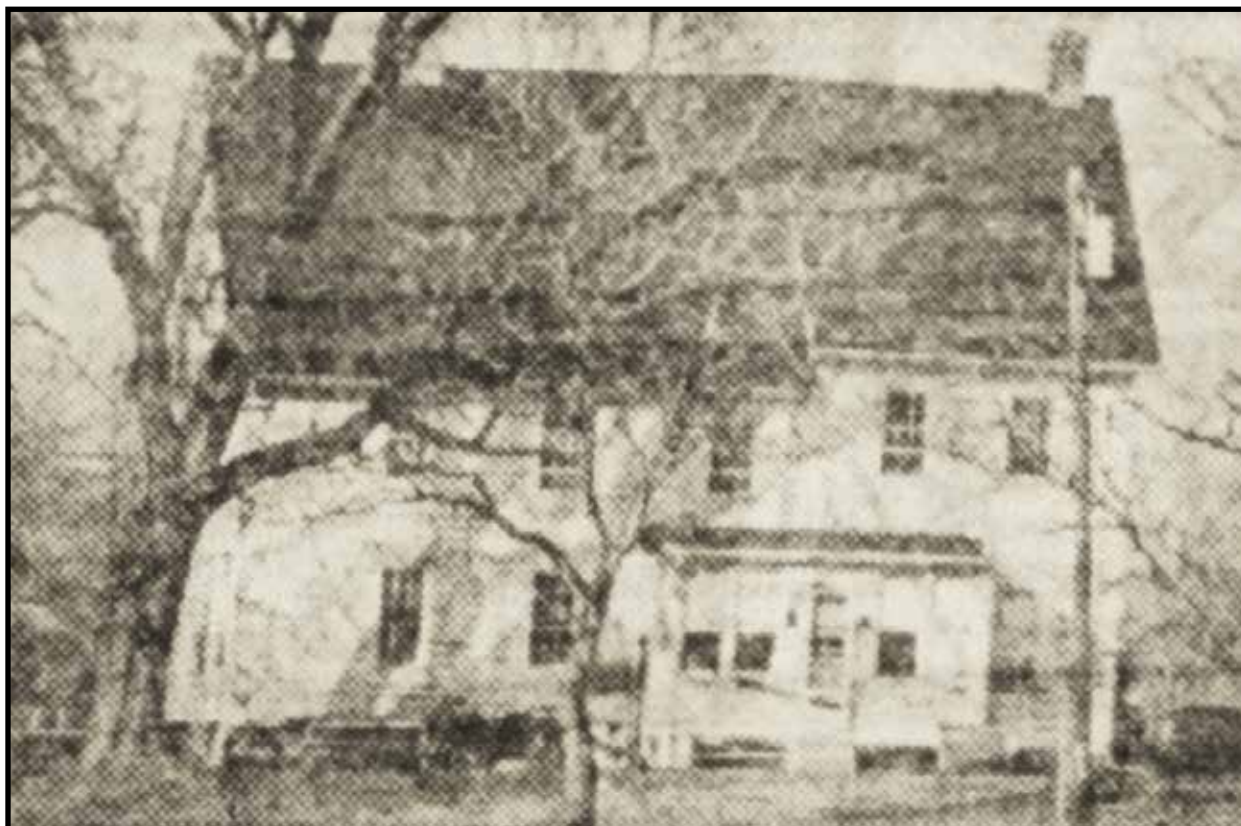
Photograph 5.1. Inset of Photograph Borton/Ballinger House, circa 1988. Source: *The Philadelphia Inquirer*, Sunday December 11, 1988.

Evidence of chimneys is largely lacking in the remnants of the cellar studied. There is a slight bump out in the masonry at the southeastern corner of the subcellar that might have been for a chimney integrated into the foundation. This is supported by the 1988 photograph of the house that shows a chimney at the eastern end of the foundation (Photograph 5.1). This photograph may also show an internal chimney between the first and second bays of the farmhouse. There is little evidence for this chimney in the foundation except for a semi-rectangular area of slates embedded within the bricks in the middle of the western half of the cellar. These slates appear to be the base of a more modern furnace, probably placed in this location during the early 20th century because of a pre-existing central chimney above it. There do not seem to be many substantial modifications to the foundation after this point. This may suggest a change in the fortunes of the farmers, who in the first three quarters of the 19th century were prosperous and expanding their family (and farmhouse). Evidence of the introduction of plumbing is apparent in several terracotta drains, circular iron stains, and iron pipes
