**WILLIAM TRENT HOUSE
PUBLIC ARCHAEOLOGY PROGRAM
ARCHAEOLOGICAL INVESTIGATIONS ON THE
EAST SIDE OF THE HOUSE**

**THE 1719 WILLIAM TRENT HOUSE MUSEUM
CITY OF TRENTON, MERCER COUNTY,
NEW JERSEY**

**FEBRUARY 2016
FINAL**

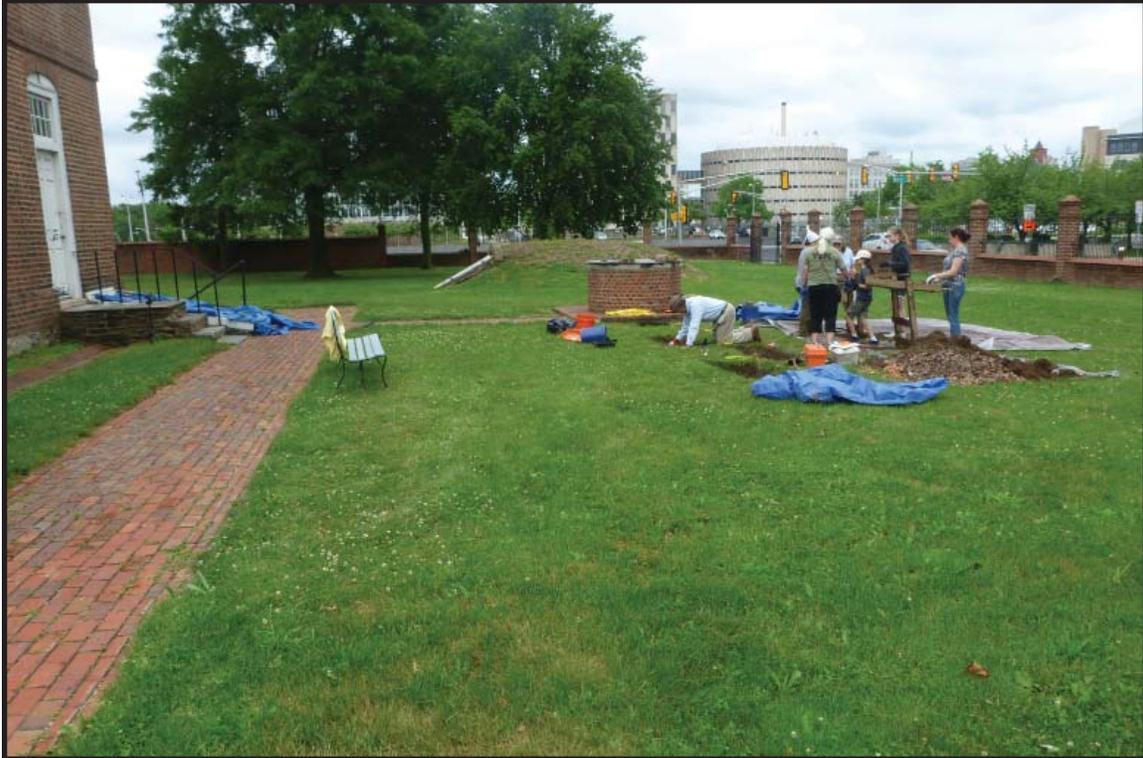
Photograph 1.2. General view of the William Trent House property showing the area subjected to archaeological investigation in the fall of 2014 and summer of 2015. The north end of the east wall of the Trent House is at left. The well is immediately beyond the excavation area (Photographer: Joshua Butchko, June 6, 2015) [HRI Neg. #14048/D2:004].

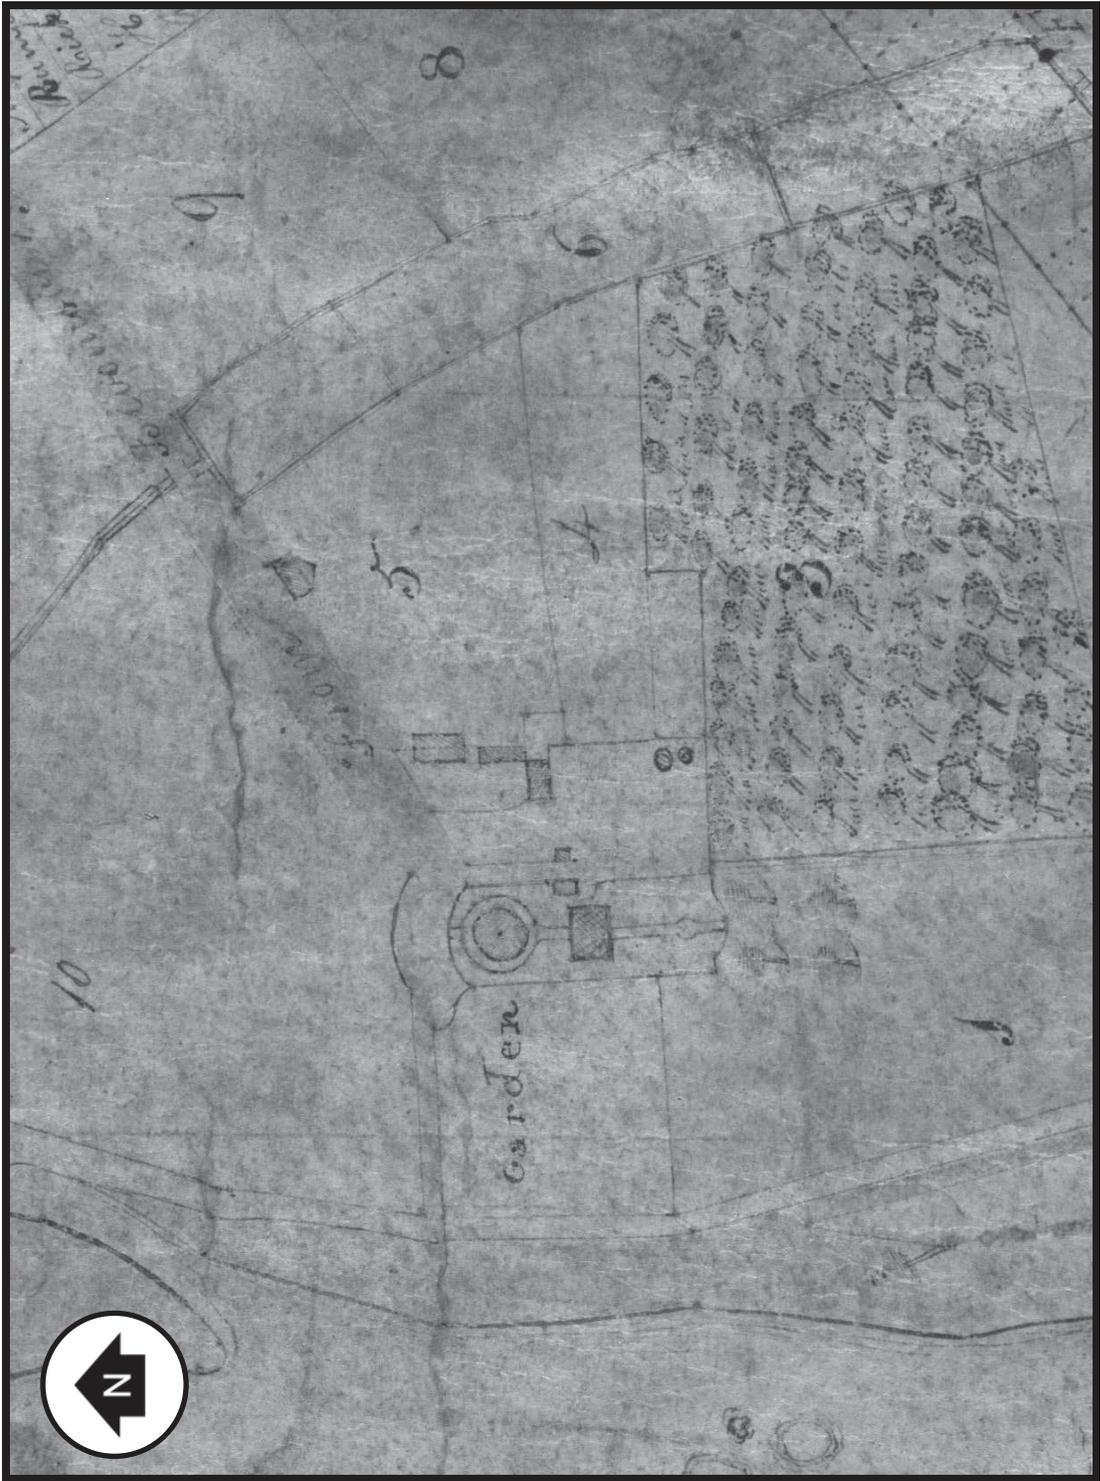
Figure 2.3. A Plan and Survey of Sundry Pieces of Land Adjoining the Delaware River and Assumpink Creek Belonging to Jn. Cox. 1789. Not to scale.

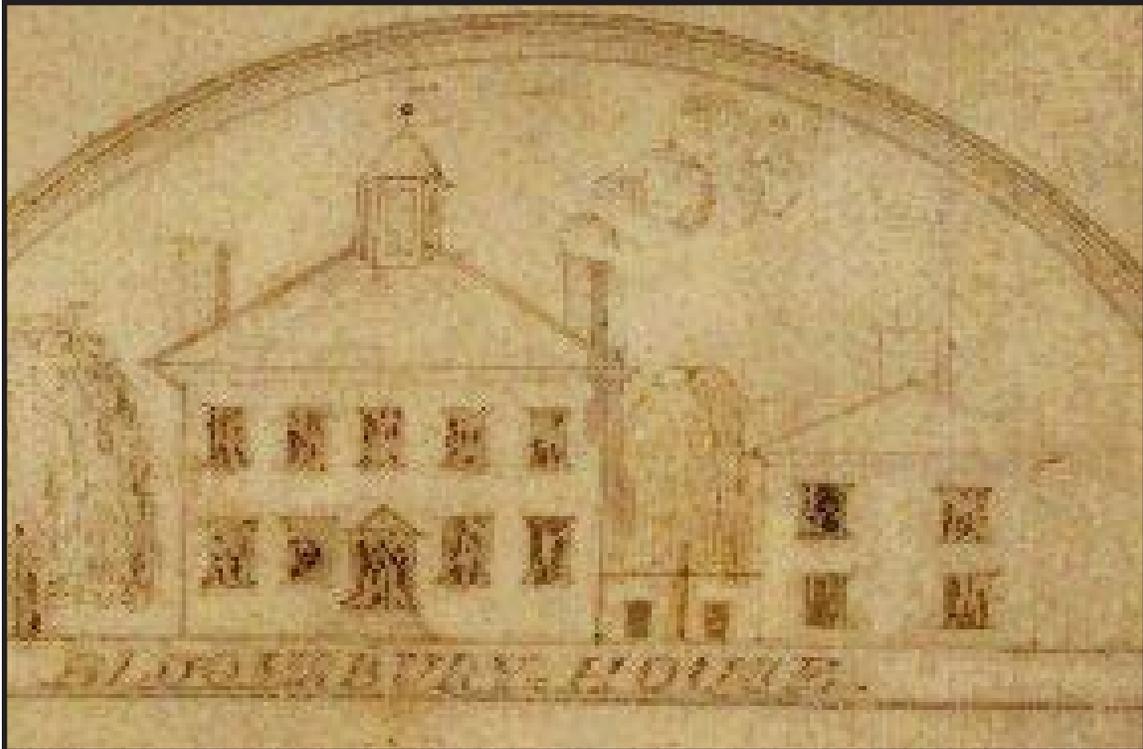
Figure 2.4. Detailed View of South Elevation of the William Trent House. *A Plan and Survey of Sundry Pieces of Land Adjoining the Delaware River and Assunpink Creek Belonging to Jn. Cox.* 1789.

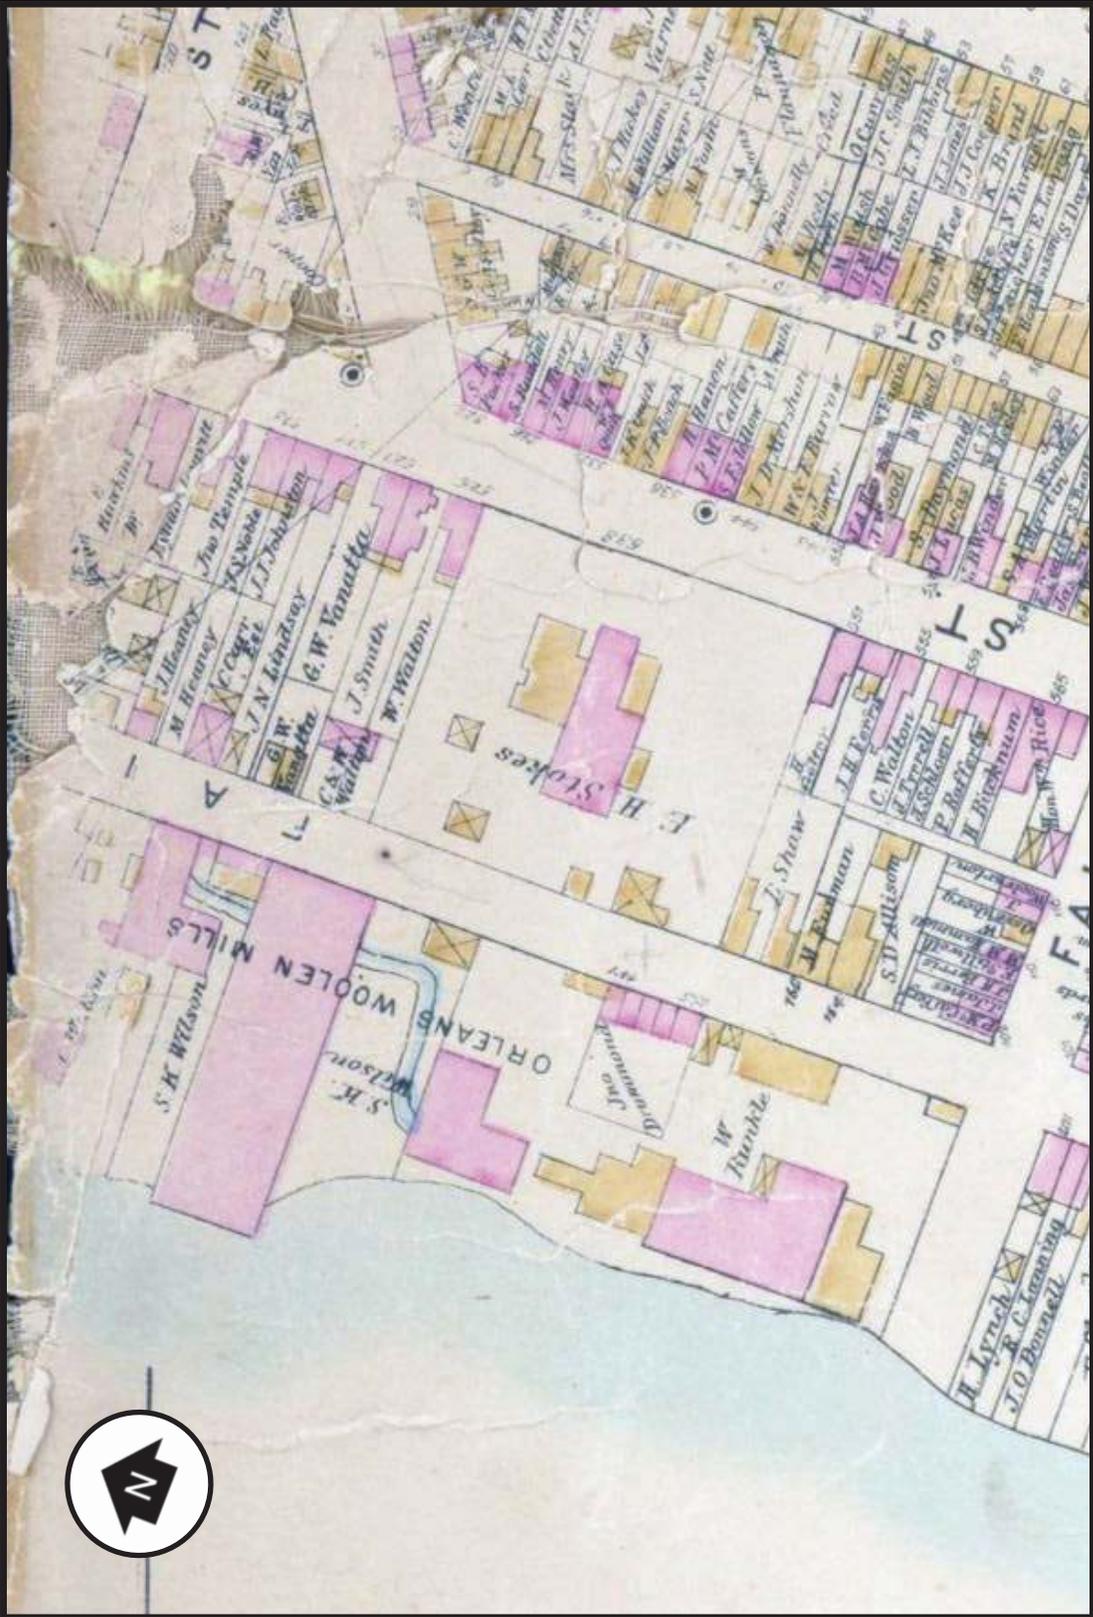
Figure 2.15. Haven, C.C. A New Real Estate and Insurance Map of Trenton, 1882. Scale: 1 inch= 130 feet (approximately).

City of Trenton maps from 1881 and 1882 and the Sanborn and Scarlett & Scarlett fire insurance maps all confirm the same general arrangement of the house and outbuildings, although it would appear that between 1882 and 1890 the larger easternmost rear addition was raised two stories and a narrow corridor-like space between it and the rear of the brick core of the east wing was filled in to create a more unified eastern façade (Figures 2.14-2.17). A photograph dated tentatively to around 1890 based on historic maps and the size of trees (the same specimens compared in later photographs) adds a critical new element to the documentary record (Photograph 2.1). This view, looking northwest from the southeast corner of the property, shows the dominant east façade of the three-bay east wing with a first-floor bay window and an elaborate greenhouse entrance facing South Warren Street. The Classical Revival treatment of the south and east elevations of the east wing are clearly evident, as is the juxtaposition of the greenhouse with the original main block of the house. The purported one-story west wing attached to the western end of the main block is probably the exterior of one of the Wilson Woolen Mills buildings on the Delaware River northwest of the house (*contra* Susan Maxman

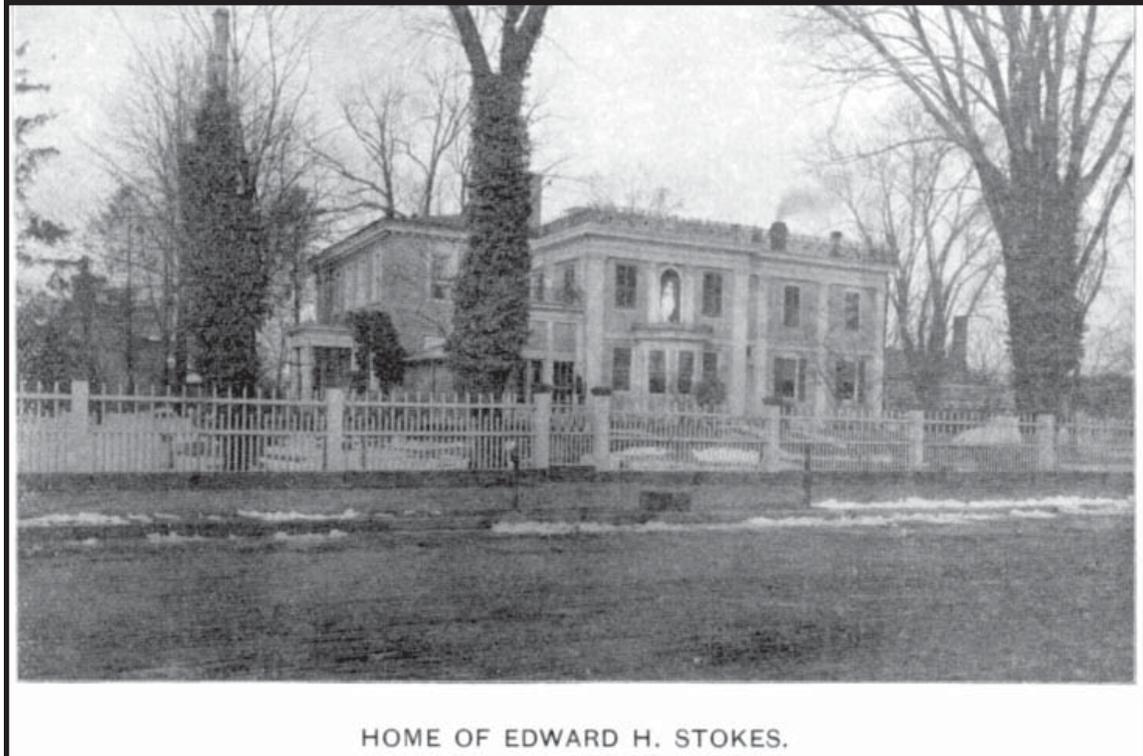
Photograph 2.2. View looking west showing the east elevation of the William Trent House. 1899. The east wing was constructed between 1850 and 1870, based on historic maps. The greenhouse, partially concealed by the tree at center, may date from the same period, but was replaced between 1908 and 1926 (cf. Figures 2.19 and 2.20; Photograph 2.2). The original main section of the house, built 1719-20, is at rear. Source: *A Review of the Department of Police, Trenton, New Jersey* 1899).

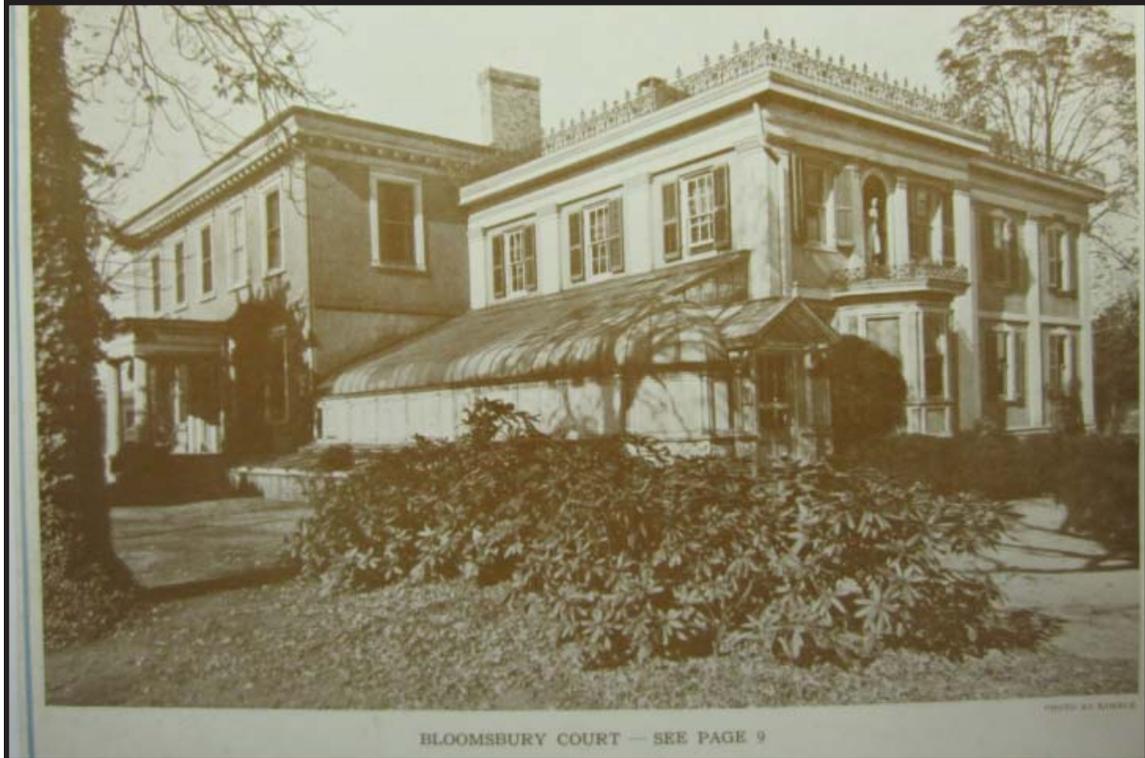
Photograph 2.3. View looking northwest showing the south and east elevations of the William Trent House. March, 1926. The original main section of the house, built *circa* 1721, is at left. The front porch on the original section of the house was in place by 1849 (cf. Figure 2.9). The east wing at right was constructed between 1850 and 1870, based on historic maps. The greenhouse shown here was constructed between 1908 and 1926 (cf. Figures 2.19 and 2.20; Photograph 2.1). Source: Trenton Free Public Library, Trentoniana Collection, Historic Houses; *Trenton Magazine*, March 1926; Library of Congress, Historic American Buildings Survey, NJ-200.

Sometime between 1908 and 1926, the original greenhouse along the south side of the east wing was replaced, as may be deduced from a comparison of the Sanborn map of the earlier year (Figure 2.19) with a photograph published in the *Trenton Magazine* in March of 1926 (Photograph 2.3). The latter photograph also shows for the first time the existence of cold frames installed along the south side of the greenhouse. The second-phase greenhouse structure with its protruding eastern end is also visible on the Sanborn fire insurance map published in 1927 (Figure 2.20).

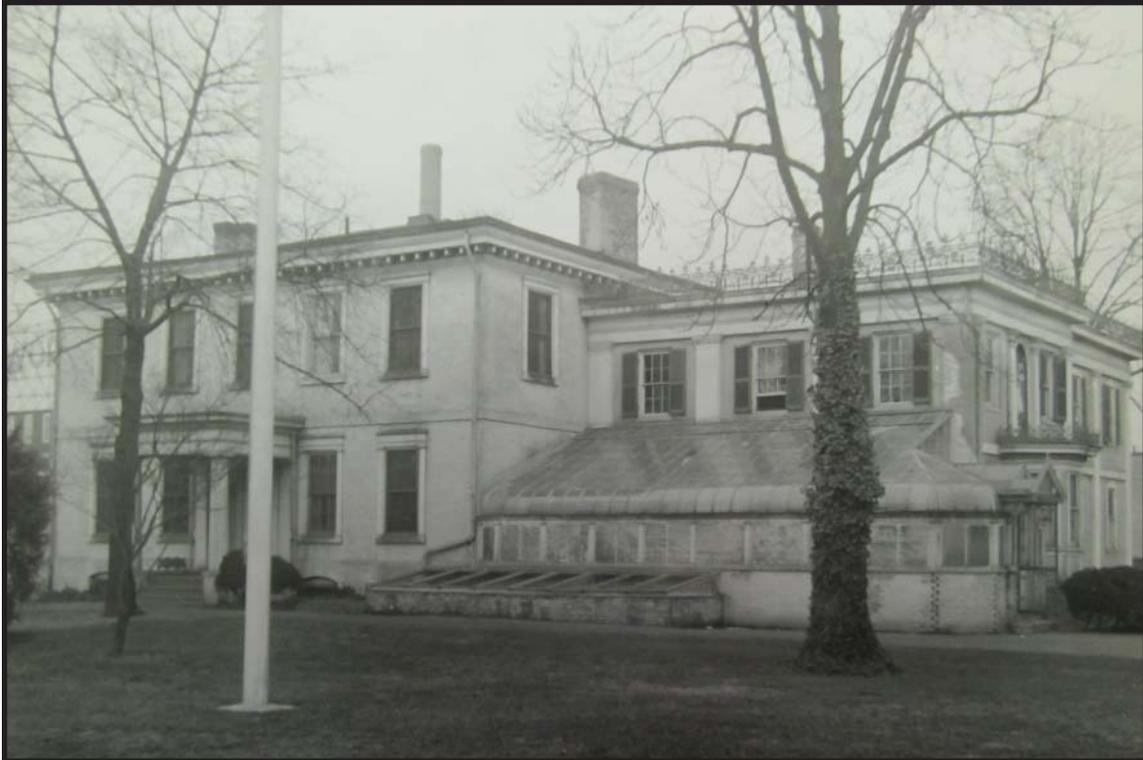
Photograph 2.4. View looking northwest showing the south and east elevations of the William Trent House. January 9, 1934. Photograph taken just prior to demolition of the east wing and greenhouse, and restoration of the original main section of the house. Source: Trenton Free Public Library, Trentoniana Collection, Historic Houses; Library of Congress, Historic American Buildings Survey, NJ-200 and WPA Project 2976, Photograph 58.

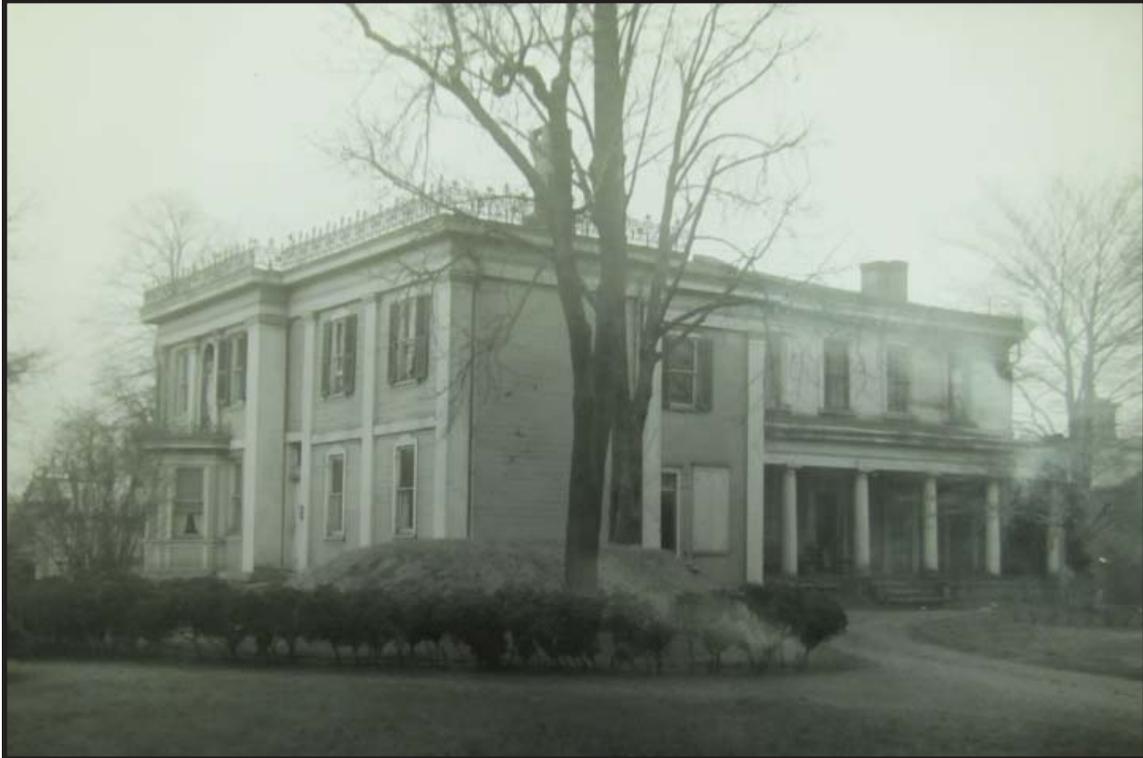
Photograph 2.5. View looking southwest showing the north and east elevations of the William Trent House. January 9, 1934. Photograph taken just prior to demolition of the east wing and greenhouse, and restoration of the original main section of the house. Source: Trenton Free Public Library, Trentoniana Collection, Historic Houses; Library of Congress, Historic American Buildings Survey, NJ-200 and WPA Project 2976, Photograph 61.

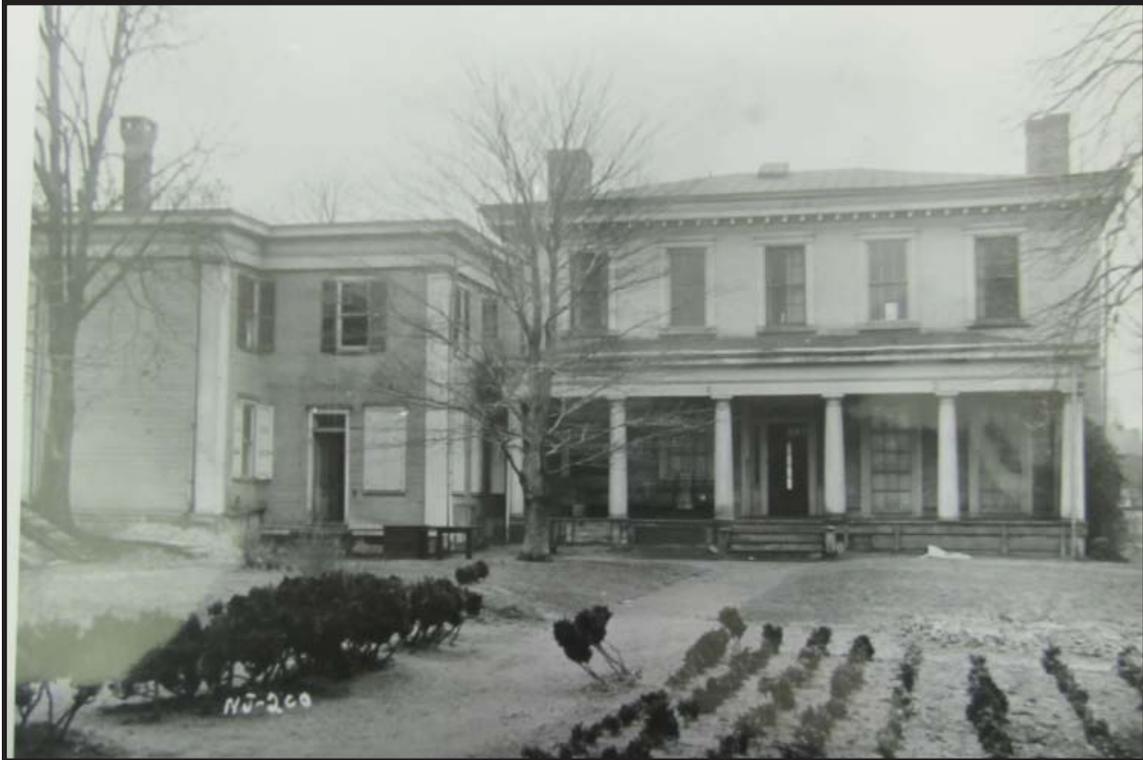
Photograph 2.6. View looking south showing the north elevation of the William Trent House. January 9, 1934. Photograph taken just prior to demolition of the east wing and greenhouse, and restoration of the original main section of the house. Note the root cellar bulkhead entrance just visible at far left. Source: Trenton Free Public Library, Trentoniana Collection, Historic Houses; Library of Congress, Historic American Buildings Survey, NJ-200 and WPA Project 2976, Photograph 60.

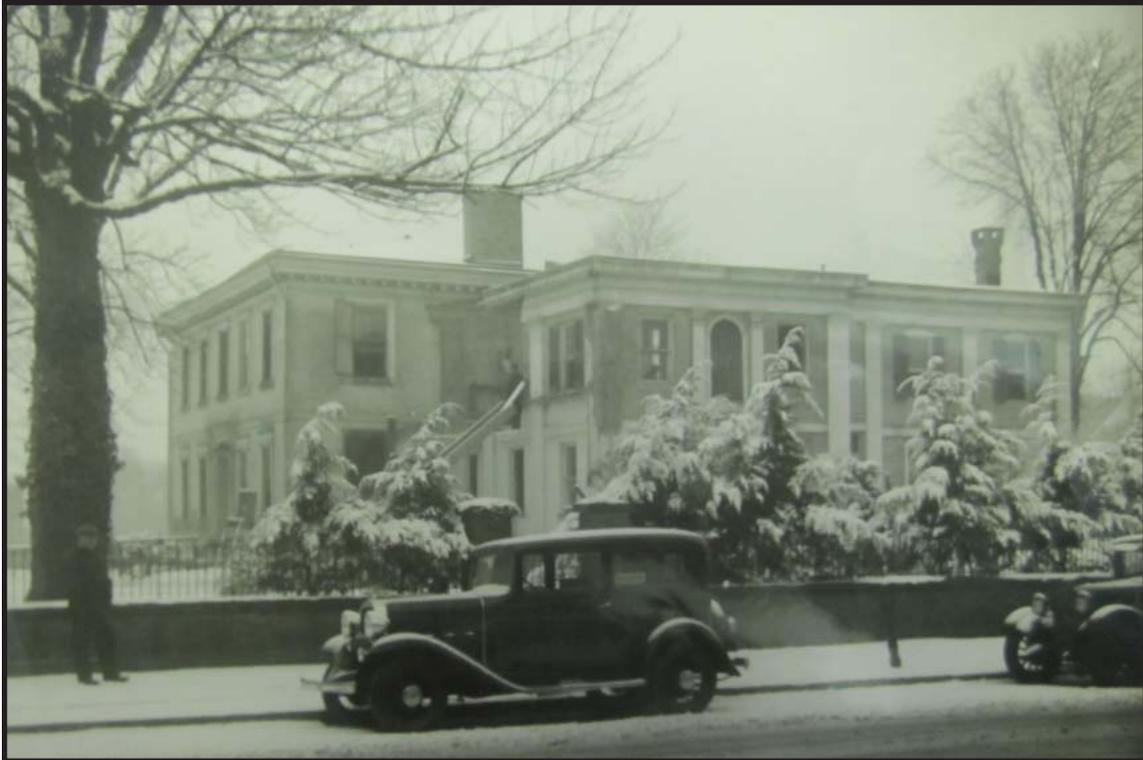
Photograph 2.7. View looking east northeast showing the south and east elevations of the William Trent House. February 1, 1934. Photograph taken in the early stages of demolition of the two-section east wing and greenhouse. The greenhouse, part of the second story front portion of the east wing, and the statue in the alcove above the east wing bay window have all been removed. Source: Trenton Free Public Library, Trentoniana Collection, Historic Houses; Library of Congress, Historic American Buildings Survey, NJ-200 and WPA Project 2976, Photograph 97.

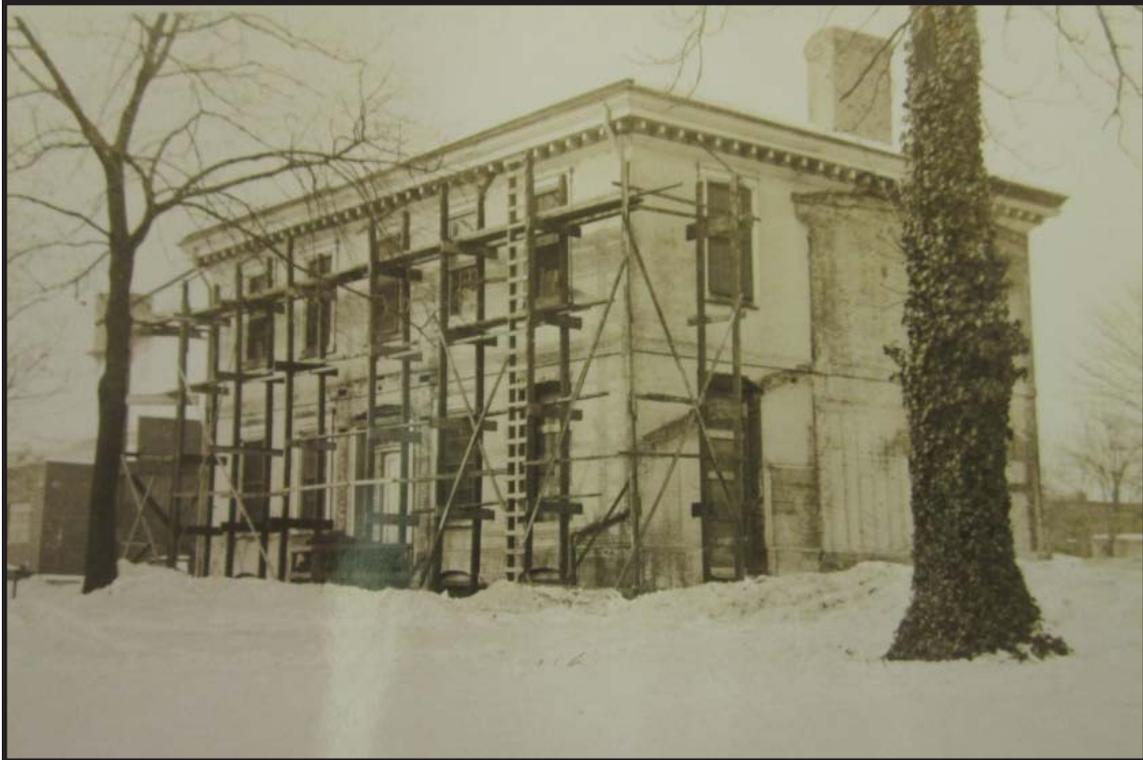
Photograph 2.8. View looking northwest showing the original main section of the William Trent House following demolition of the east wing and greenhouse. 1934. Note the outlines of the east wing and greenhouse, and the re-opened original first floor window and blocked greenhouse doorway, in the east wall of the house. Source: Trenton Free Public Library, Trentoniana Collection, Historic Houses.

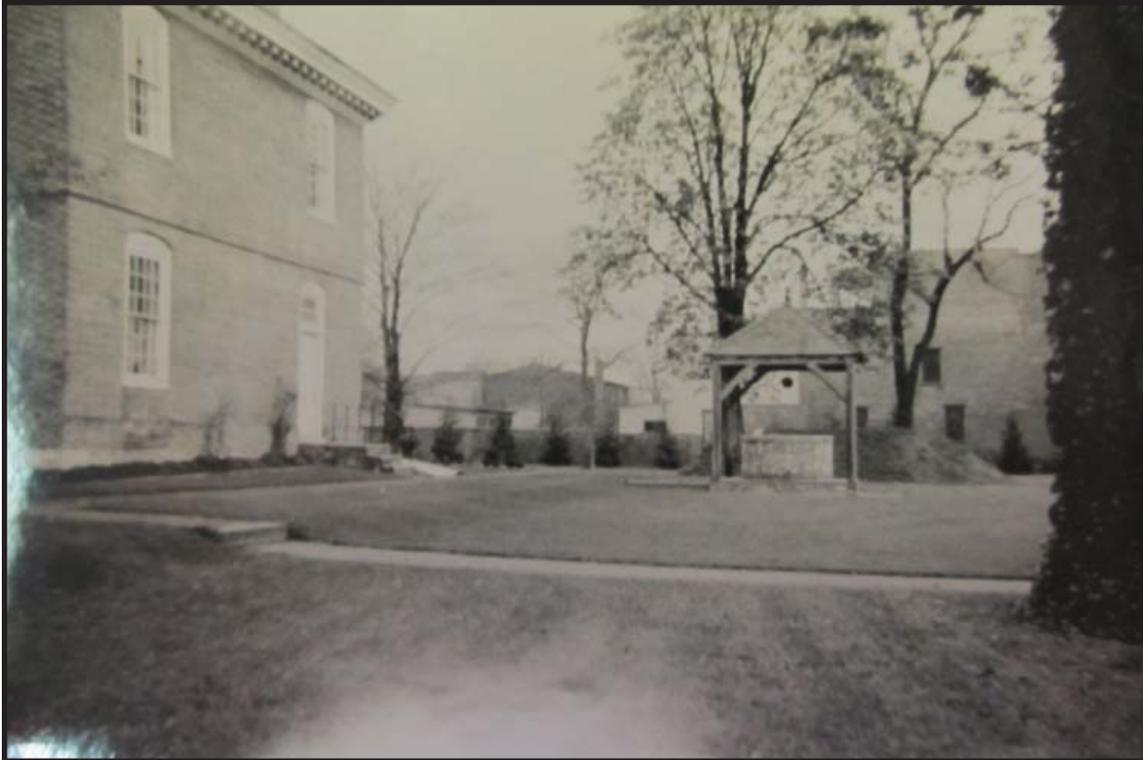
Photograph 2.9. View looking north across the landscaped site of the removed east wing and greenhouse. 1940. The restored original main section of the William Trent House is at left. Note the restored well with the root cellar beyond. Source: Trenton Free Public Library, Trentoniana Collection, Historic Houses.

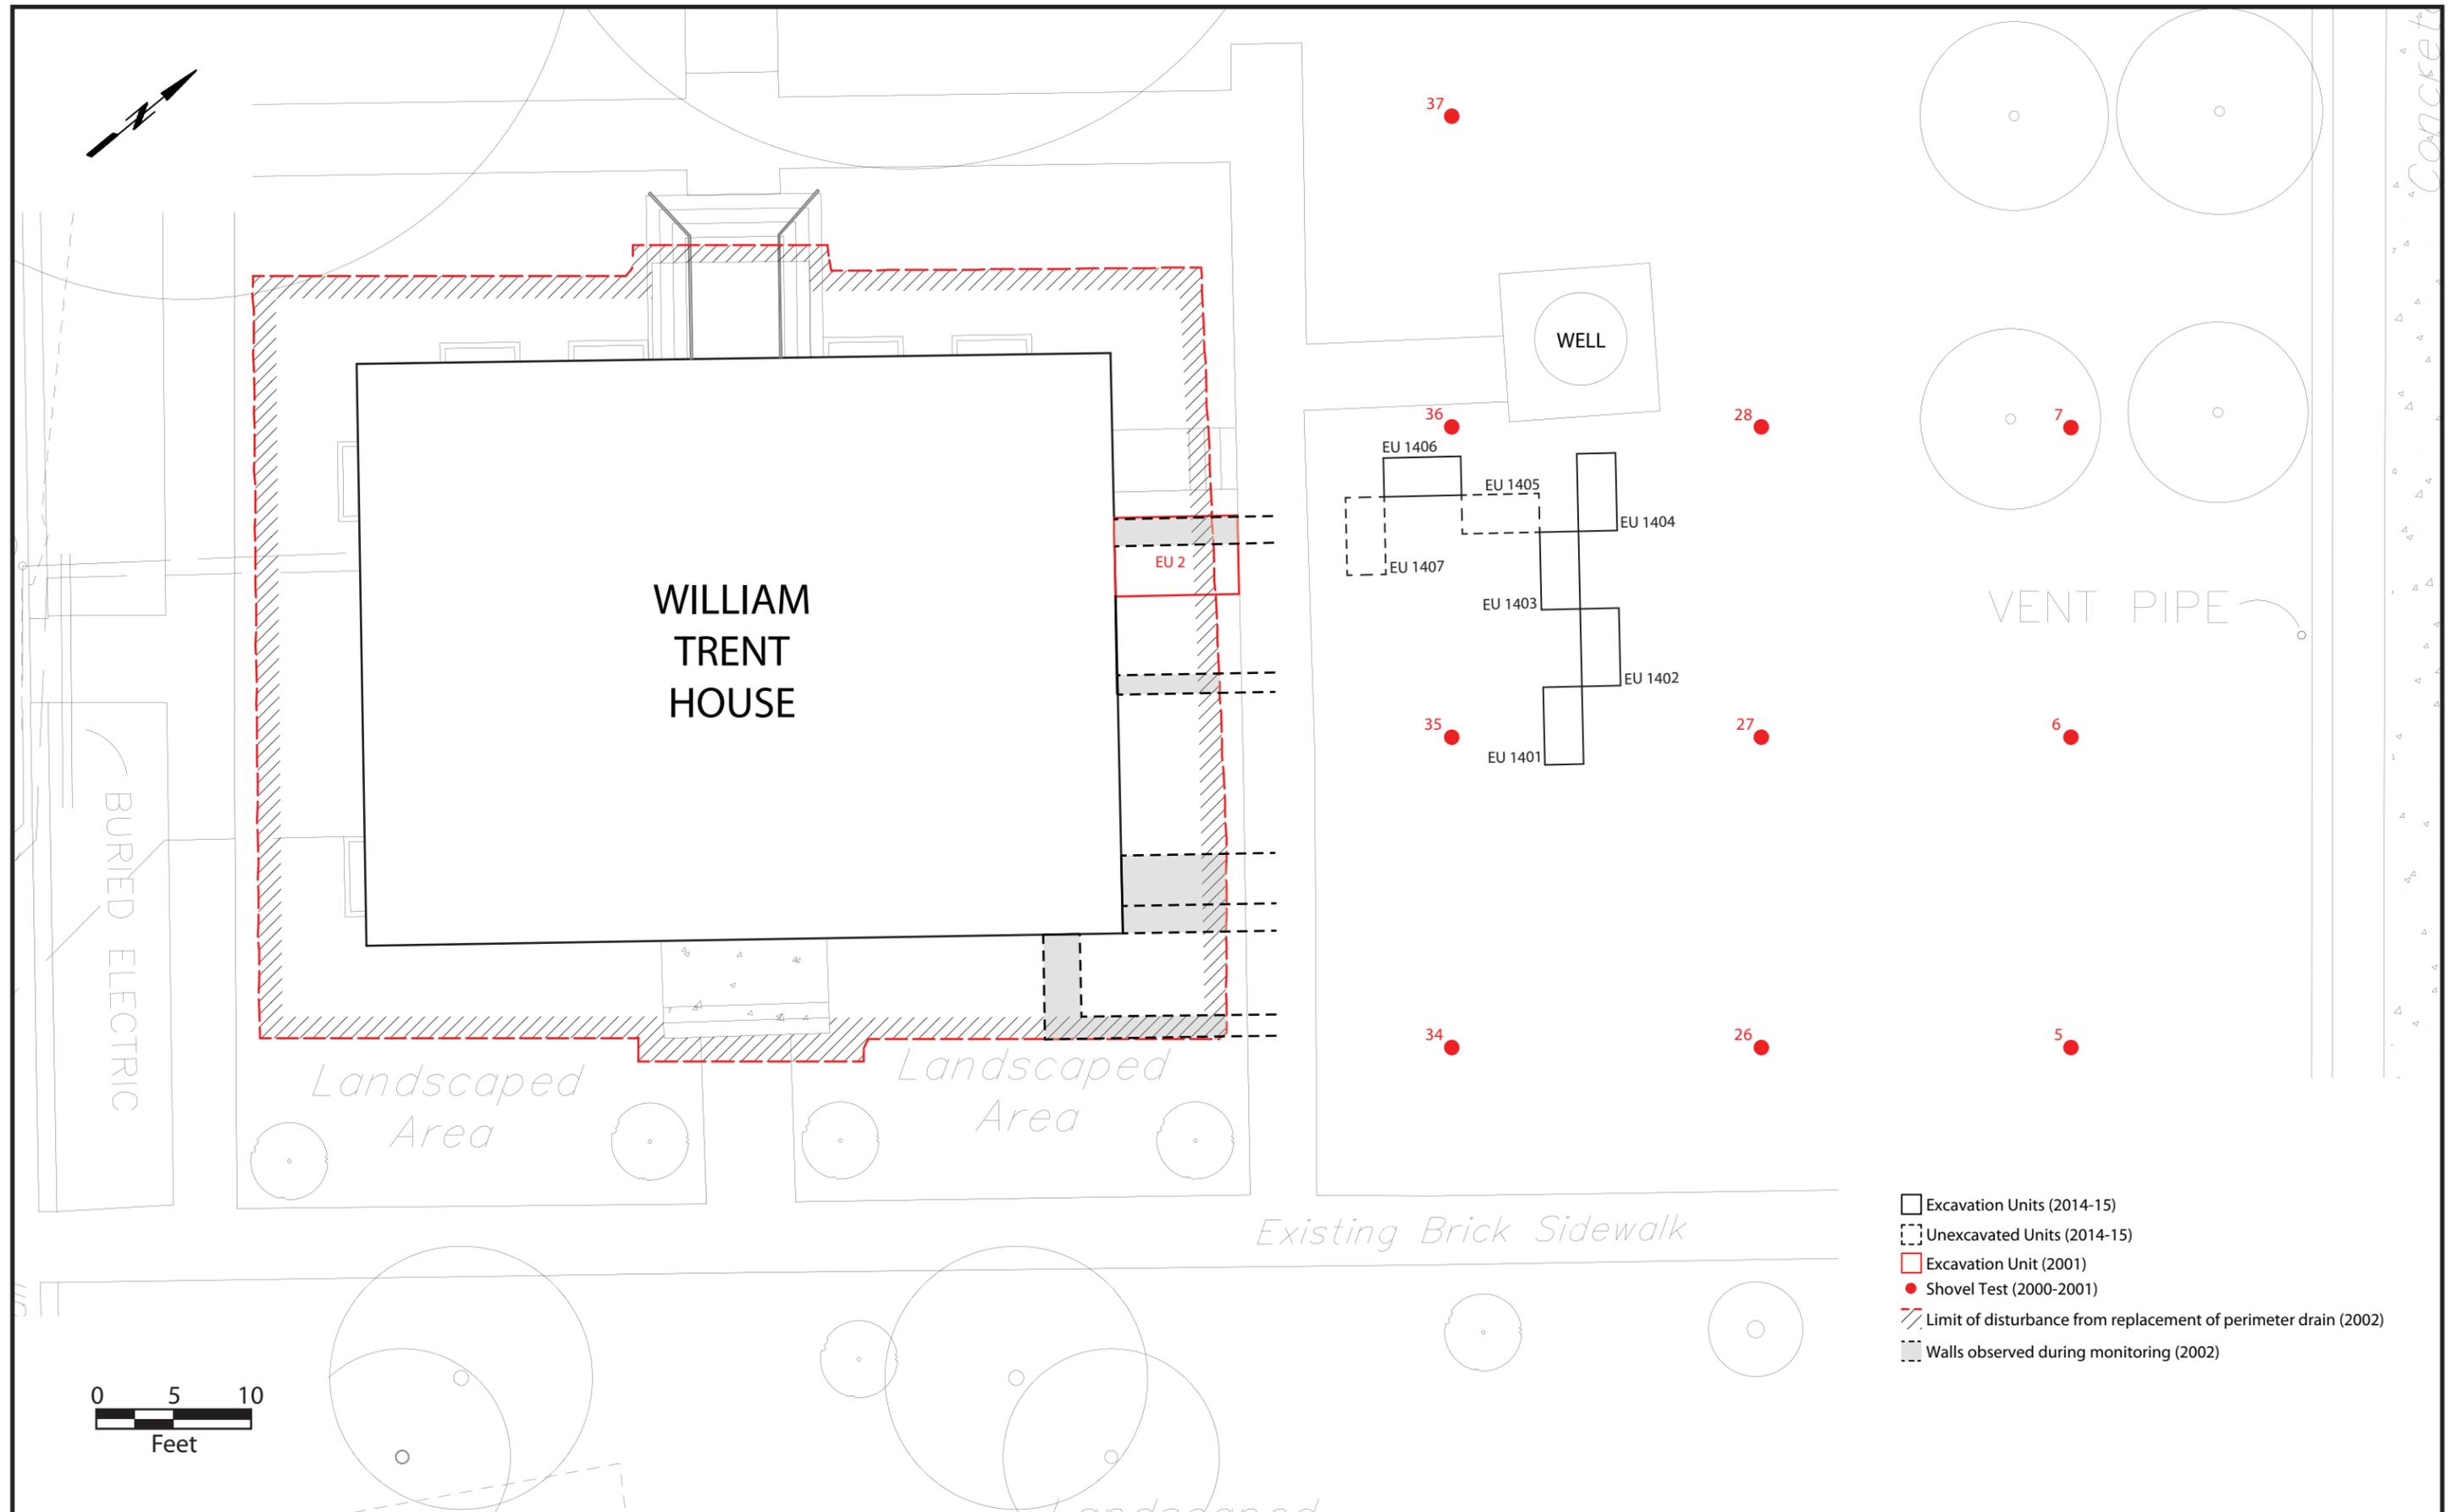
Figure 3.1. Site Plan Showing Locations of Archaeological Tests and Monitoring, 2001-02 and Excavation Units, 2014-15.

A series of seven connected excavation units, each 5 x 2.5 feet in plan, was laid out in the area east of the William Trent House with the goal of locating remains of the kitchen wing and gangway built in 1742 and of the 19th-century east wing (Figure 3.1). Four of these excavation units (EU #s 1401-1404) were placed along a line running parallel to and 30 feet east of the east wall of the house (Photograph 3.4). Since the combined width (or east-west dimension) of the kitchen and connecting gangway, based on archival and map evidence, was believed to be 40 feet, with each of these two structures being 20 feet wide, it was reasoned that these units should encounter the south wall of the kitchen. The axis of these four units also followed a north-south line that passed through the approximate center of the well. Since the well was suspected to be in its original mid-18th-century location, and was noted in a sale advertisement of 1759 as being inside the kitchen, this feature was also factored into the placement of these four excavation units. The remaining three units (EU #s 1405-1407) were placed west of Excavation Units 1401-1404 in an effort to locate the south wall of the gangway, possible remnants of which had been found in an excavation unit dug adjacent to the east wall of the house in 2001 (Figure 3.1 [EU 2]).

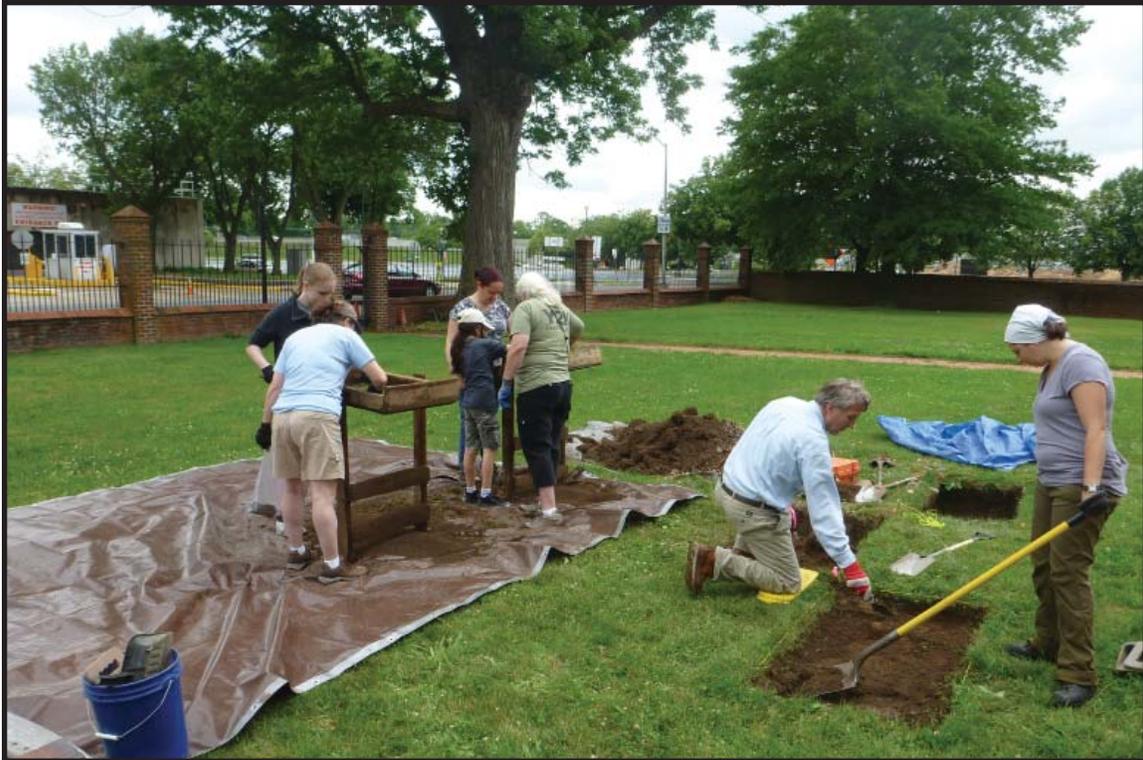
Photograph 3.1. William Trent House Public Archaeology Program in progress. View looking south-east showing excavation and screening (Photographer: Joshua Butchko, June 6, 2015) [HRI Neg. #14048/D2:001].

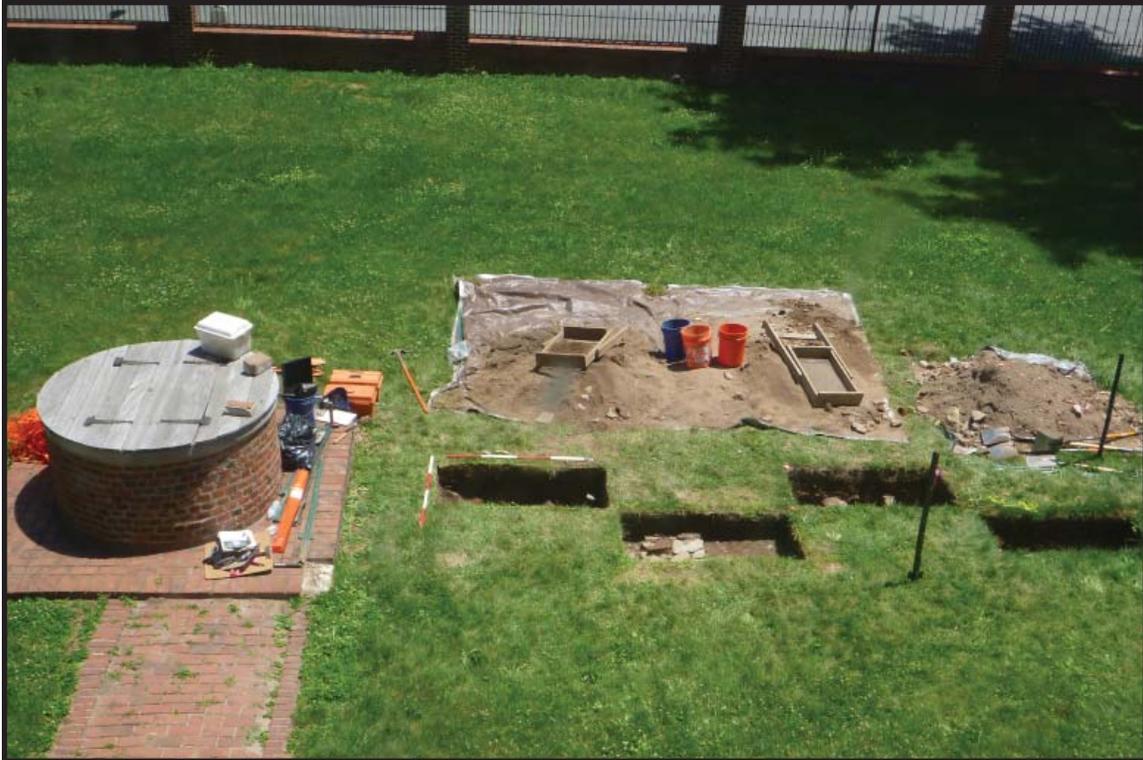
Photograph 3.4. General view of Excavation Units 1401-1404 looking east from the second floor of the William Trent House. Note the long axis of the excavation units is on a line passing through the center of the well at left. Scales in feet (Photographer: Joshua Butchko, June 13, 2015) [HRI Neg. #14048/D3:016].
