**WILLIAM TRENT HOUSE
PUBLIC ARCHAEOLOGY PROGRAM
ARCHAEOLOGICAL INVESTIGATIONS ON THE
EAST SIDE OF THE HOUSE**

**THE 1719 WILLIAM TRENT HOUSE MUSEUM
CITY OF TRENTON, MERCER COUNTY,
NEW JERSEY**

**FEBRUARY 2016
FINAL**

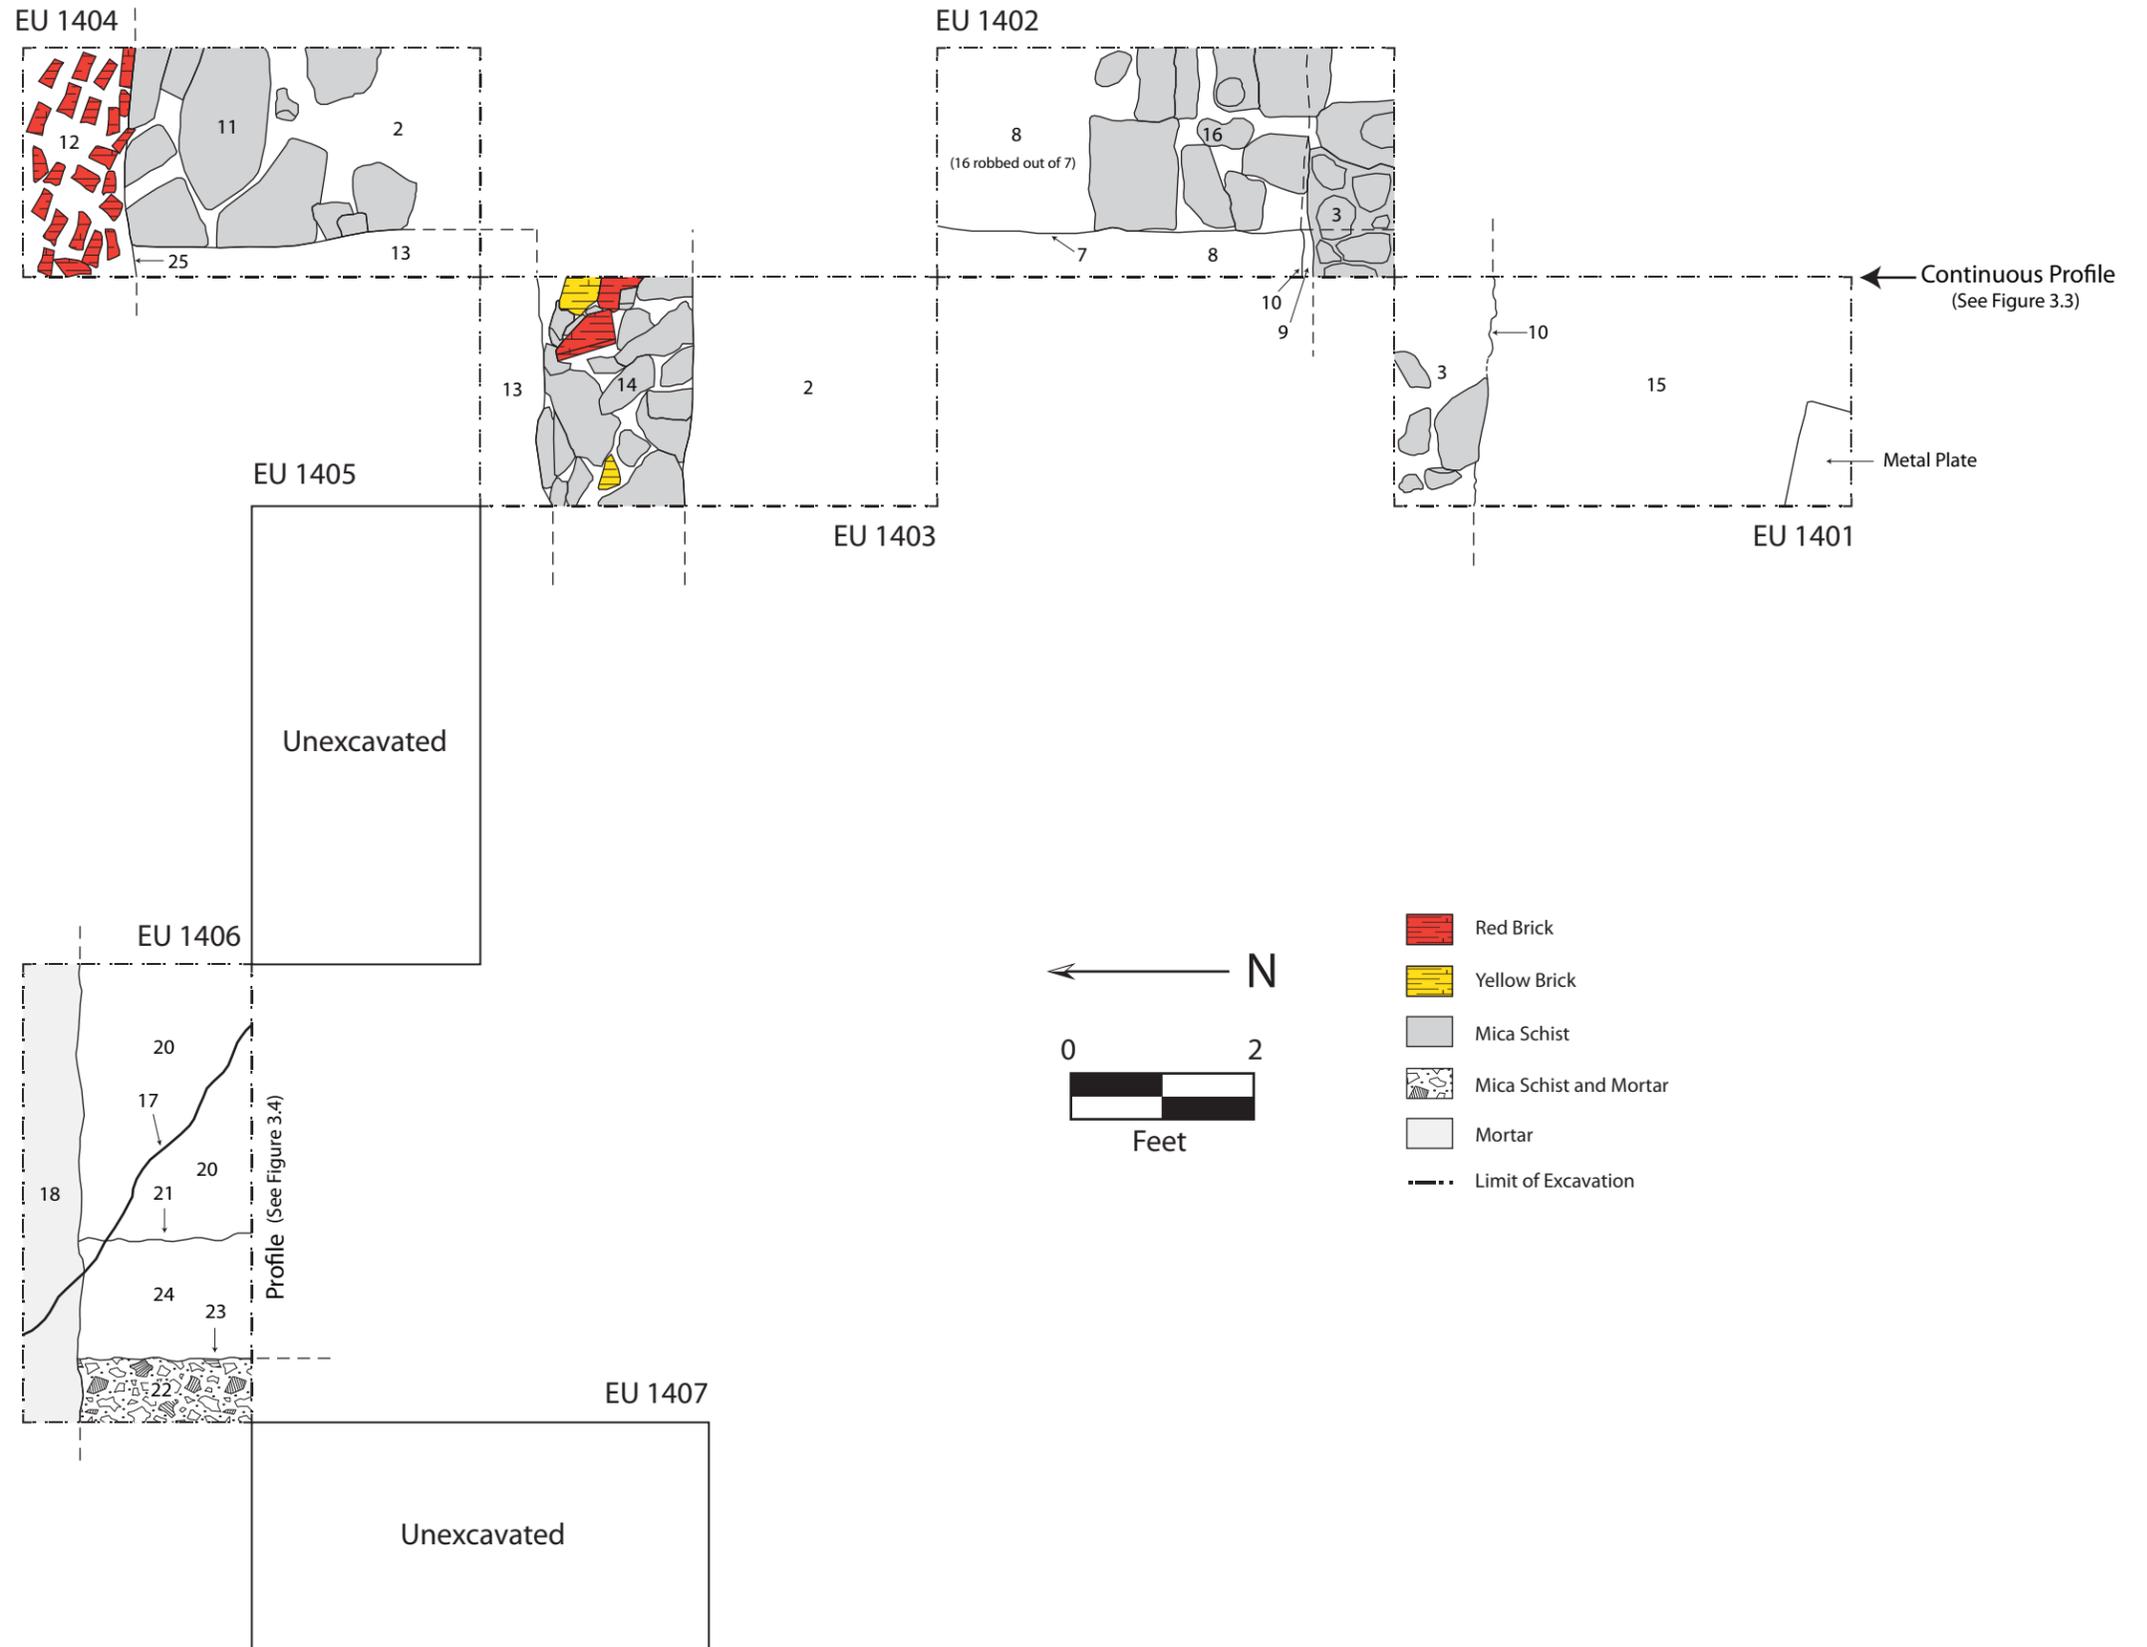
Figure 3.2. Detailed Site Plan of Excavation Units 1401-1404 and 1406.

In Excavation Unit 1402 the natural subsoil, a silty sand, had been cut into by the builders' trench [7] for what appeared to be a partially robbed-out north-south schist foundation [16]. Only the western face of this masonry feature was exposed, and if it is indeed a foundation, it is at least 2 feet wide. Its date of construction is uncertain, although it was overlaid by Context 4, a deposit that contained predominantly late 18th- and early 19th-century ceramics. It is possible that these masonry remains relate to the 18th-century

At the intersection of Excavation Units 1401 and 1402, the foundation identified as Context 16 was overlaid by, but not obviously bonded into, an east-west dry-laid mica schist and brick rubble footing [3] which was placed within a builders' trench [10] in-filled with mottled silty sand [9] (Photograph 3.5). This footing is likely the foundation for the main south wall of the mid-/late 19th-century east wing. Overall, the masonry remains at the intersection of Excavation Units 1401 and 1402 are somewhat disarticulated and do not easily lend themselves to secure interpretation without further excavation. It may be that these all represent the disturbed remains of the southeast corner of the core section of the east wing. The south face of the east-west footing was abutted by a sequence of three layers, the lowermost of which, a mottled silty sand [15], is considered to be a fill deposit within the footprint of the late 19th-/early 20th-century greenhouse.

Excavation Unit 1403 encountered a roughly 1.5 to 2-foot-wide, east-west mica schist and brick rubble foundation [14] at a depth of just under 1 foot beneath the current grade (Photograph 3.6). Soils on either side of this foundation were only minimally excavated, sufficient to expose the width and orientation of the wall. The foundation was entirely overlaid and abutted on its south side by a mottled silty sand layer with building rubble [2] associated with the mid-1930s demolition of the east wing. Abutting the north side of the foundation, however, a noticeably different layer of brick and stone debris [13] was observed beneath Context 2. Not fully excavated, this latter deposit contained fragments of yellow brick, often referred to as Dutch brick, which are typically assigned to the early 18th century or earlier.

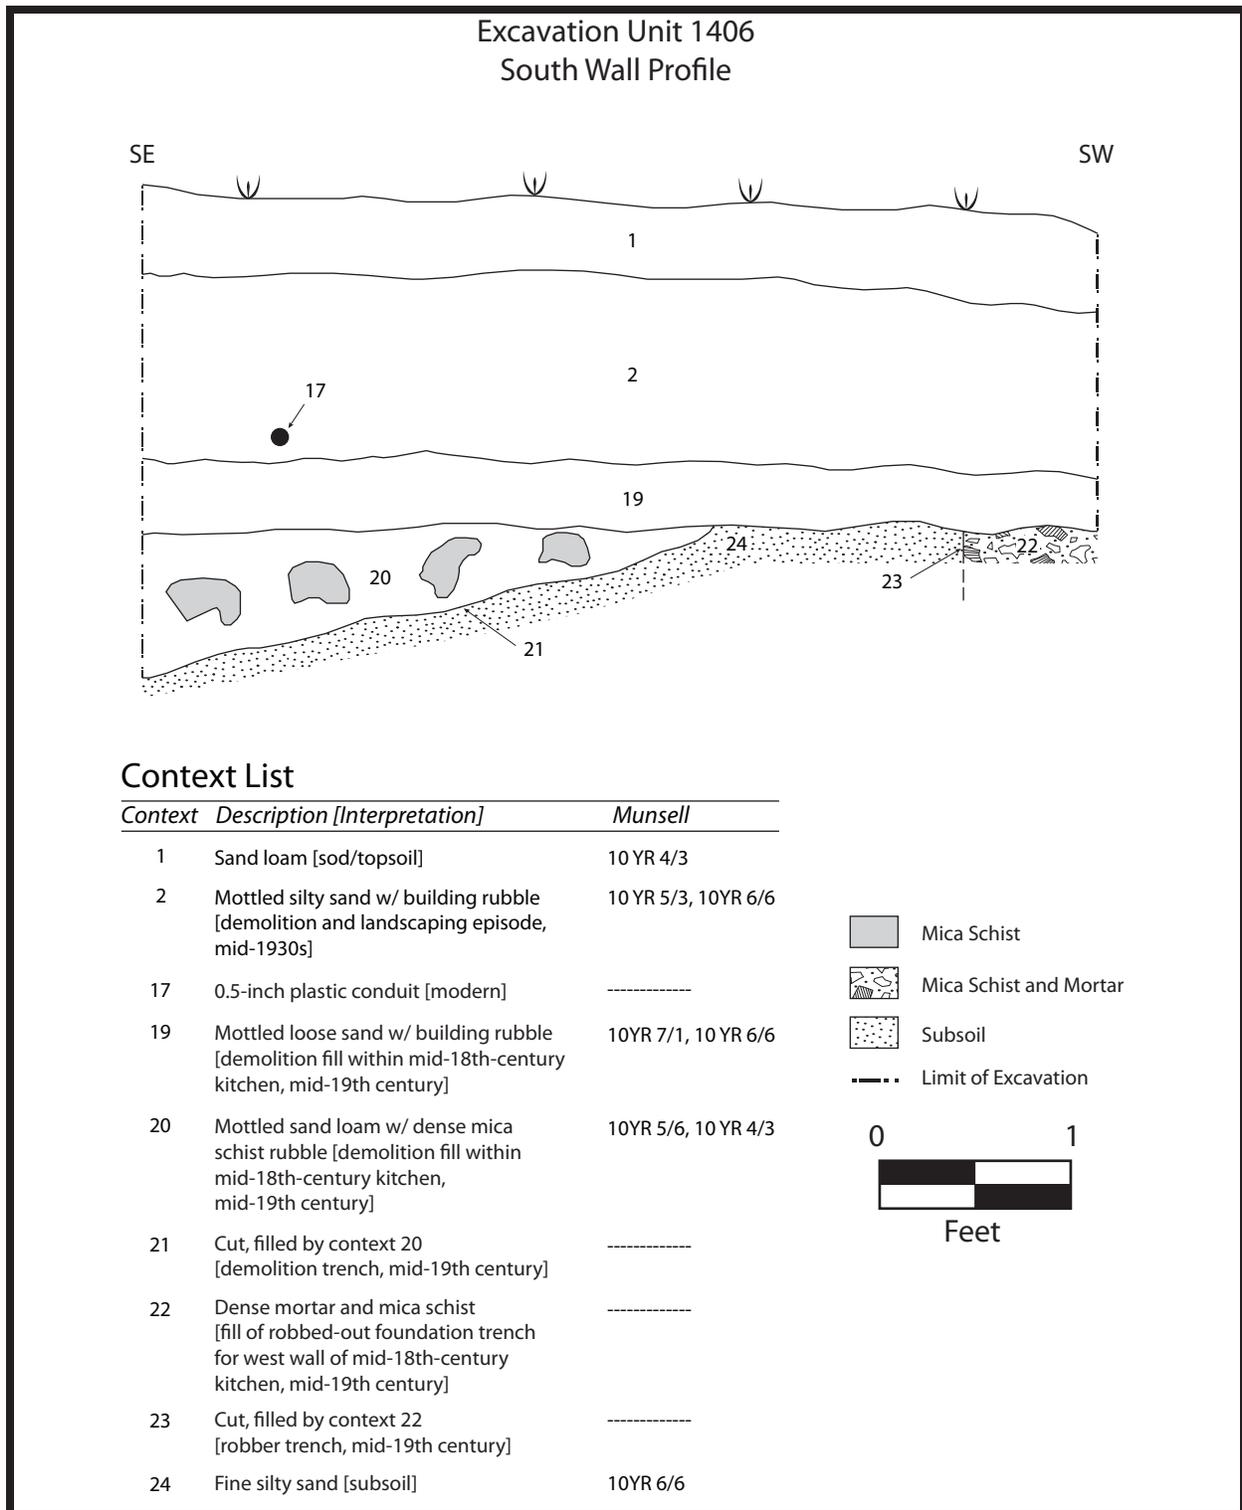
Figure 3.4. Excavation Unit 1406, South Wall Profile.

unit, the other roughly in the center. A north-south vertical cut [23], filled with a compact mortar and mica schist deposit [22], was identified approximately 0.5 feet from the western edge of the excavation unit. Even though this apparently north-south linear feature is 17 feet east of the house (as opposed to 20 feet), it is provisionally interpreted as the robbed-out trench of the west wall foundation of the mid-18th-century kitchen wing. To the east, a second, shallow cut [21] was identified sloping downward from the center of the unit towards the eastern limit of excavation. This cut contained a mottled sandy loam with dense building rubble, mainly chunks of mica schist and mortar [20] and is interpreted as a mid-19th-century demolition layer, possibly equivalent to Context 13 in nearby Excavation Units 1403 and 1404.

Contexts 20-24 in Excavation Unit 1406 were all overlaid by a 0.3-foot-thick deposit of mottled loose sand with building rubble, mainly mica schist and brick fragments [19], perhaps also equivalent to Context 13 in Excavation Units 1403 and 1404 and therefore probably of mid-19th-century date. Along the northern edge of the unit, this layer was overlaid by a compact 0.15-foot-thick deposit of mortar [18], possibly a construction deposit related to the mid-1930s restoration of the house and well. Contexts 18 and 19 were overlaid across the entire unit by a 1.1-foot-thick deposit of mottled silty sand with building rubble, including brick and mica schist fragments [2]. This deposit was encountered consistently throughout all units of this investigation and again is associated with mid-1930s grading and landscaping of the Trent House property following the demolition of the east wing and restoration of the main block of the house. A 0.5-inch modern plastic conduit [17] was encountered within this deposit [2] and left in place throughout the excavation.

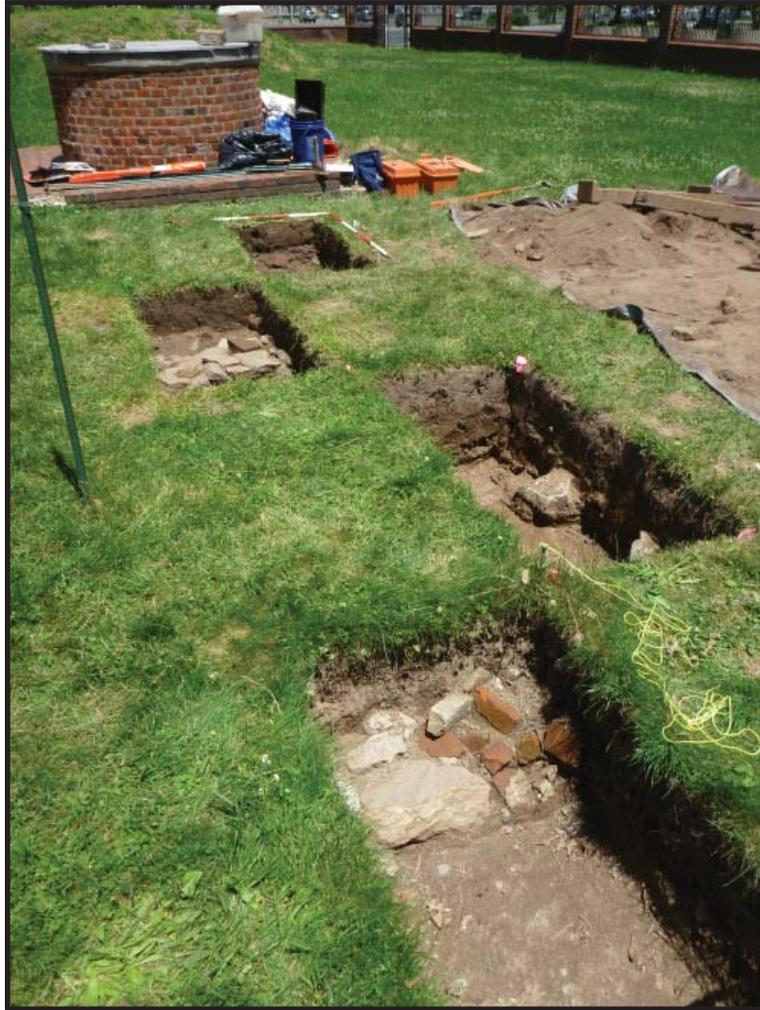
Photograph 3.5. General view of Excavation Units 1401-1404 looking north. The masonry [3] in Excavation Unit 1401 in the foreground is interpreted as remains of the south wall of the late 19th-/early 20th-century east wing. Scales in feet (Photographer: Joshua Butchko, June 13, 2015) [HRI Neg. #14048/D3:018].

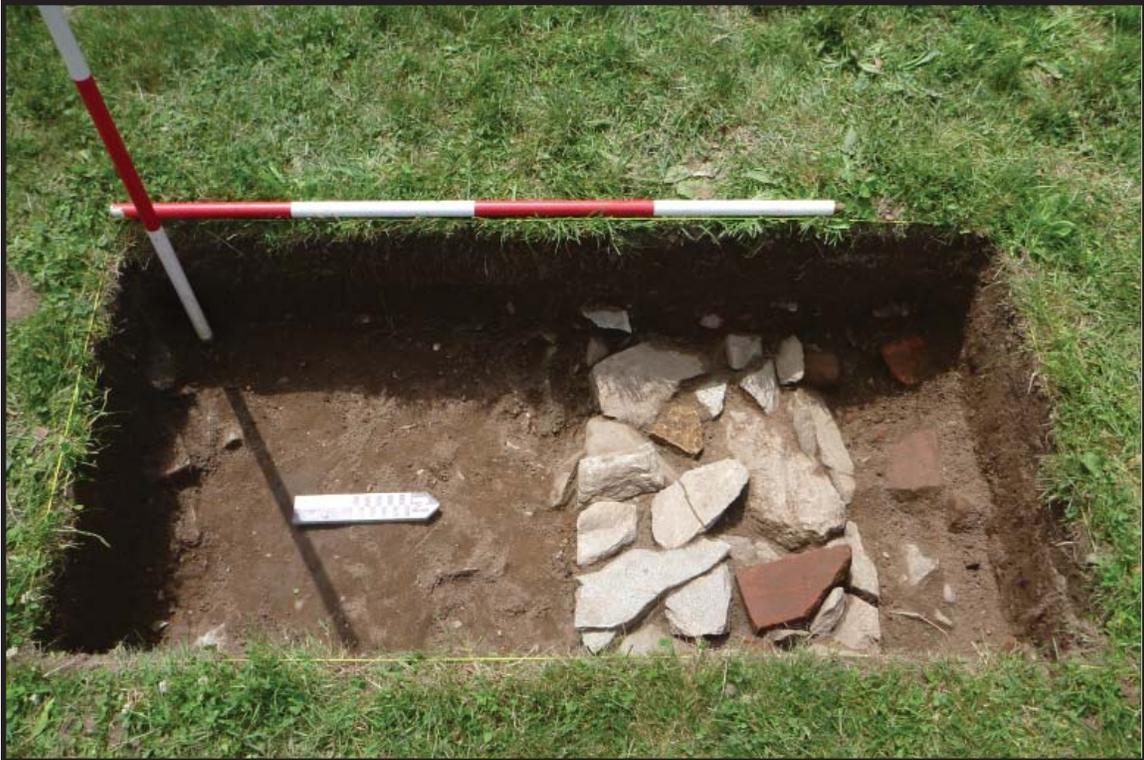
Photograph 3.6. View of Excavation Unit 1403 looking west. This foundation [14] is tentatively interpreted as the south wall of the mid-18th-century kitchen. Note the brick rubble fill [13] on the north side of the foundation, thought to be debris associated with the demolition of the kitchen in the mid-19th century. Scales in feet and tenths of feet (Photographer: Joshua Butchko, June 13, 2015) [HRI Neg. #14048/D2:013].

Currently, the east-west foundation [14] is tentatively interpreted as the south wall of the mid-18th-century kitchen wing and the rubble layer containing yellow brick is thought to relate to this structure's demolition, which may have occurred in the late 1840s, prior to the construction of the east wing. Again, further exploration would be needed to confirm these preliminary interpretations.

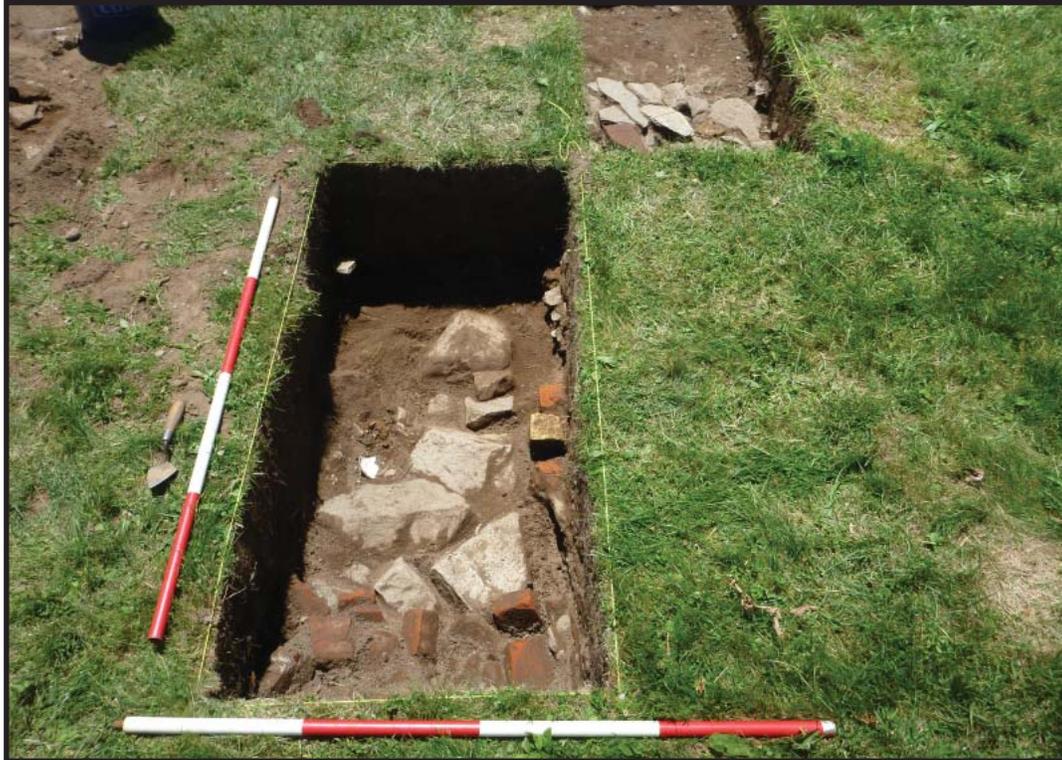
Photograph 3.7. View of Excavation Unit 1404 looking south. The masonry remains in this unit [11] may be part of a hearth or foundation associated with the mid-18th-century kitchen. The foundation [14] in Excavation Unit 1403 beyond is tentatively interpreted as the south wall of the mid-18th-century kitchen. Scales in feet (Photographer: Joshua Butchko, June 13, 2015) [HRI Neg. #14048/D3:007].

Context 13, the brick and stone rubble layer identified abutting the foundation in Excavation Unit 1403 was also traced into the western part of Excavation Unit 1404. In this latter unit, it was again sealed by Context 2, the mid-1930s fill, and abutted another expansive mica schist and cobble stone feature [11] that had a well-defined western edge (Photograph 3.7). Since this feature has only one defined edge and measures at least 2 feet east-west by 4 feet north-south, it is thought that it may represent the base of a hearth or fireplace, rather than the remains of a wall foundation. Opening of a larger excavation area to the south of Excavation Unit 1404 and east of Excavation 1403 would likely resolve the identity of these remains. Toward the northern end of Excavation Unit 1404, the mica schist and cobble feature [11] was disturbed and clearly cut [25] by a pit-like feature filled with densely packed brick rubble [12]. This cut and fill feature is almost certainly related to the reconstruction of the upper portion of the nearby well, which is believed to be in the same location as the mid-18th-century well reportedly located within the kitchen.

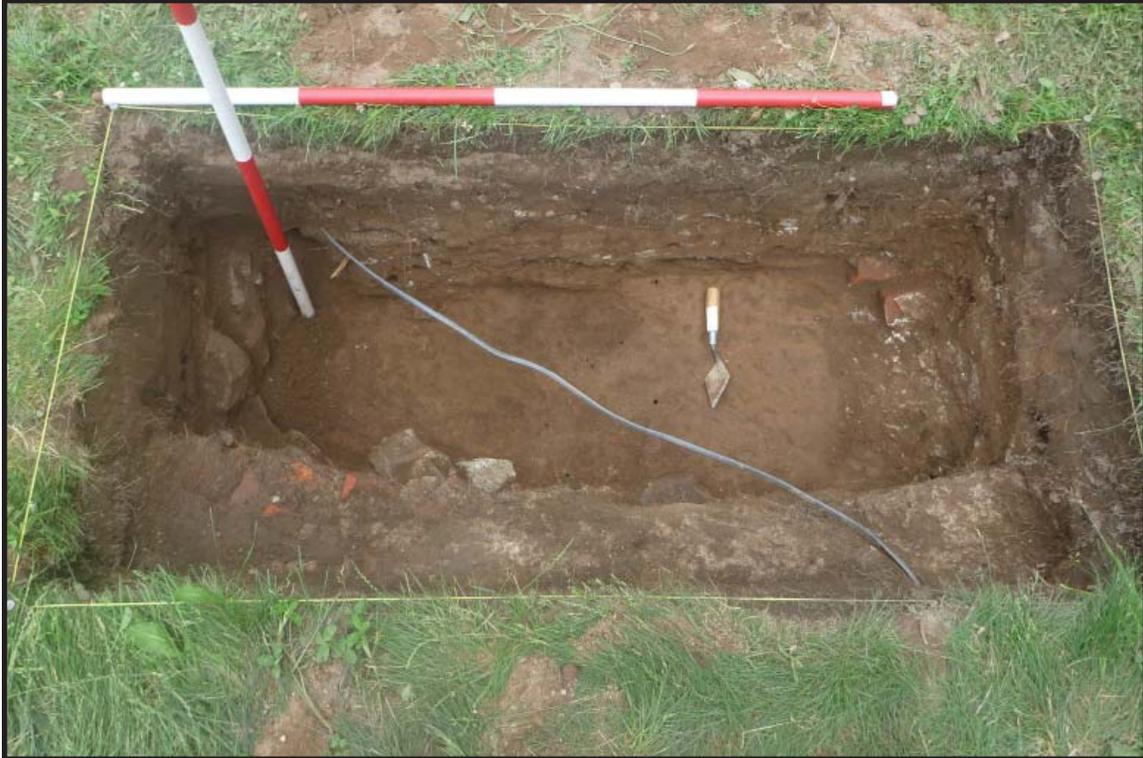
Photograph 3.8. View of Excavation Unit 1406 looking south. This view shows the unit at the conclusion of excavation with the exposed subsoil [24] extending from the mortar-and-rubble-filled trench [22, 23] at right, possibly marking the west wall of the mid-18th-century kitchen, to the mica schist rubble demolition layer [20] in the unit profile at left. Scales in feet (Photographer: Joshua Butchko, June 13, 2015) [HRI Neg. #14048/D4:008].

not encounter clear evidence of the east wall of the gangway or west wall of the kitchen 20 feet east of the house, but a filled feature with a distinct vertical cut [22, 23] running north-south roughly 17 feet east of the house is interpreted as a “robber trench” for a foundation. In the conjectural site plan it is postulated that this trench marks the east wall of the gangway and west wall of the kitchen. Further excavation would be required to confirm this interpretation.

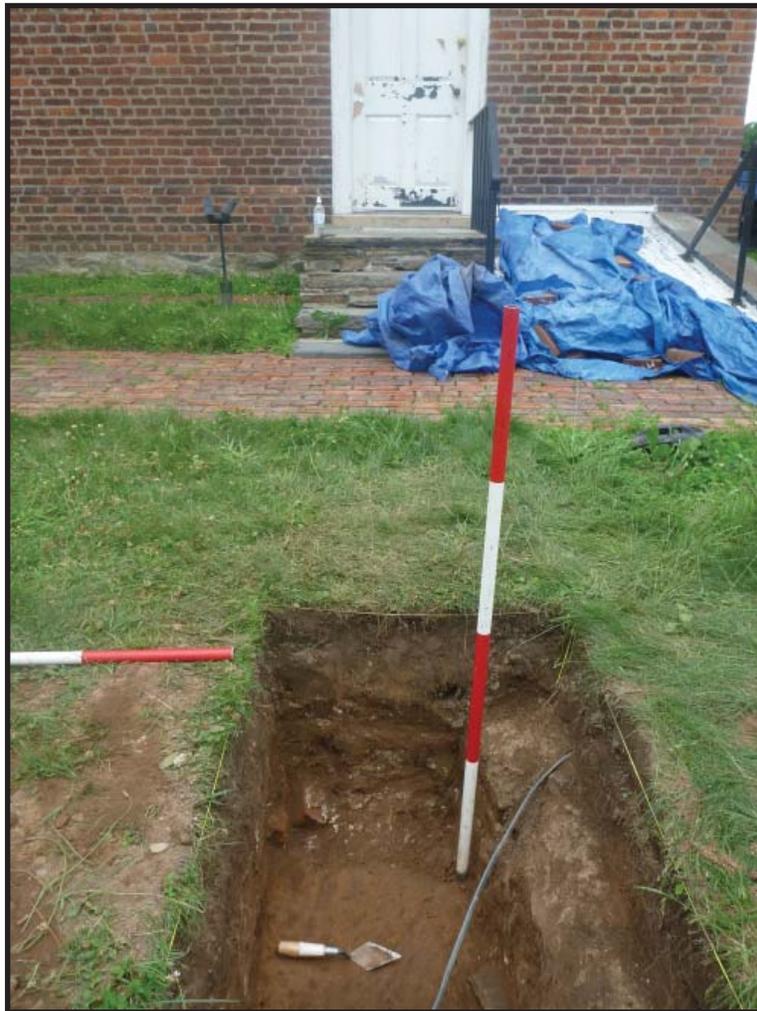
Photograph 3.9. View of Excavation Unit 1406 looking west. This view shows the unit at the conclusion of excavation with the exposed subsoil [24] in the base of the unit cut by the mortar-and-rubble-filled trench [22, 23] at the far end. This trench is thought to mark the west wall of the mid-18th-century kitchen. The spread of mortar higher up in the soil profile at right is interpreted as a construction deposit from the mid-1930s restoration. In the background, the steps and doorway leading into the first floor of the main house and the basement entry immediately to the right (beneath the tarpaulin), would have been enclosed within the gangway leading from the house to the kitchen. Scales in feet (Photographer: Joshua Butchko, June 13, 2015) [HRI Neg. #14048/D4:016].

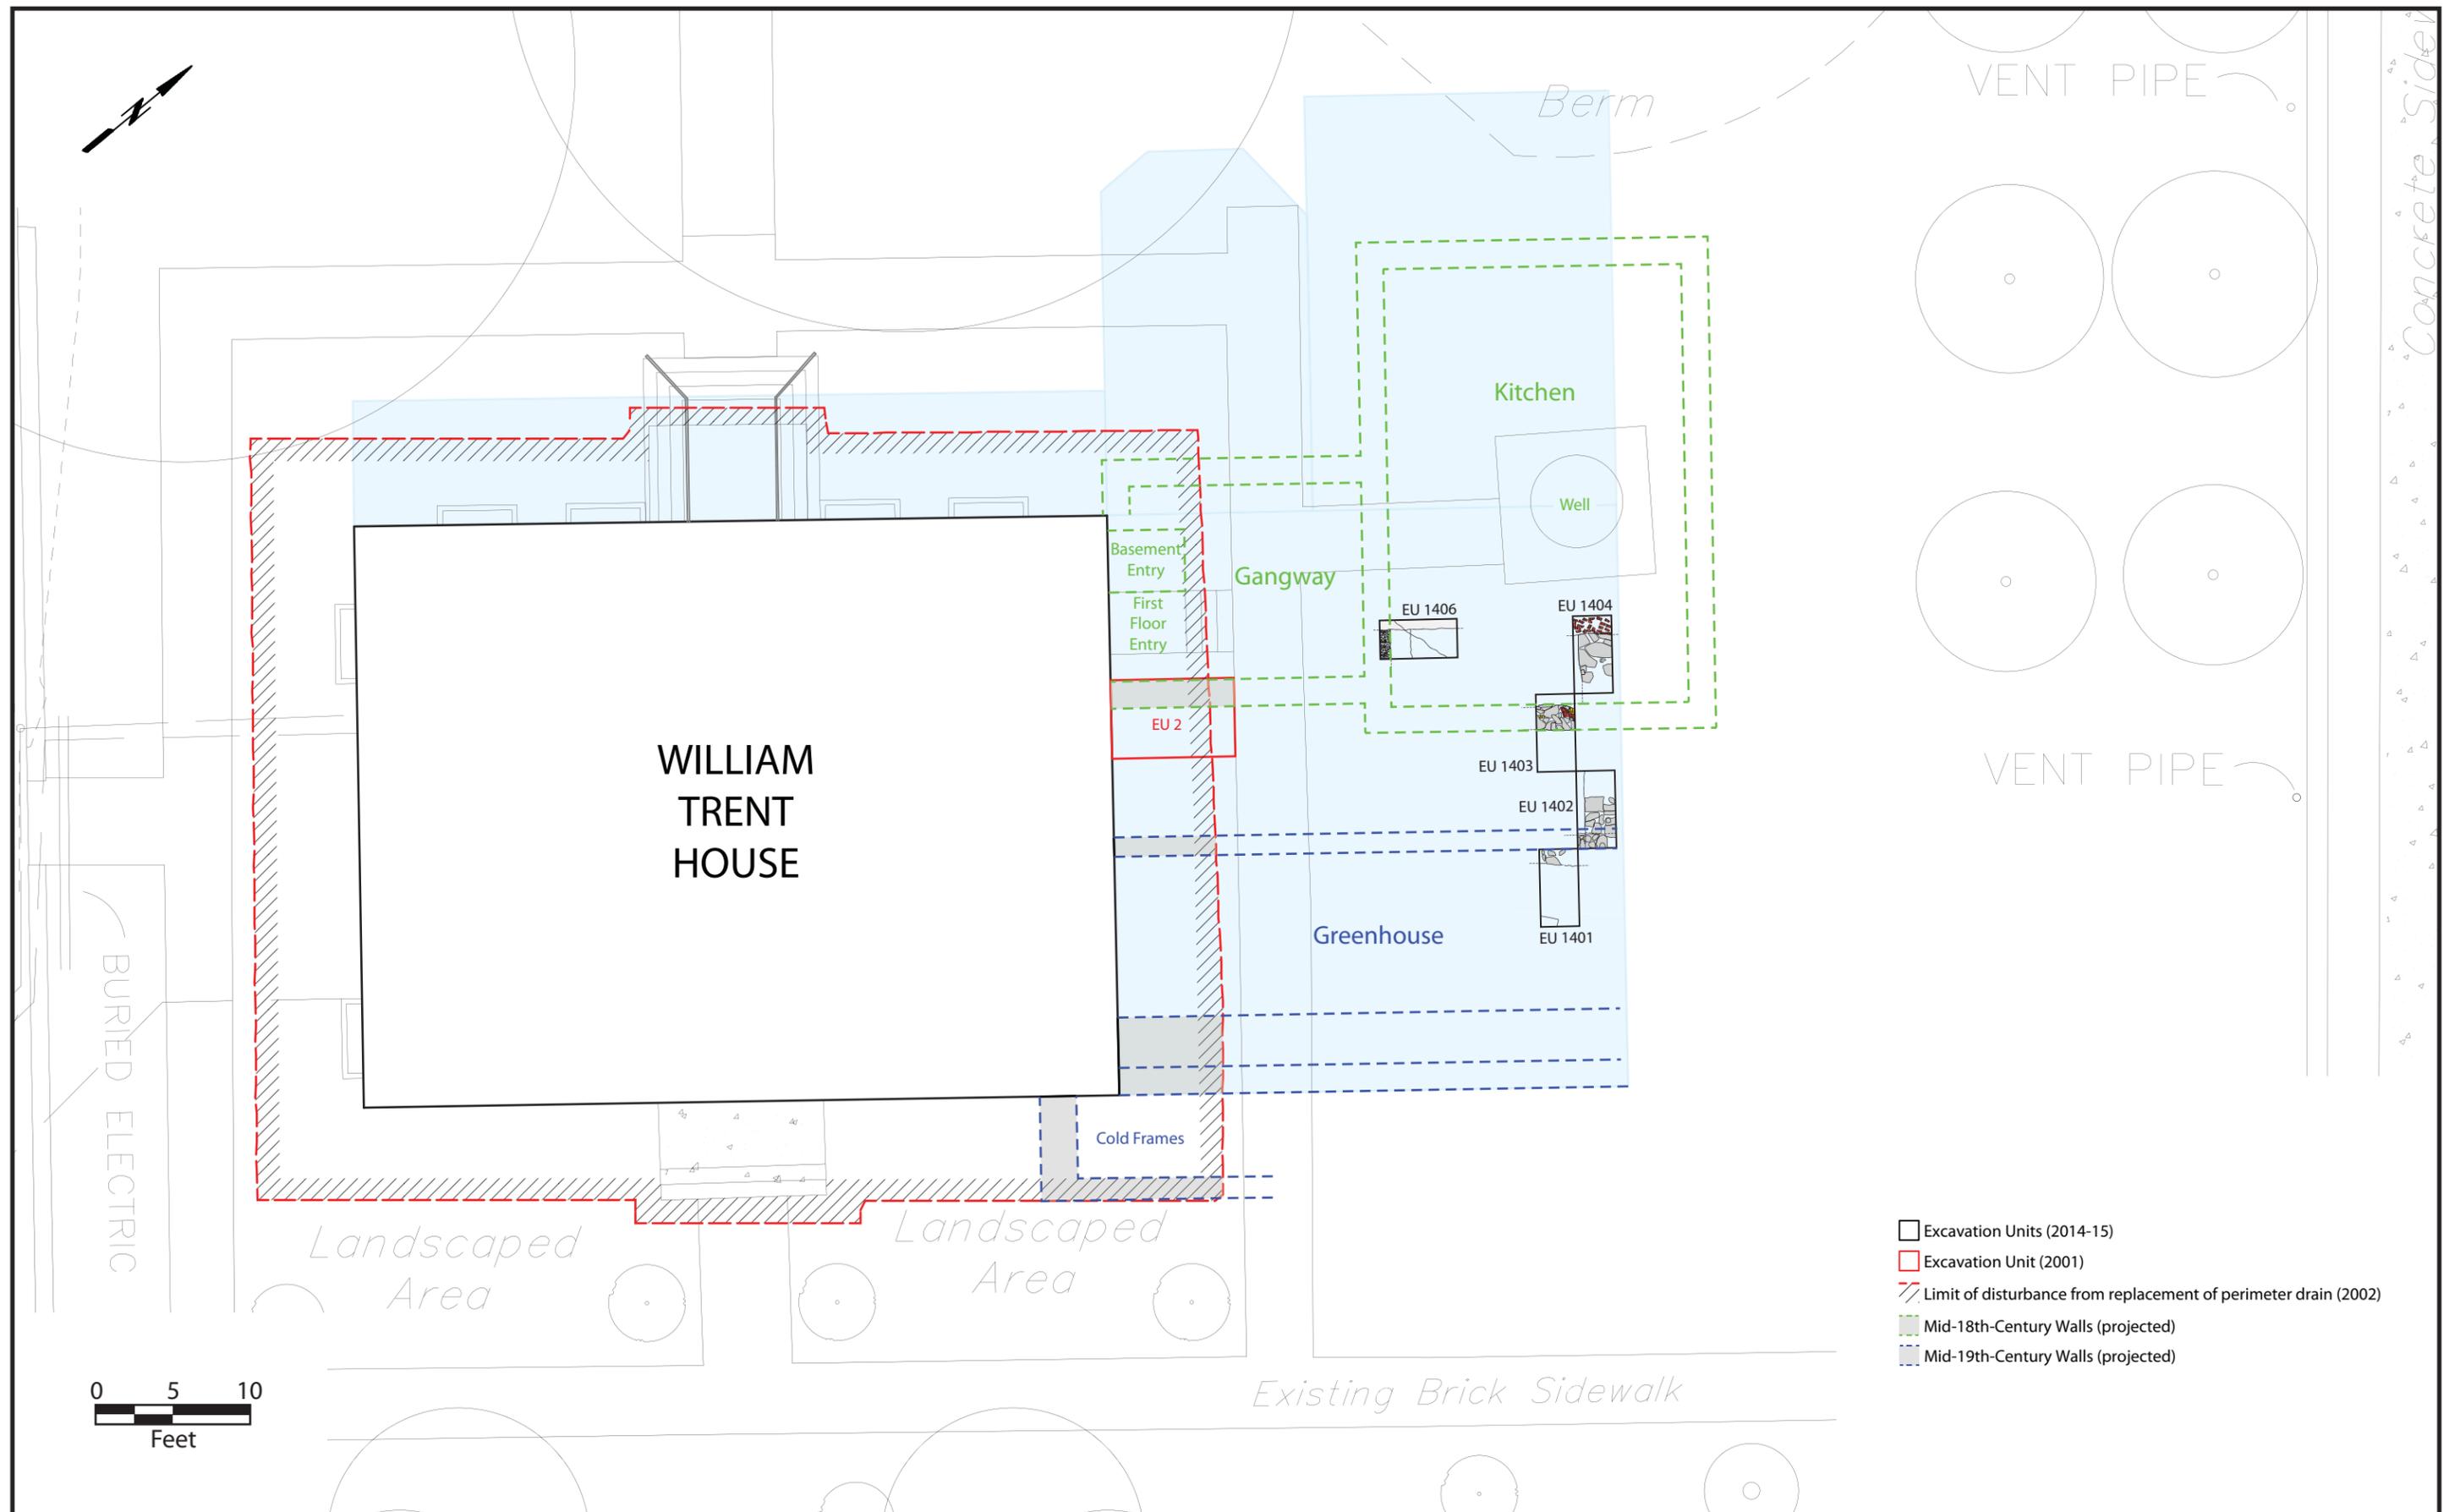
Figure 3.5. Conjectural Site Plan, Mid-18th-Century Kitchen Wing and Gangway, and Mid-19th-Century East Wing of House.

The mid-18th-century gangway and kitchen, based on the archival evidence, are each believed to measure 20 feet east-west, while in their north-south dimensions the gangway is 14 feet and the kitchen 30 feet. If the east-west foundation documented in Excavation Unit 2 in 2001 as projecting from the east side of the house, just south of the present-day stoop, is correctly identified as the south wall of the gangway, then the 14-foot dimension means that the gangway would have projected north beyond the north face of the main house. The west end of the gangway would necessarily have contained both one or two steps leading up to a doorway into the first floor of the house and also, immediately to the north, a stairway leading down into the basement. Excavation Unit 1406 did

Elements of the mid-19th-century east wing were also encountered during the 2014-15 excavations and appear to match up reasonably well with evidence recorded in 2002 when the perimeter drain was replaced around the house. The masonry remains found at the intersection of Excavation Units 1401 and 1402 are thought to be part of the south and possibly

east walls of the main block of the east wing. The south wall lines up with a foundation noted further to the west when the perimeter drain was replaced. To the south of the south wall was the greenhouse that butted up against the south side of the east wing. Two phases of greenhouse construction were observed on the maps and in the archaeological monitoring of 2002, one dating from *circa* 1870 and the other, a rebuild, dating from *circa* 1908-26.
