**ARCHAEOLOGICAL MONITORING
FIRST REFORMED CHURCH OF NEW BRUNSWICK
CITY OF NEW BRUNSWICK, MIDDLESEX COUNTY
NEW JERSEY**

AUGUST 2019

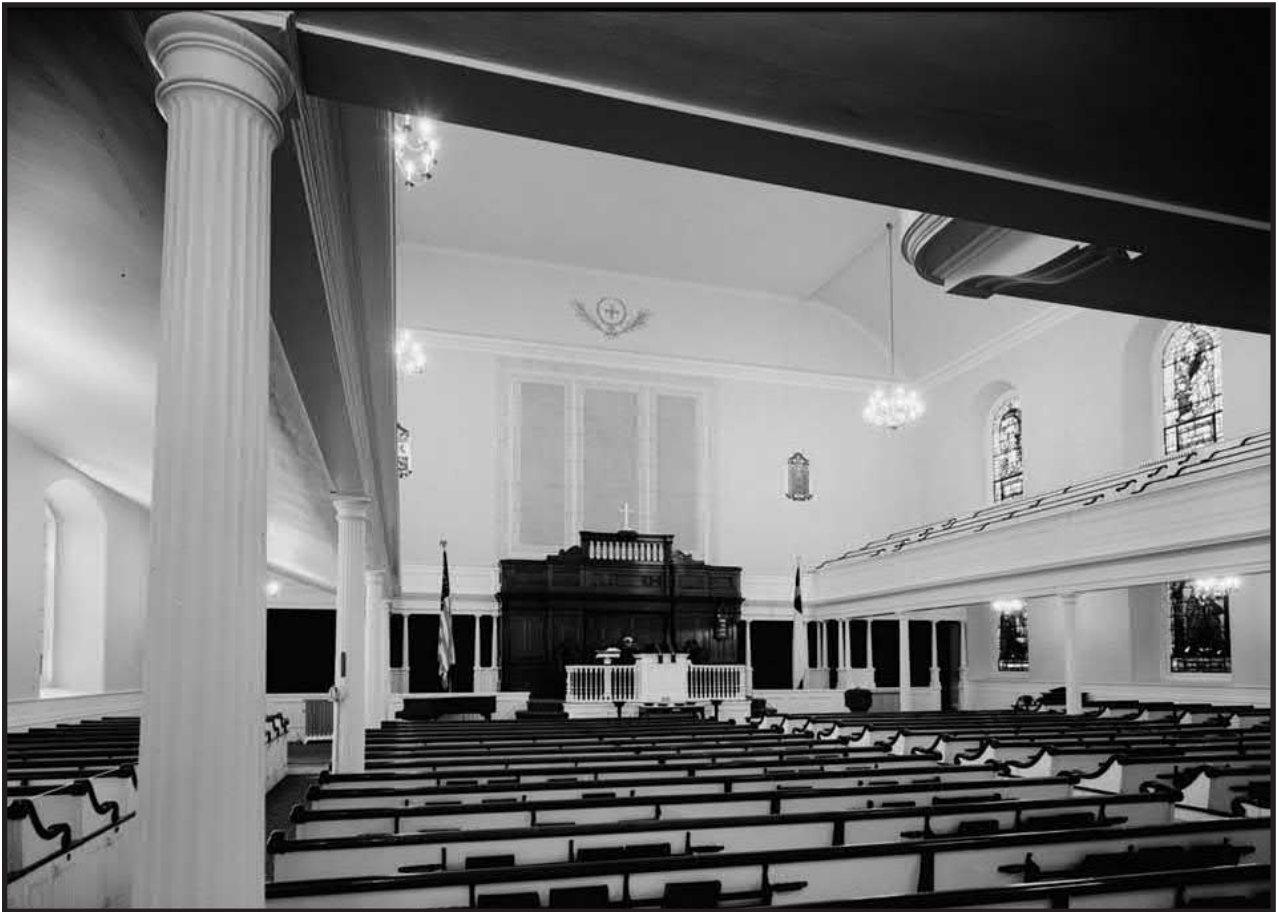
Photograph 1.3. View looking west showing the interior of the auditorium at the First Reformed Church of New Brunswick. 1960. Source: HABS 1960.

The interior of the church historically comprised a large auditorium with a narrow foyer extending across its eastern end (Photograph 1.3). The auditorium contained a first-floor seating area defined by a central aisle and two side aisles, one to the north and the other to the south. A second-floor balcony with additional seating encircled the auditorium on its northern, eastern and southern sides accessed through stairs in the foyer and in vestibules in the northwest and southwest corners of the auditorium. The pipe organ was positioned centrally against the west wall of the auditorium fronted by a pulpit set on the lip of the dais at the end of the central aisle.

3.2). A simple diagram showing how a typical water-powered pipe organ functioned, based on an example at the Emmanuel Catholic Church in Dayton, Ohio, is included here as Figure 3.3. Engines of this type are still occasionally found in use today (Photograph 3.6). The First Reformed Church’s water-powered pipe organ was originally positioned on the first floor of the sanctuary centrally positioned at the western end of the church directly above the water engine (see above, Photograph 1.3). This organ was destroyed by

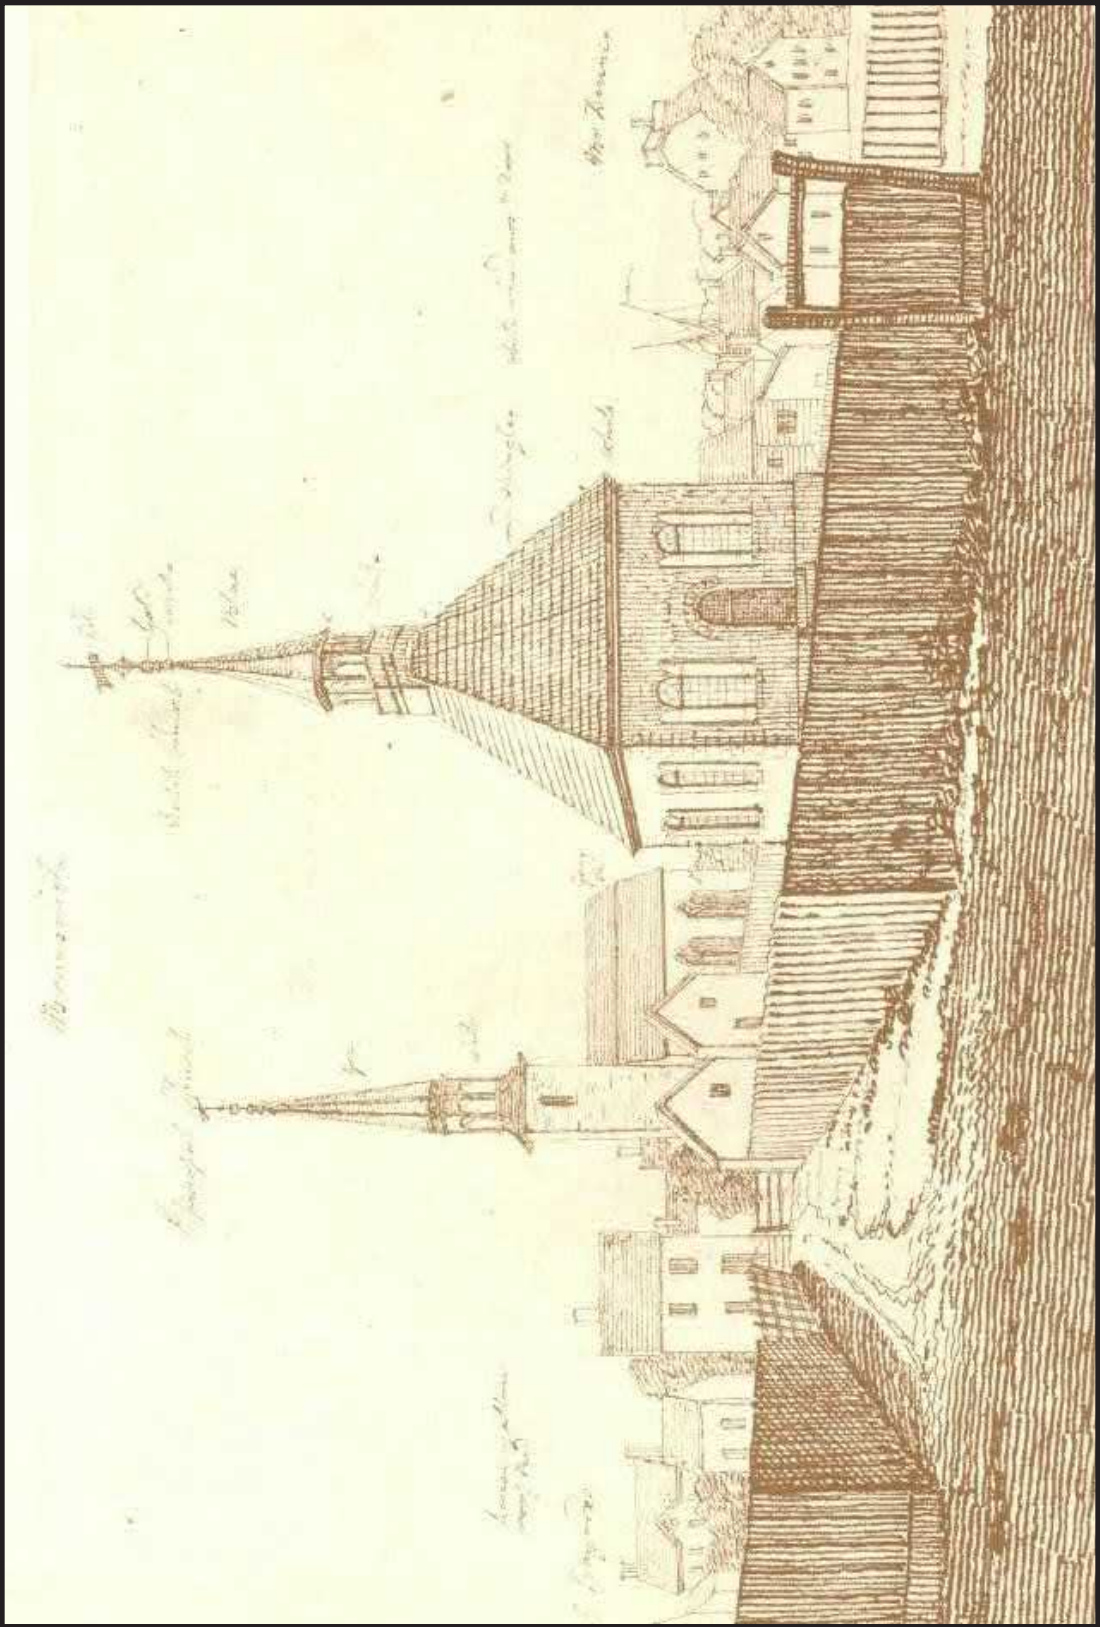
Figure 2.1. Artist's Rendering of the First Dutch Reformed Church, circa 1790. This view is looking north from Bayard (Prince) Street along the alley that passed to the rear of the church property. The original First Dutch Reformed Church on the site is in the foreground and has a side door in its south façade. The main entrance into the church was on its eastern side, which would have faced Neilson (Queen) Street and the Raritan River. The church beyond is Christ Episcopal Church. Source: Listokin 1976.

No securely attributed historic images of this church building have been found, but an artist's rendering of uncertain date and provenance (Figure 2.1) echoes the above description and suggests the building closely resembled other better documented contemporary structures, such as the First Dutch Reformed Church in Albany, New York. The location of the church is confirmed through its appearance on “A Map of the Corporation of the City of New Brunswick” surveyed in 1784, the year in which the city received its charter. The church building is shown on the west side of Queen's (Neilson) Street, south of Barrack (Paterson) Street (Figure 2.2).

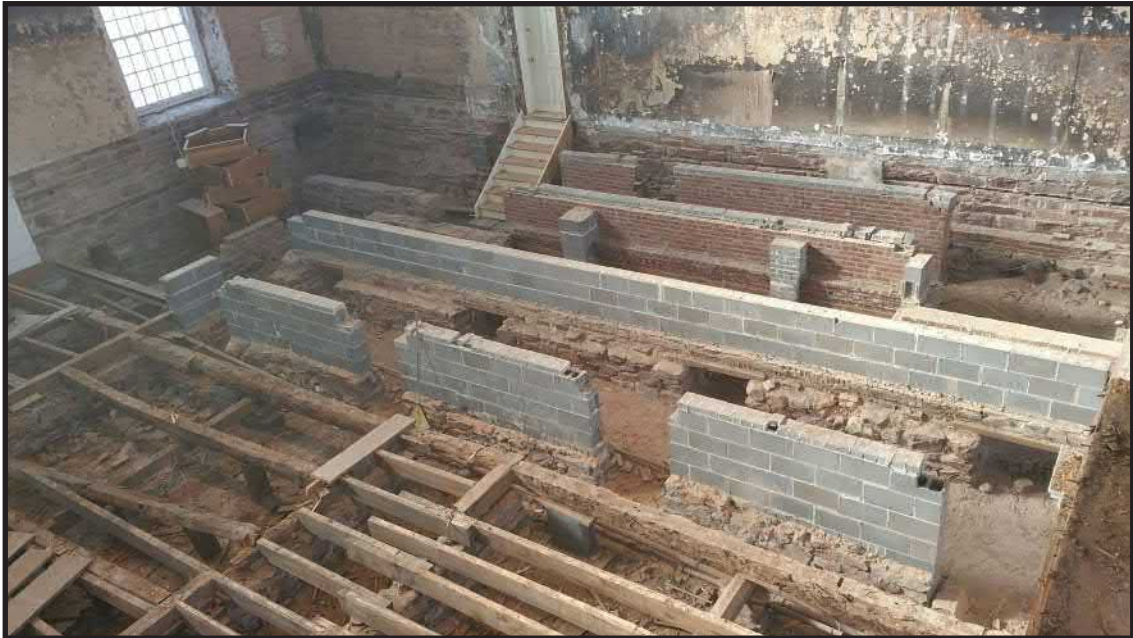
Photograph 3.1. View looking southwest showing exposed floor joists and stone, brick and cinder-block foundations supporting the first floor of the church auditorium and sanctuary. The cinderblock and brick foundations supported an elevated dais in the sanctuary at the western end of the building (Photographer: E-Tomic Construction Services, January 2015).

At the western end of the church, a series of parallel, north-south foundations were documented which supported the dais within the sanctuary (Figure 3.1; Photograph 3.1). The easternmost of these foundations, located approximately 24 feet east of the church's west wall, likely supported the front of the pulpit which was positioned at the eastern edge of the dais. This foundation rose up directly from the western end of the center aisle foundations. A second foundation ran north-south approximately four feet to the west and probably supported the rear of the pulpit. Both of these foundations consisted of mortared medium to large stones with a grey-colored sandy mortar and both directly underpinned cinderblock footings that had been added to raise and possibly expand the area of the dais further to the east.

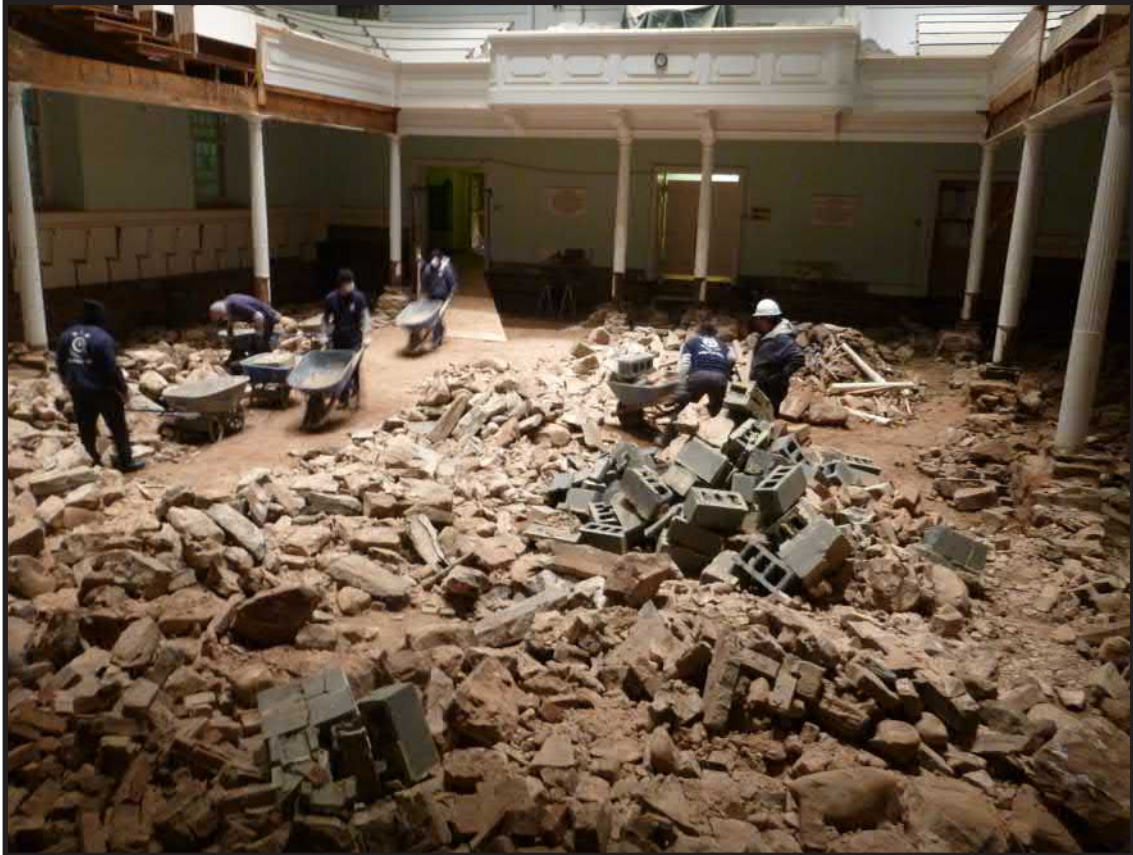
Photograph 3.2. View looking east-northeast showing the contractor removing the demolished first-floor foundations. Note the stone footings underpinning the wooden columns supporting the second-floor balcony (Photographer: Joshua Butchko, January 2015) [HRI Neg. #15001/D1:060].

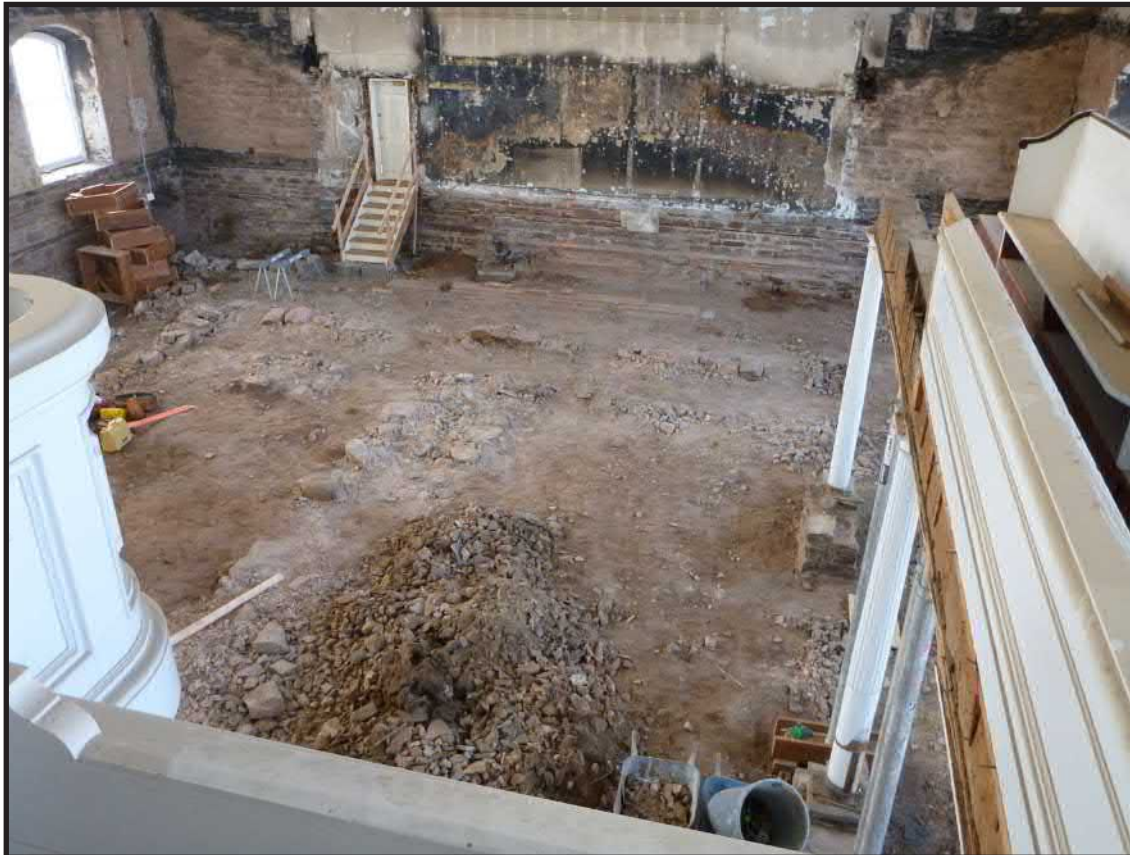
Photograph 3.3. View looking west-southwest from the second floor balcony showing the church auditorium after removal of the first-floor foundations and prior to excavation for new construction. The second-floor balcony has been mostly removed by the time this photograph was taken. Note the extensive charring on the far west wall from the fire of May 29, 1971 and the ghosting of the stairs leading up to the balcony in the northwest and southwest corners of sanctuary (Photographer: Joshua Butchko, January 2015) [HRI Neg. #15001/D1:190].

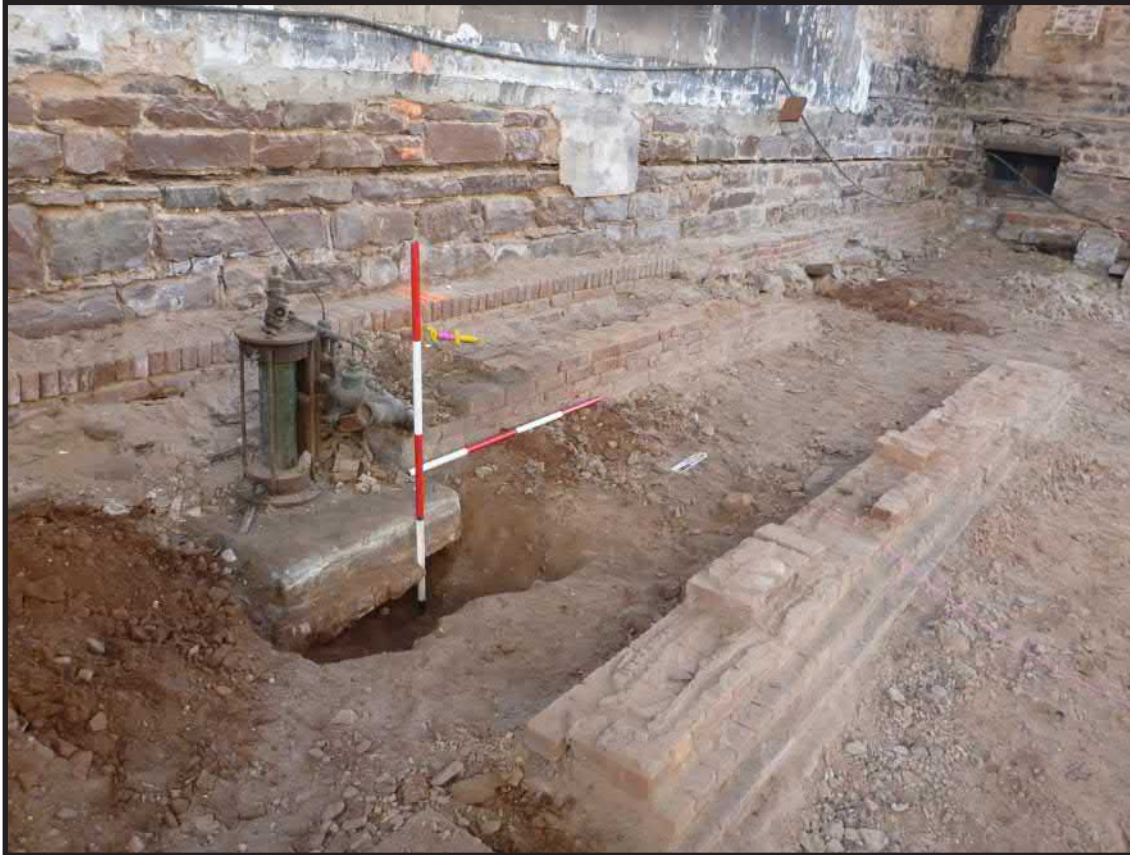
Photograph 3.4. View looking northwest showing the partially removed foundations for the dais in the sanctuary. The main west wall of the church is in the background with a brick capping on the foundation offset. The top of the brick capping is considered to represent the original first-floor level of the dais, which was later raised to a higher level, probably to allow for installation of a new pipe organ powered by a water engine. A brick foundation has also been built up against the offset of the church's west wall foundation with the water engine for the pipe organ set on a bluestone slab inserted roughly midway along its course. A second mortared brick on stone foundation in the foreground provides additional support for the dais and organ. Scales in feet and tenths of feet (Photographer: Joshua Butchko, January 2015) [HRI Neg. #15001/D1:161].

The final two sets of north-south foundations were both located closer to the west wall of the church and evidently supported the massive pipe organ that was positioned against the center of the west wall (Photographs 1.3 and 3.4). Both were mortared stone foundations on top of which rose a mortared brick footing several courses high capped by a thin layer of cinderblock. One of these foundations, 22 feet long and two feet wide, ran parallel to and approximately six feet east of the west wall. Its southern end abutted the northern end of the mortared stone foundation observed in the southwest corner of the church (see above). Many of the bricks in this foundation were stamped "S & F" indicating their manufacture by the Sayre & Fisher Brick Company, of Sayreville, NJ, which was in operation from *circa* 1850 until the late 1960s (Bayley 2019). The underlying mortared stone base extended approximately two feet beneath the ground surface and was laid in a trench cut into the natural bedrock. As the lower mortared stone courses were being removed by the contractor, it became apparent that much of the foundation was comprised of fragments of grave markers, chiefly footstones, presumably relocated from graves in the churchyard. Each of these stones was retrieved under archaeological supervision and mortar adhering to their surfaces was carefully removed. In all, portions of at least 42 different footstones were retrieved during the dismantling of this wall. Thirty-five were made of marble;

The water engine that was found seated on the bluestone slab is an item of some considerable interest (Photographs 3.4 and 3.5). This artifact was removed from the slab by the contractor and has been placed into storage by the church. Constructed chiefly of cast iron, it displayed a manufacturer's mark indicating that it was made by the Ross Valve Manufacturing Company of Troy, New York. This firm was established in 1879 and remains in operation today, although its production of water engines is believed to have ceased in the 1950s or 1960s (www.rossvalve.com; Self 2017). This particular water engine was likely made in the late 19th or early 20th century and represents an important upgrade of the church's service equipment. The device powered the church's pipe organ using the pressure of water drawn from the city water supply system to drive a piston that operated the pipe organ's bellows (Figure

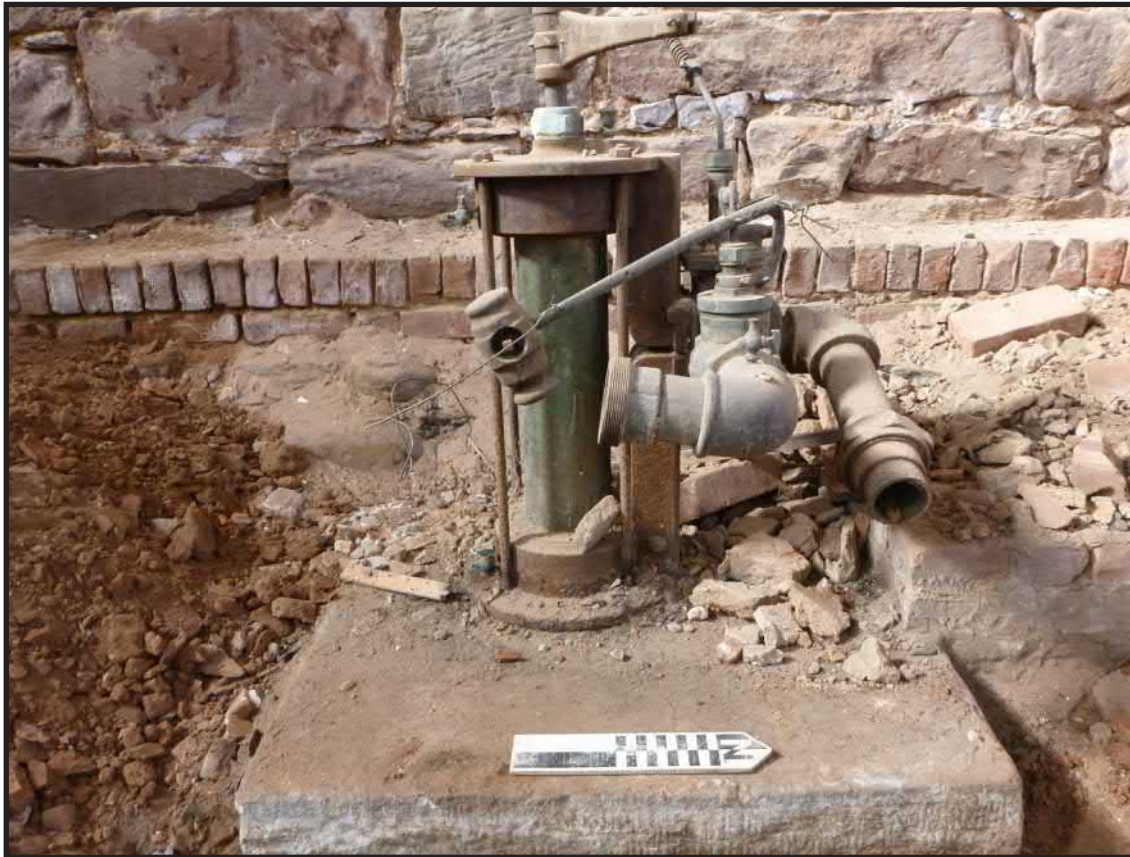
Photograph 3.5. Detailed view of the Ross Valve Manufacturing Company water engine uncovered in the crawlspace adjacent to the interior of the west wall of the church. Seated on a rectangular bluestone slab, this device was hooked up to the city water mains and used hydraulic pressure to power the bellows for the church's pipe organ. Note how the bluestone slab is mortared into the brick masonry at right, implying that the water engine was probably installed at the same time as the brick foundation. Scale in feet and tenths (Photographer: Joshua Butchko, January 2015) [HRI Neg. #15001/D2:035].

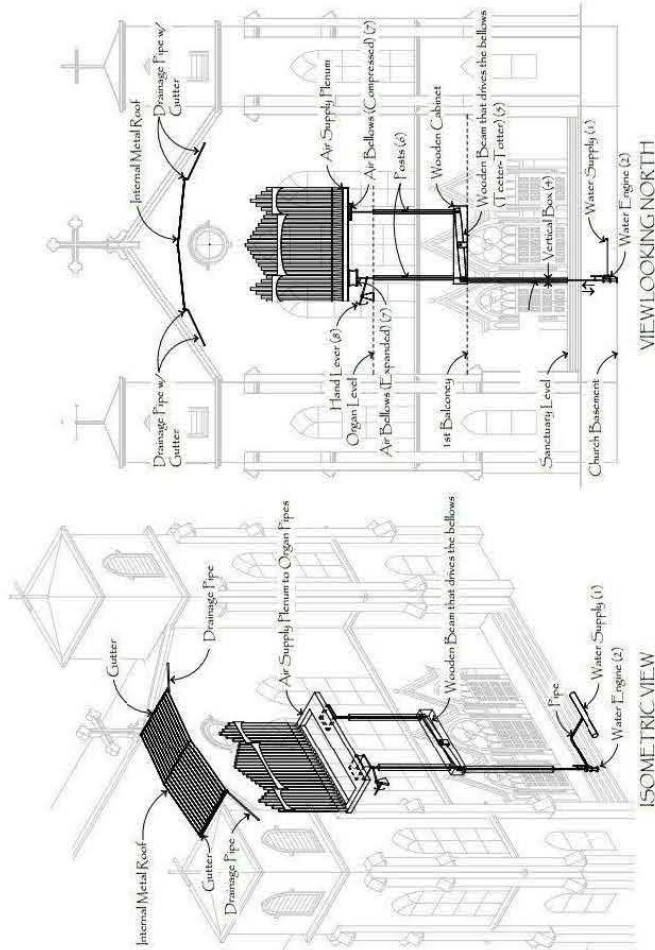
1887 Felgemaker Pipe Organ.
Original Water Power Mechanism with Protective Interior Roof

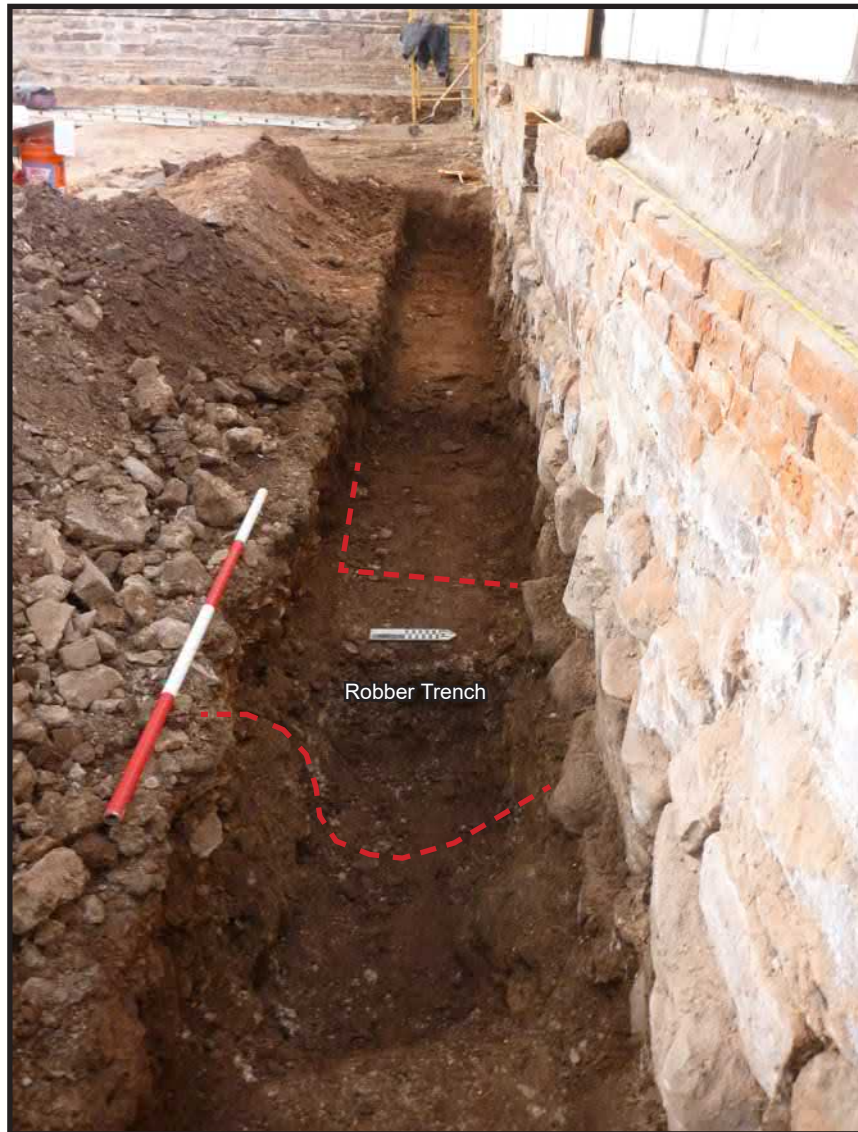
Photograph 3.9. View looking west showing Trench 1 fully excavated. At right is the stone masonry of the church's north wall foundation capped with three courses of brick on top of which the first floor of the auditorium was set. Scales in feet and tenths of feet (Photographer: Joshua Butchko, February 2015) [HRI Neg. #15001/D3:117].

Trench 1 was excavated along the south, interior face of the north wall of the church extending westward from the northeast corner of the auditorium (Figures 3.4-3.6; Photographs 3.9 and 3.10). This trench, measuring approximately 45 feet long, two feet wide and 3.5 feet deep, was dug for the new foundations placed alongside and reinforcing the north wall of the church. Trench 1 opened with a 0.3-foot-thick layer of mottled loose sandy silt [Context 1] interpreted as a modern accumulation of dust and dirt. This layer overlaid abutting one-foot-thick deposits of mottled silty clay with pebbles [2, 6] and wet silty loam [3, 7] interpreted as subfloor fill within the church interior.

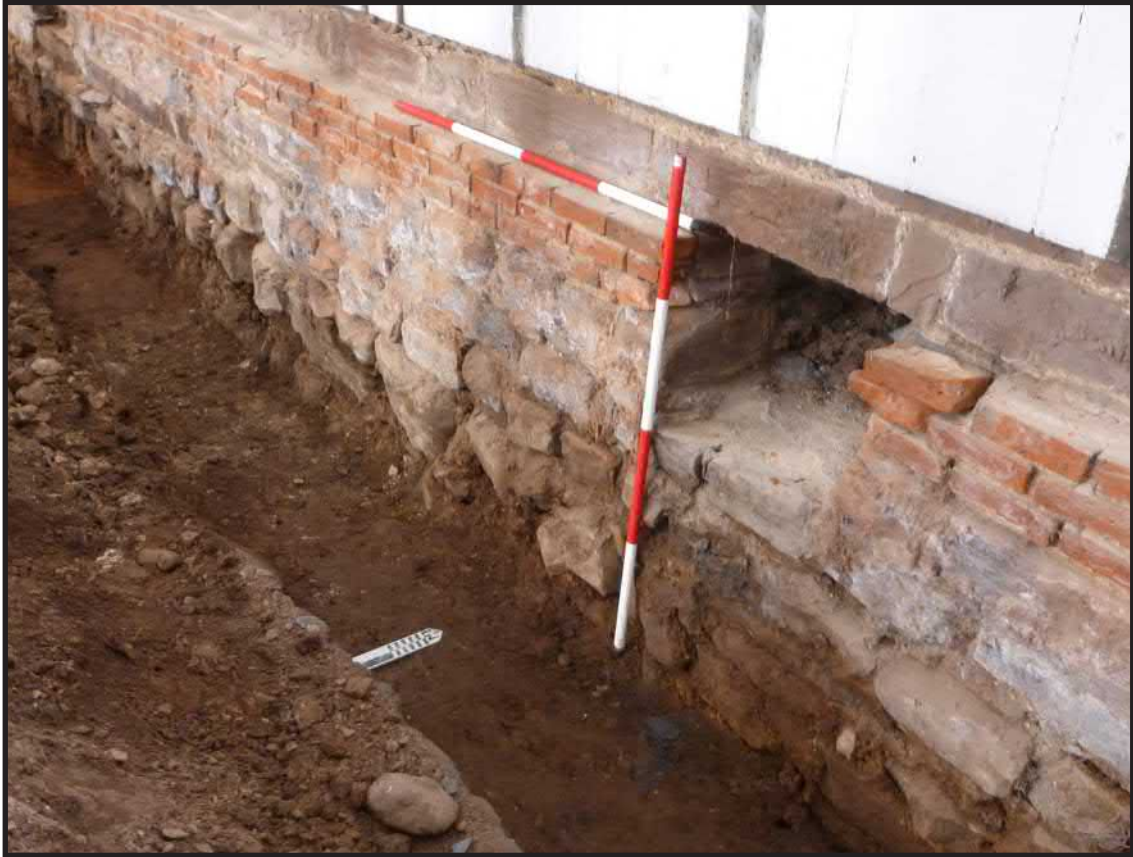
Photograph 3.10. View looking northwest midway along Trench 1. In the floor of the trench to the left of the north arrow/small scale rod is a concentration of mortar, plaster and rubble cut into by the foundation for the church’s north wall. This material is thought to be the fill of a robber trench reflecting the removal of the foundation for the northeast corner of the original church of 1767 or of a north-south wall that extended north beyond the footprint of the original church. The top surface of the three courses of brick masonry represents the first-floor level of the auditorium. The rectangular recess in the foundation to the right of the vertical scale pole is a joist pocket for one of the principal members of the first-floor framing. Scales in feet and tenths of feet (Photographer: Joshua Butchko, February 2015) [HRI Neg. #15001/D2:237].

Approximately 24 feet west of the east wall of the auditorium, a cut feature [5] containing a dense deposit of plaster and mortar mixed with schist and sandstone rubble [4] was identified in the south wall and base of the trench (Figure 3.5; Photograph 3.10). This deposit was six feet wide (east to west) and roughly lined up with similar deposits identified in Trenches 2 and 6, Pier Footings 1, 10 and 15, and the excavations for the new basement stairs and elevator shaft. In this instance, the deposit in Trench 1 was tentatively interpreted as a robber trench perhaps relating to the removal of the northeast corner of the original church built in 1767 (see below for further discussion) or the removal of a wall for an addition appended to the north side of this earlier church. Three displaced, probable human bone fragments were recovered during the excavation of Trench 1. These were documented in the field and returned to the church staff for safe keeping.

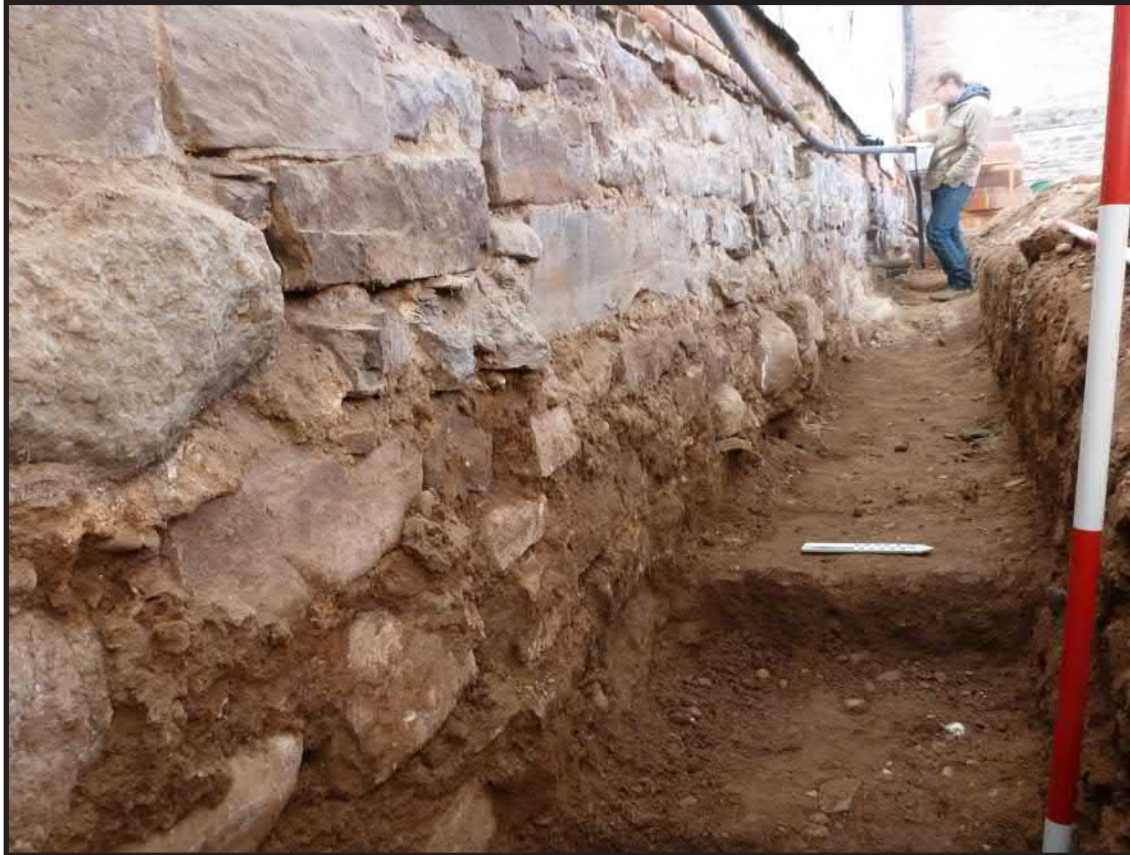
Photograph 3.11. View looking west showing Trench 2 fully excavated. At left is the stone masonry of the church's south wall foundation capped with three courses of brick on top of which the first floor of the auditorium was set. Scales in feet and tenths of feet (Photographer: Joshua Butchko, February 2015) [HRI Neg. #15001/D3:108].

Trench 2 was excavated along the north, interior face of the south wall of the church extending westward from the southeast corner of the auditorium (Figures 3.4, 3.7 and 3.8; Photographs 3.11-3.14). Like Trench 1 on the opposite side of the church, this trench, measuring approximately 45 feet long, 2 feet wide and 3.5 feet deep, was dug for the new foundations placed alongside and reinforcing the south wall of the church. Trench 2 opened with a 0.3-foot-thick layer of mottled loose sandy silt [1] interpreted as a modern accumulation of dust and dirt. This layer overlaid abutting one-foot-thick deposits of mottled silty clay with pebbles [2, 6] and wet silty loam [3, 7] interpreted as subfloor fill within the church interior.

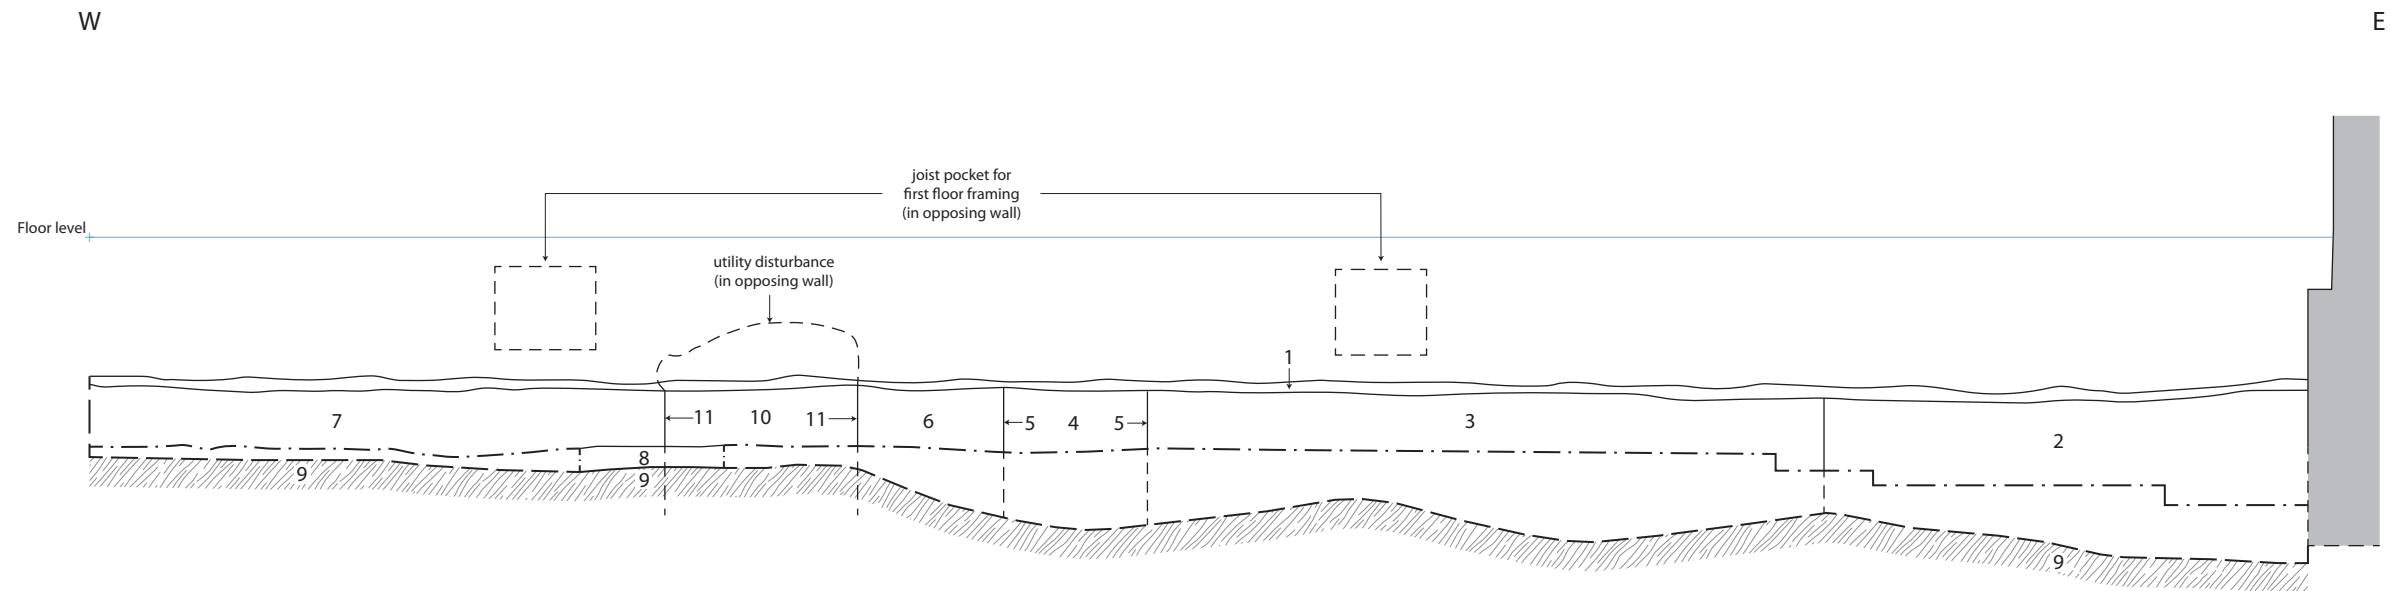
First Reformed Church of New Brunswick
Trench 2
North Profile

Context	Description [Interpretation] (Munsell)
1	Loose, dry mottled sandy silt [recent subfloor accumulation] (10YR 4/2, 10YR 4/4)
2	Mottled silty clay w/ pebbles [fill, 19th/20th century] (10YR 5/3, 10YR 4/6)
3	Mottled wet silty loam [fill, 19th/20th century] (10YR 2/1, 10YR 3/1)
4	Grey/pink mortar w/ some stone rubble [fill of robber trench for southeast corner of 1767 church, c. 1811-12] (10YR 6/1, 10YR 4/1)
5	Cut, filled by context 4 [robber trench for southeast corner of 1767 church, c. 1811-12]
6	Mottled silty clay w/ pebbles [fill, 19th/20th century] (10YR 5/3, 10YR 4/2)
7	Mottled wet silty loam [fill, 19th/20th century] (10YR 2/1, 10YR 3/1)
8	Weathered shale [subsoil]
9	Shale bedrock
10	Brick rubble w/ mottled silt [fill, 20th-century utility] (10YR 4/4, 10YR 5/3)
11	Cut, filled by context 10 [20th-century utility]

Figure 3.7. Church Interior, Trench 2, North Profile.

Approximately 24 feet west of the existing interior east wall, a cut feature [5] containing a dense deposit of plaster and mortar mixed with schist and sandstone rubble [4] was identified in the north wall of the trench (Figure 3.7; Photograph 3.12). This deposit was 3.5 feet wide (east to west) and lined up closely with similar deposits identified in Trenches 1 and 6, Pier Footings 1, 10 and 15, and the excavations for the new basement stairs and elevator shaft. As was the case with Trench 1, this deposit was interpreted as a robber trench representing the removal of a portion of the original church built in 1767, in this instance the southern end of the foundation for its eastern wall. Approximately three feet west of the robber trench,

a second cut feature [10] was identified, filled with dense brick rubble with mottled silt [11]. This intrusion was interpreted as a trench for some 20th-century utility pipes that were observed protruding from the south wall of the church. Both the robber trench and the utility trench were cut down into decayed shale [8]. This shale layer, interpreted as weathered bedrock, was encountered 1.45 feet below grade and extended to the full depth of excavation which terminated in shale bedrock [9].

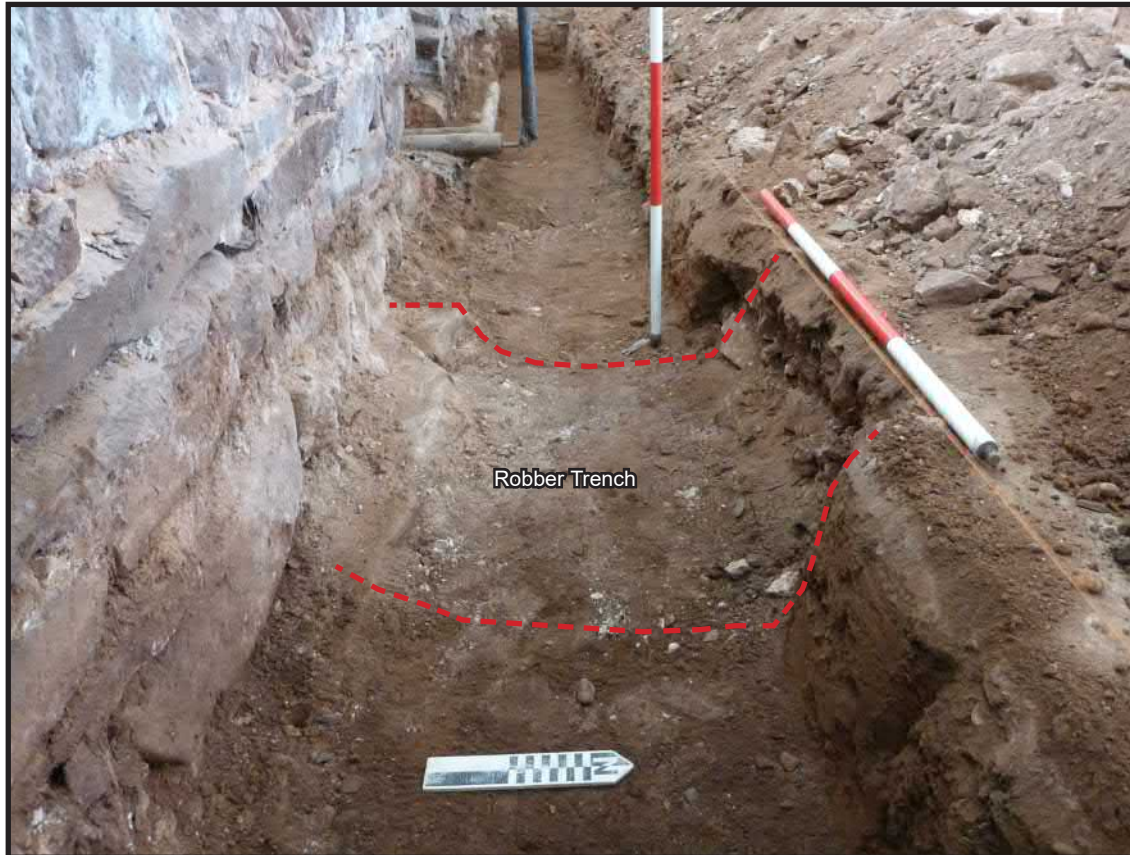
Photograph 3.12. View looking west showing the central portion of Trench 2 fully excavated. At left is the stone masonry of the church's south wall foundation. In the north wall (at right below the horizontal scale pole) and floor of the trench is a concentration of mortar, plaster and rubble thought to be the fill of the robber trench reflecting the removal of the foundation for the east wall of the original church of 1767. The lower part of the foundation extending west from the robber trench (i.e., away from the viewer) is offset and on a slightly different alignment to the masonry above and is considered to be a re-used, in-situ segment of the north foundation of the original church of 1767. Scales in feet and tenths of feet (Photographer: Joshua Butchko, February 2015) [HRI Neg. #15001/D2:232].

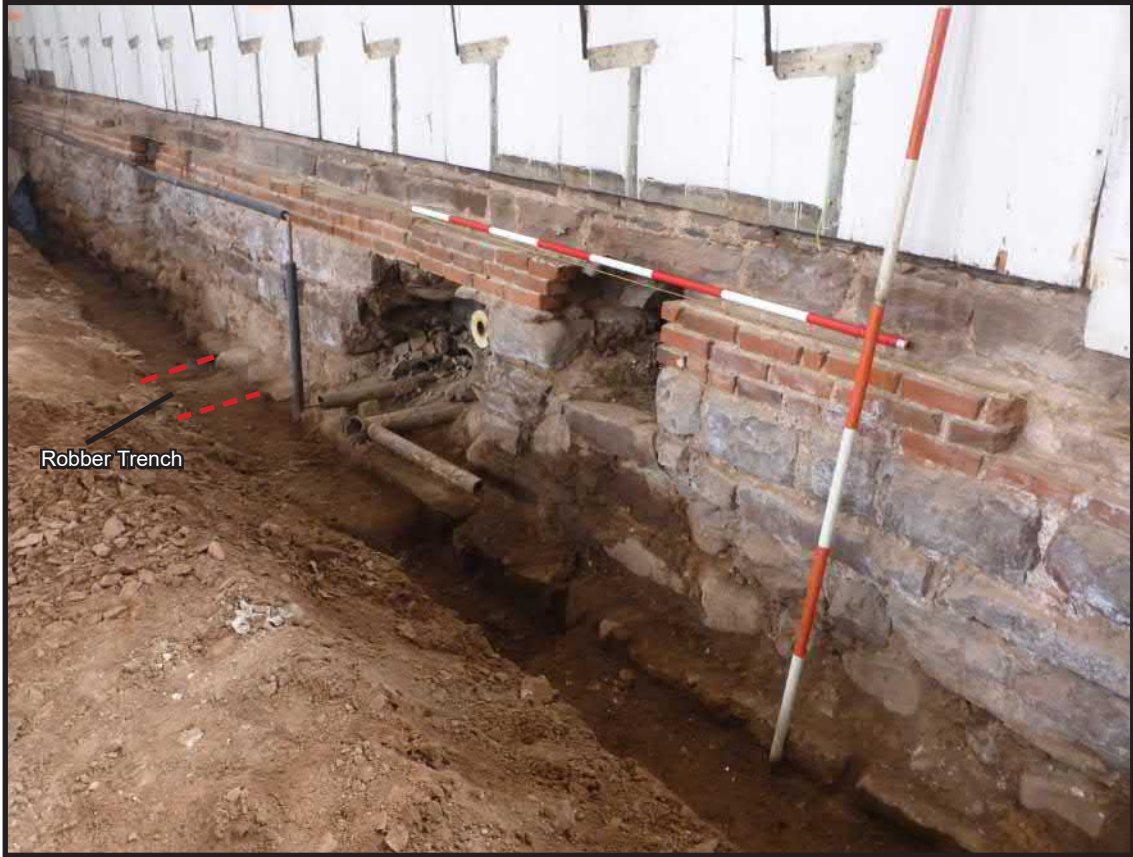
Photograph 3.13. View looking southeast showing the western end of Trench 2. The ghosting in the whitewashed wall covering at top shows where the ends of pews were secured to the south wall of the church. The top surface of the three courses of brick masonry represents the first-floor level of the auditorium. The two higher rectangular recesses in the foundation are joist pockets for two of the principal members of the first-floor framing. The larger void with the protruding pipes is the result of a later intrusion caused by the installation of utilities. At the base of the vertical scale pole is an offset in the foundation which is on a slightly different alignment to the masonry above. This offset is considered to be a re-used, in-situ segment of the south foundation of the original church of 1767. The offset was absent to the east beyond the robber trench reflecting the removal of the foundation for the east wall of the original church of 1767. Scales in feet and tenths of feet (Photographer: Joshua Butchko, February 2015) [HRI Neg. #15001/D3:188].

As with the church's north wall, the lower part of the foundation incorporated an offset composed of rough-dressed stone bonded with greyish pink mortar and capped with three courses of brick (Photographs 3.13 and 3.14). Again, a series of three 1.5-foot-square joist pockets spaced 18 feet apart were noted as settings for the principal framing members supporting the auditorium floor with the top surface of the brick masonry and the tops of the joist pockets again representing the first-floor level of the auditorium.

However, unlike the north wall foundation, the westernmost portion of the south wall foundation also contained a second stone offset, lower down toward the base of the trench, which followed a slightly different alignment to the rest of the masonry above (Photograph 3.13). This offset did not extend eastward beyond the point where the robber trench for the

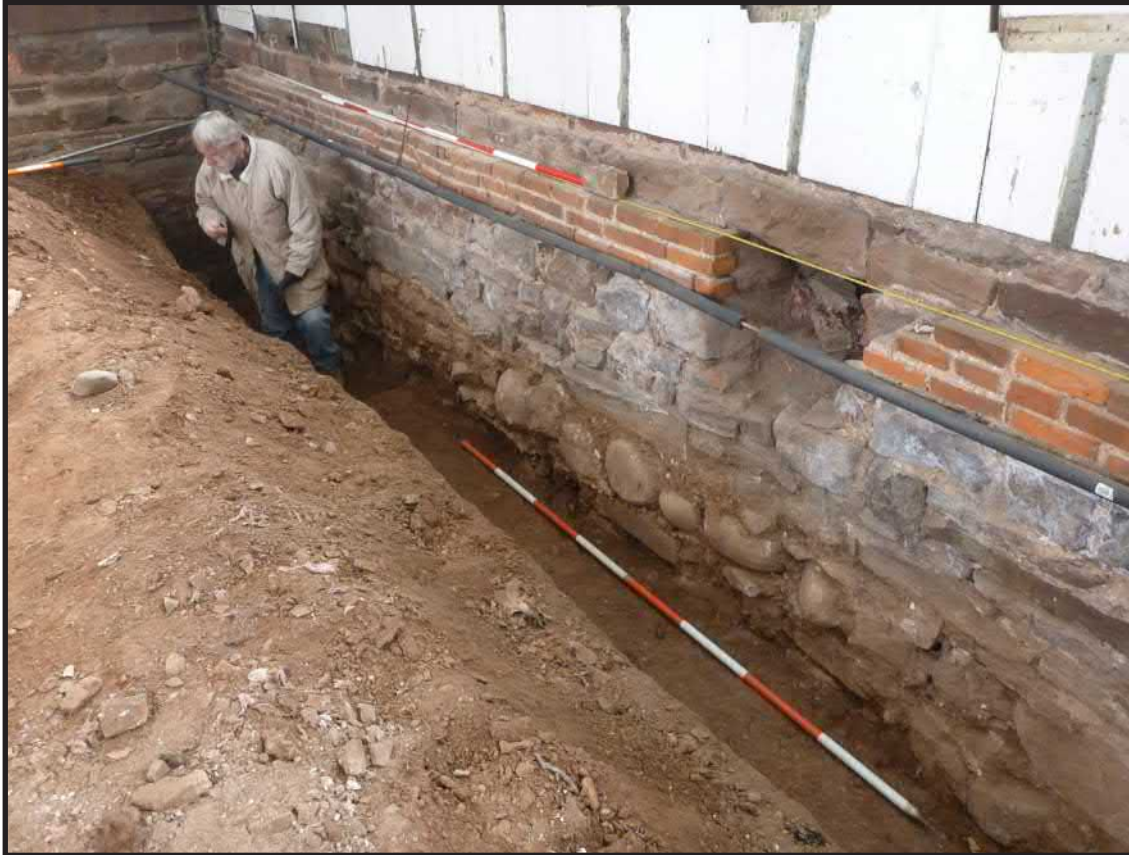
Photograph 3.14. View looking southeast showing the eastern end of Trench 2. The ghosting in the whitewashed wall covering at top shows where the ends of pews were secured to the south wall of the church. The top surface of the three courses of brick masonry represents the first-floor level of the auditorium. The rectangular recess in the foundation is a joist pocket for one of the principal members of the first-floor framing. Note that, unlike with the western section of this foundation in Trench 2, there is no offset in the masonry at the base of the foundation (cf. Photograph 3.13). Scales in feet (Photographer: Joshua Butchko, February 2015) [HRI Neg. #15001/D3:198].

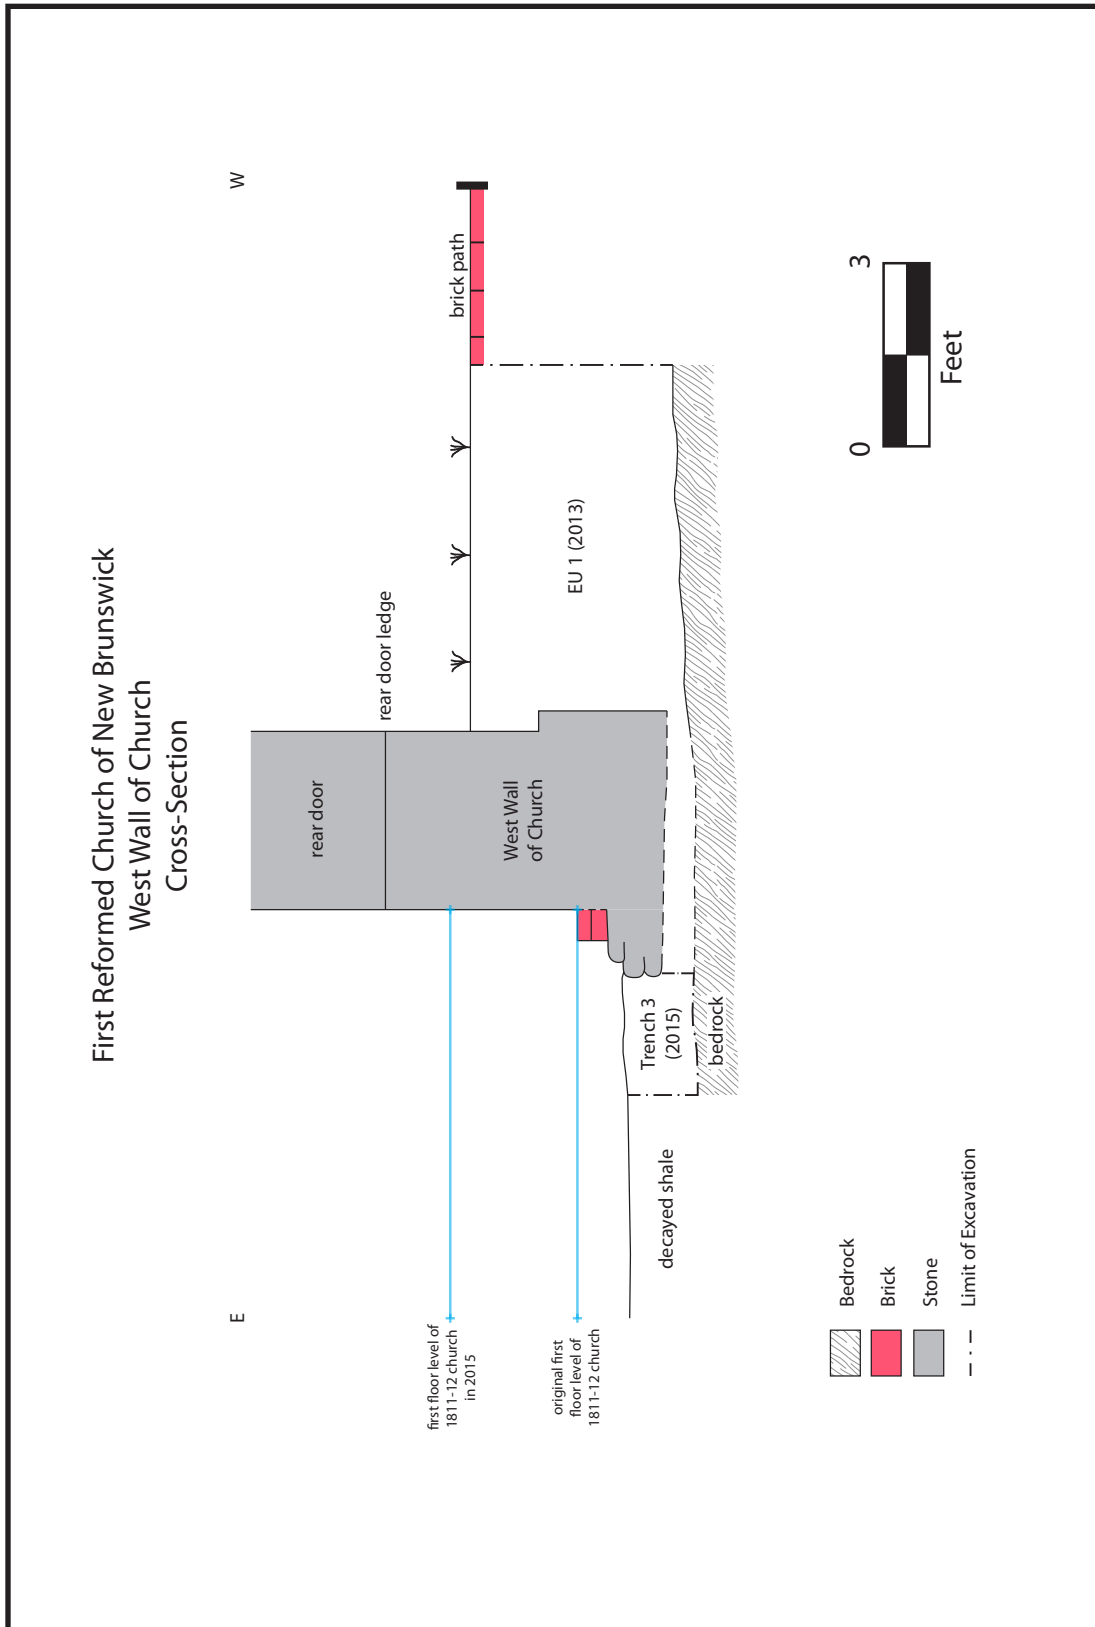
Figure 3.9. Cross-Section Through West Wall of Church Showing Interior and Exterior Elevations.

Trench 3 was excavated along the east, interior face of the west wall of the church extending north to south between the northwest and southwest corners of the auditorium (Figures 3.4, 3.9 and 3.10; Photographs 3.15 and 3.16). This trench, measuring approximately 59 feet long, 2.5 feet wide and one foot deep, was dug for the new foundations placed alongside and reinforcing the west wall of the church. A cross-section through the west wall shows it to be three feet thick above grade, while its foundation was between four and 4.5 feet thick at its base (Figure 3.9). The foundation was set on bedrock.
