**ARCHAEOLOGICAL MONITORING
FIRST REFORMED CHURCH OF NEW BRUNSWICK
CITY OF NEW BRUNSWICK, MIDDLESEX COUNTY
NEW JERSEY**

AUGUST 2019

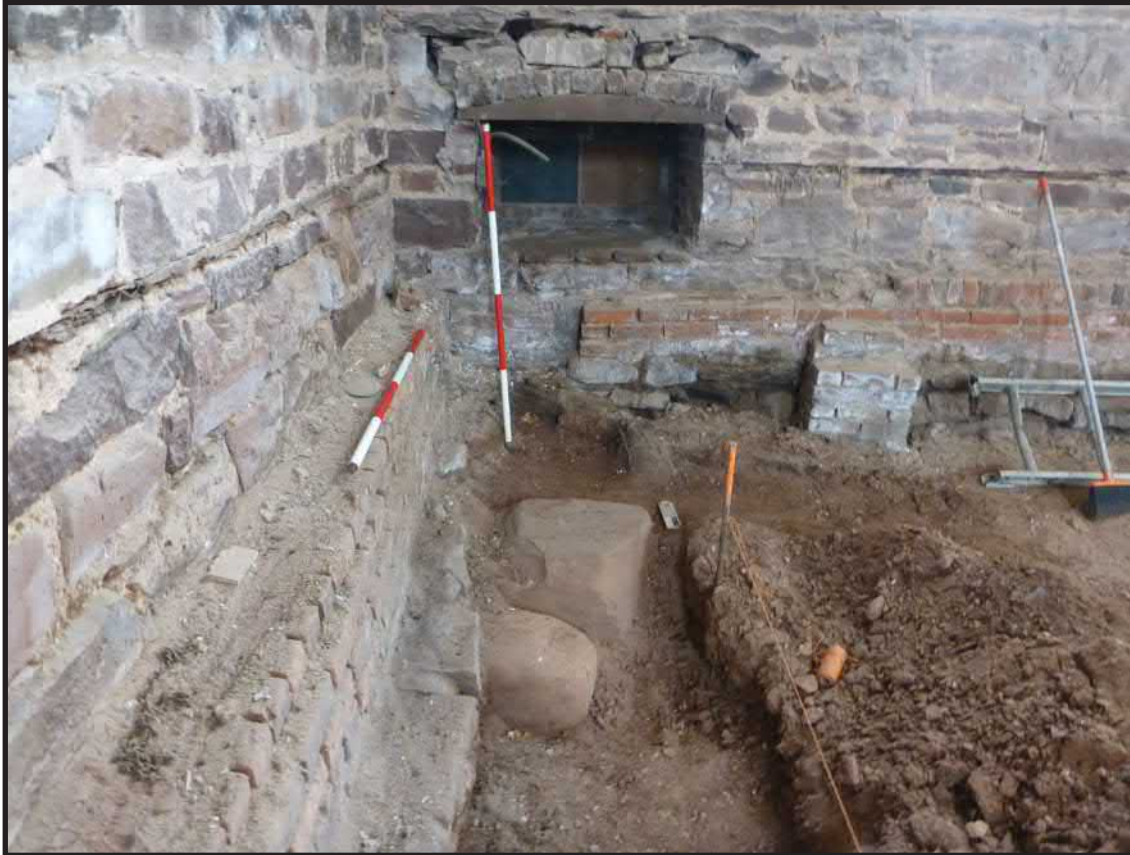
Photograph 3.15. View looking north showing the northern end of Trench 3 in the northwest corner of the auditorium. Note the four courses of brick masonry on top of the western stone foundation at left and three courses on the northern foundation at right, on top of which the first-floor framing for the dais was originally set (it was later raised to a higher elevation). A wooden nailer for lath and plaster wall covering is visible running horizontally in the west wall at left. The brick-arched opening with cast-iron lintel in the north wall in the center of the view is a former window opening inserted in the later 19th century to provide light for a stair giving access to the crawlspace. The large blocks of stone in the foreground are considered to be remnants of the northwest corner of the original church built in 1767. Scales in feet and tenths of feet (Photographer: Joshua Butchko, January 2015) [HRI Neg. #15001/D2:246].

Approximately 2.5 feet south of the northern end of Trench 3 (i.e., just inside the northwest corner of the auditorium), part of a mortared stone footing [3] was identified (Photograph 3.15). This was interpreted as a possible remnant of the western end of the north wall foundation of the original church built in 1767. The masonry appeared to be partially bonded into the foundation of the west wall of the existing church building, suggesting that the original church's

A notable feature at the western end of the foundation for the north wall of the church was a brick-arched window opening with a cast-iron lintel (Photograph 3.15). Clearly a later insertion into the exterior wall of the church, this window is thought to have provided light for a stair leading down into the crawlspace in the northwest corner of the building. Other modifications in brick to the corner foundation also appear to be related to this stairway, which is thought to have been added in the later 19th century, possibly coincident with the installation of the water engine for the pipe organ, which would have required access for maintenance purposes.

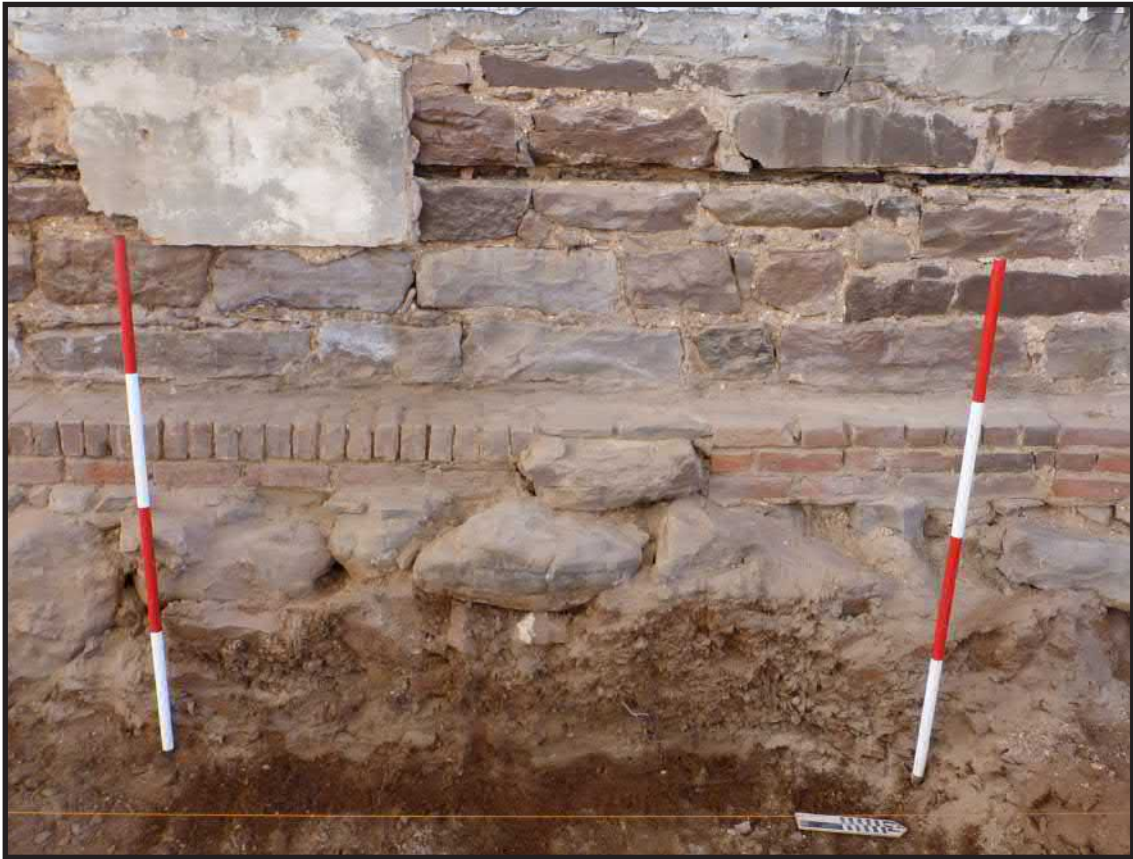
Photograph 3.16. View looking west showing part of the church’s west wall and foundation. The top of the two to three courses of brick masonry represents the level of the first floor in the auditorium. The wood nailer above has a section wall plaster still attached. The stone masonry beneath the bricks is conjectured to be part of the foundation of the original church built in 1767 re-used in the present church of 1811-12. Scales in feet and tenths of feet (Photographer: Joshua Butchko, February 2015) [HRI Neg. #15001/D3:030].

west wall coincided with that of the existing church and was re-used as part of the latter's construction (Photograph 3.16). The foundation remnants at the northern end of Trench 3 were of similar width and continued the alignment of the robber trench and foundation fragments identified in Trenches 4 and 5; these features are all thought to represent traces of the original's church's northern wall. The foundation remnants identified in Trench 3 were preserved in place and sealed by the concrete poured for the new footings.

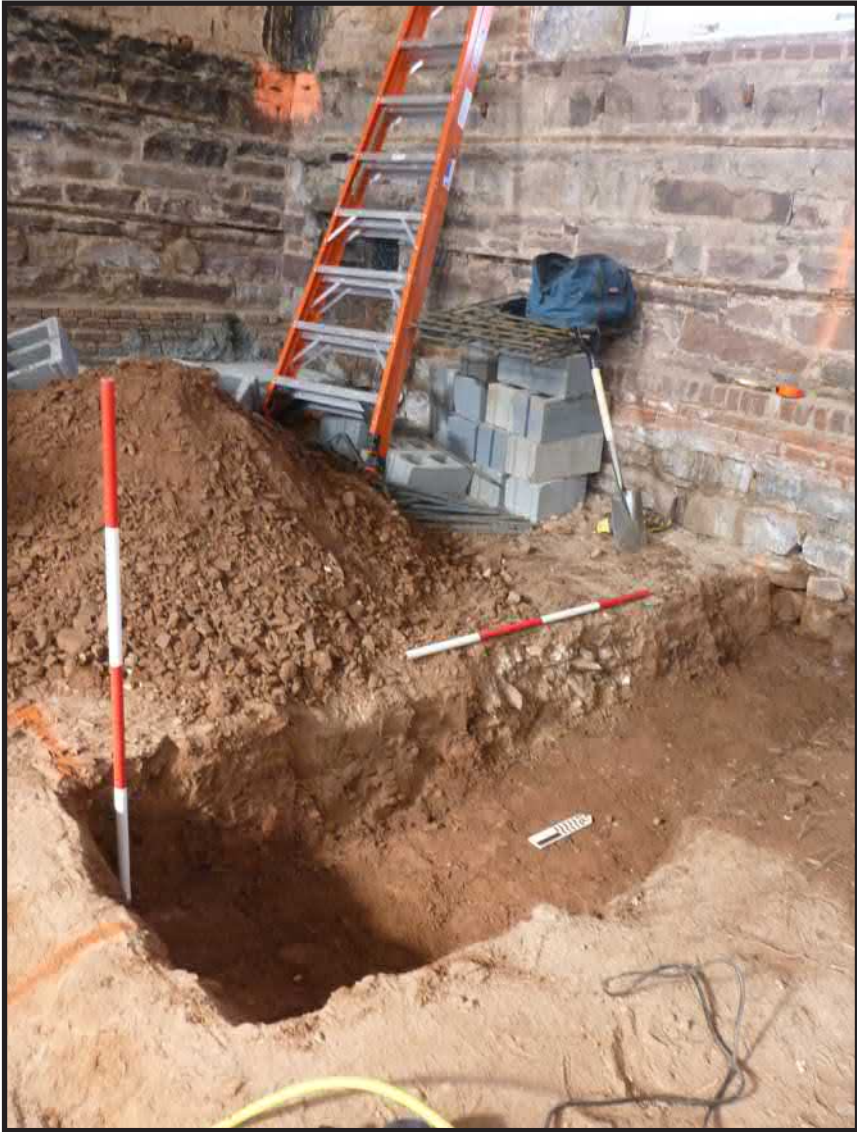
Photograph 3.17. View looking northwest showing the cut feature filled with mortar, plaster and rubble which is interpreted as the robber trench reflecting the removal of the foundation for the north wall of the original church of 1767. Scales in feet and tenths of feet (Photographer: Joshua Butchko, February 2015) [HRI Neg. #15001/D5:024].

Approximately 2.75 feet from the north end of the trench, a cut feature [3] containing a dense deposit of plaster and mortar mixed with schist and sandstone rubble [4] was identified (Photograph 3.17). This cut was three feet in width from north to south and followed the same east-west alignment of the truncated foundation remnants identified in Trenches 3 and 5. This cut was interpreted as a robber trench associated with the removal of the foundation for the north wall of the earlier church built in 1767. The robber trench was approximately 0.6 feet deep and cut into the natural weathered shale [2] that overlay shale bedrock.

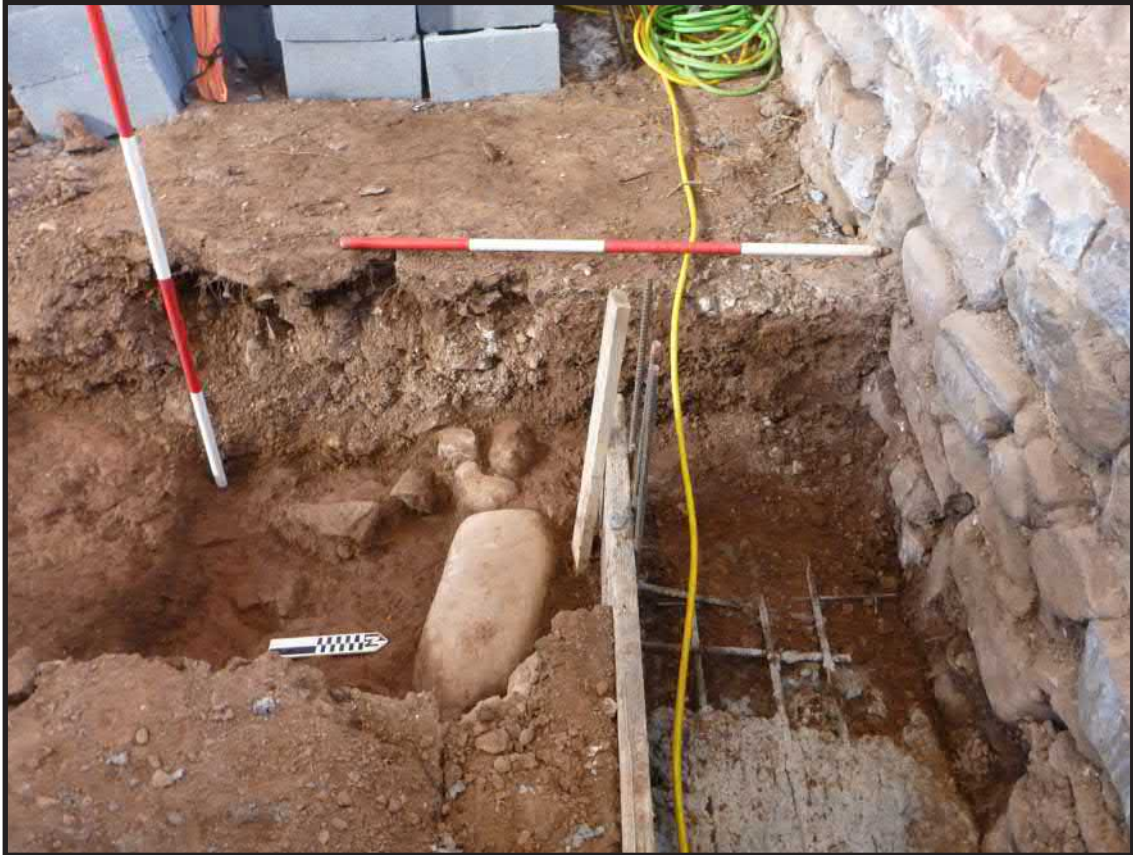
Photograph 3.18. View looking west showing the west profile at the north end of Trench 5 where it intersected with the south profile of Trench 1. The north wall of the 1811-12 church is at right. The mixed plaster, mortar and rubble fill of the robber trench resulting from the removal of the original church's north wall is visible in the soil profile to the left of the vertical wood post. Remnants of the foundations of the original church's north wall are visible in the base of the trench directly beneath. Scales in feet and tenths of feet (Photographer: Joshua Butchko, February 2015) [HRI Neg. #15001/D5:150].

Trench 5, roughly 3.5 feet wide and up to two feet deep, was excavated approximately 23.5 feet east of the interior face of the church's west wall and extended the full north-south width of the church interior (Figures 3.4 and 3.12). As with Trench 4, Trench 5 was divided into northern and southern sections, 11.5 and 13 feet in length respectively, separated by a 12-foot-wide gap in the center of the auditorium, where the larger Basement Excavation Area was located. The northern end of Trench 5 intersected with the west end of Trench 1's south profile (Photograph 3.18). The southern end of Trench 5 intersected with west end of Trench 2's north profile.

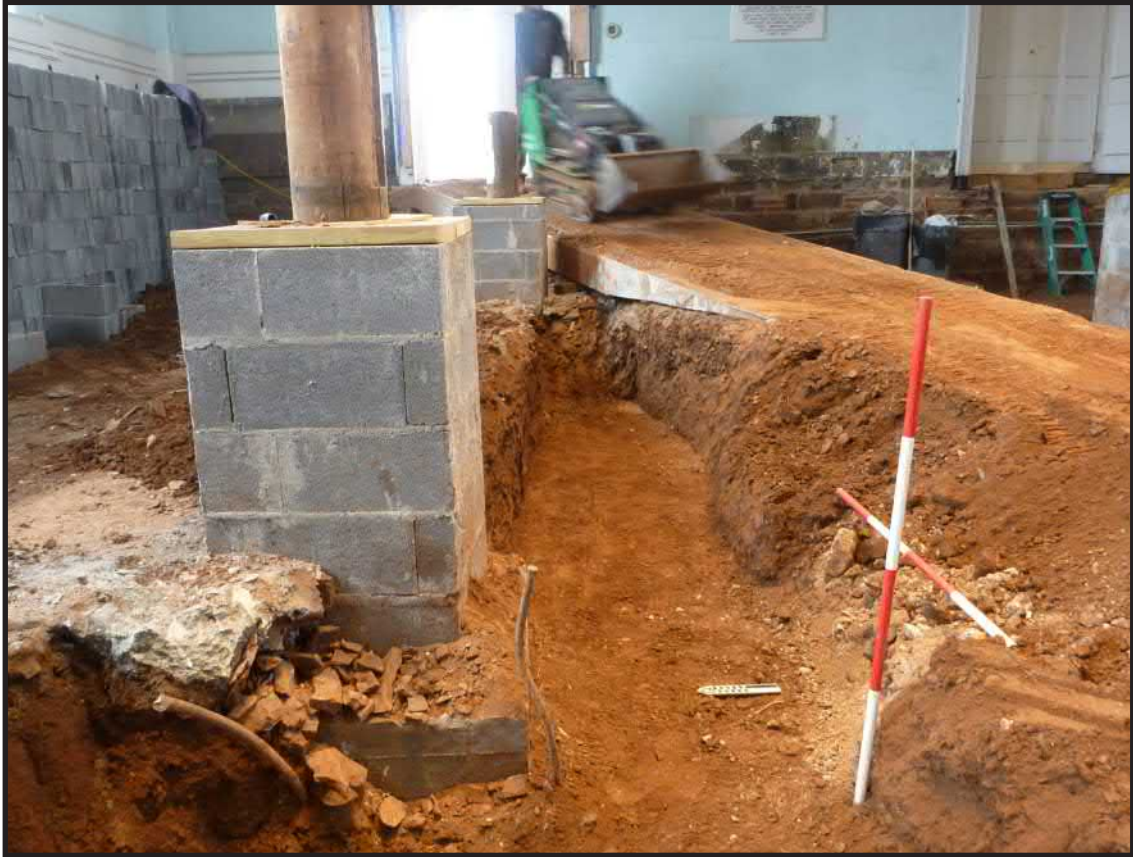
Photograph 3.19. View looking east showing the south profile of Trench 6 at right and the concentration of mortar and stone rubble interpreted as a robber trench reflecting the removal of the foundation for the east wall of the original church built in 1767. Pier Footing 1 has been recently installed at left, replacing the mortared stone foundation that had originally supported the wooden column above. Scales in feet and tenths of feet (Photographer: Joshua Butchko, March 2015) [HRI Neg. #15001/D8:142].

Approximately 24 feet west of the east wall of the auditorium, immediately south of Pier Footing 1, a cut feature [5] was identified in the south profile of the trench containing a dense concentration of plaster and mortar mixed with schist and sandstone rubble [4] (Photograph 3.19). This feature was 2.5 feet in width from east to west and appeared to run on a north-south alignment continuing a similar deposit that had been exposed and documented in excavations for nearby

Pier Footing 1. In both Trench 6 and Pier Footing 1, this feature was interpreted as a robber trench resulting from the removal of the foundation for the east wall of the original church built in 1767. A single bone fragment, probably human, was recovered during the excavation of Trench 6. This was documented in the field and immediately returned to the church for safe keeping.

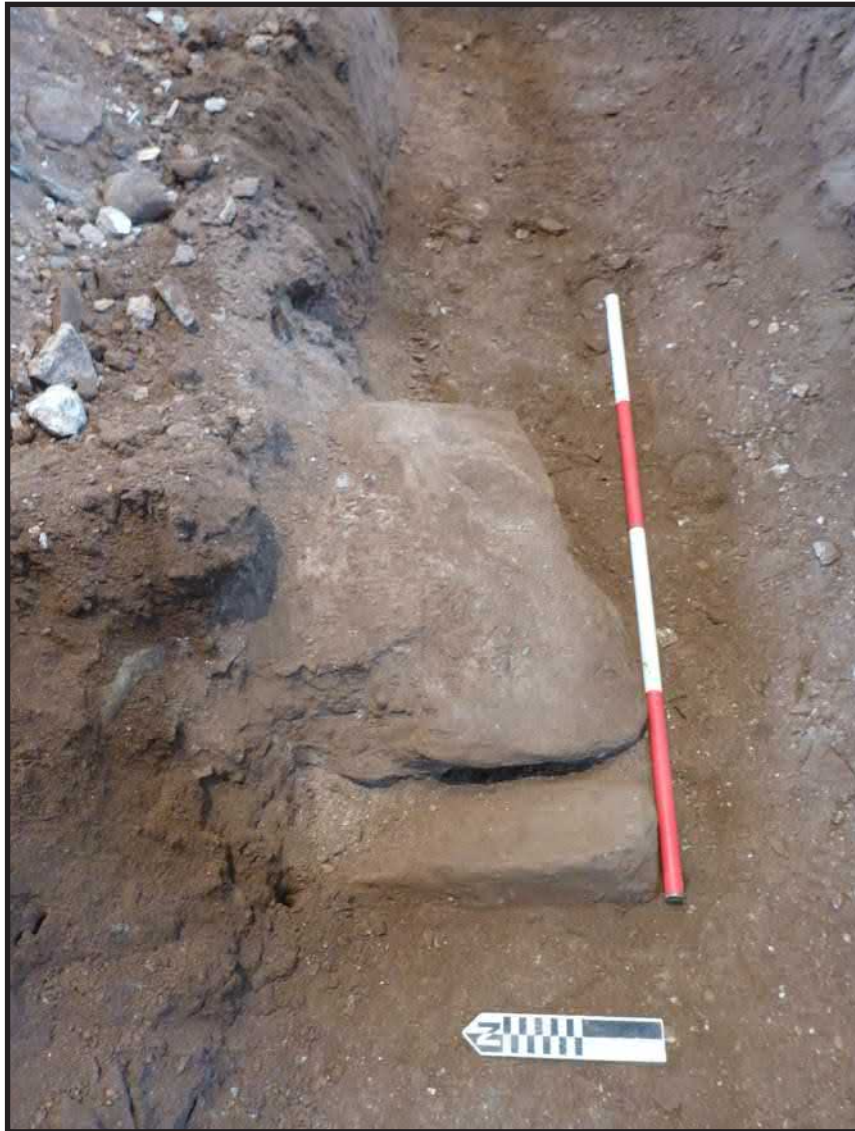
Photograph 3.20. View looking east showing the mortared stone footings encountered along the north profile of Trench 7. These remains are interpreted as part of the eastern foundation of the original church built in 1767. Scales in feet and tenths of feet (Photographer: Joshua Butchko, March 2015) [HRI Neg. #15001/D8:091].

Approximately 24 feet west of the east wall of the auditorium, remnants of a mortared stone foundation [3] were identified (Photograph 3.20). These followed the north-south alignment of similar foundation remnants exposed in the adjacent Elevator Excavation Area. Together, these foundations were interpreted as surviving traces of the foundation for the east wall of the original church built in 1767. These foundation remnants were of similar width and followed the same alignment as the robber trench identified in Trenches 1, 2 and 6 and Pier Footings 1 and 15. The founda-

tion remnants identified in Trench 7 were preserved in place and sealed by the concrete poured for the new footings.

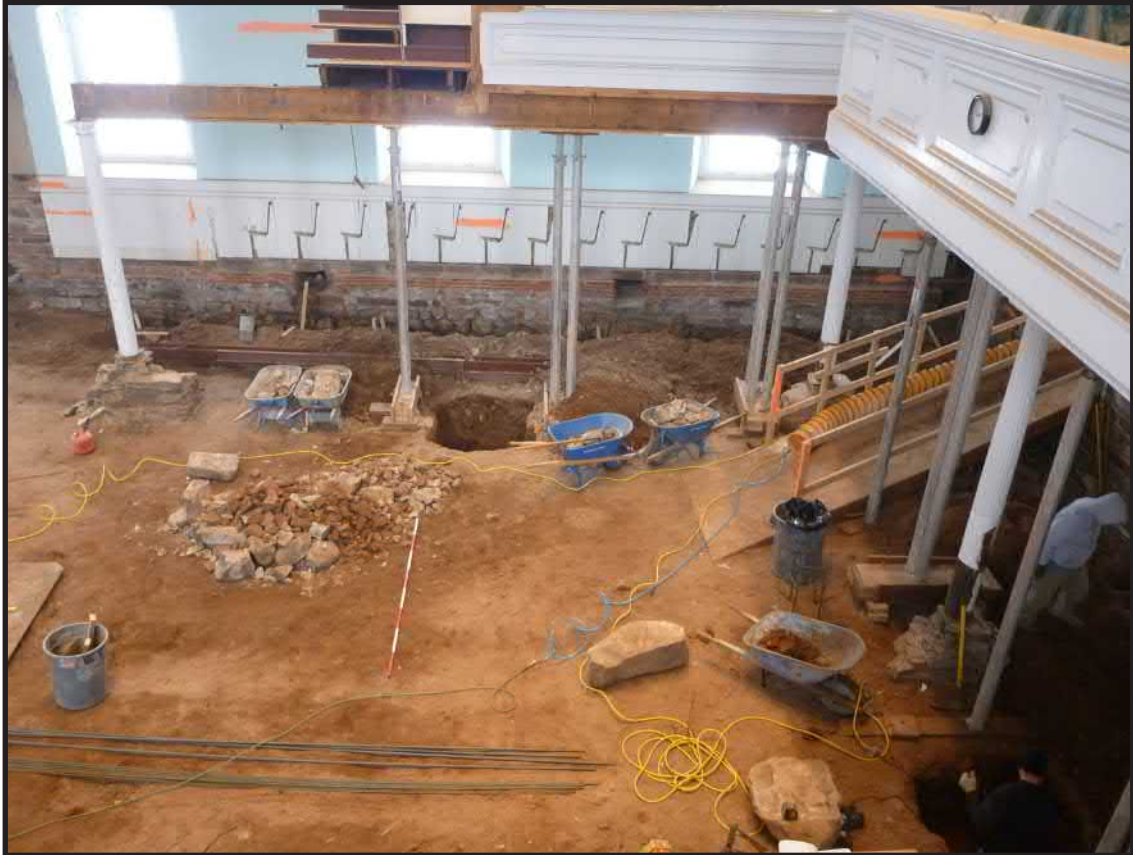
Photograph 3.21. View facing north showing the church interior at the start of pier footing excavations. The deep excavation between the temporary props holding up the balcony was dug to allow installation of a temporarily removed wood column on a new concrete and cinderblock footing (Pier Footing 1). Scale in feet (Photographer: Joshua Butchko, February 2015) [HRI Neg. #15001/D3:179].

Excavations for 19 pier footings [Pier Footings 1-19] were conducted concurrent with other excavations and construction activity taking place within the interior of the auditorium (Figure 3.4; Photograph 3.21). Footing excavations were generally between four and five feet square in plan and extended to depths of between 3 and 4 feet. Pier Footings 4, 10, 18 and 19 were excavated within the base of the Basement and Elevator Area Excavations and were extended deeper into the natural bedrock than elsewhere, well below the depth of archaeological concern. The remaining footings were located in the eastern half of the auditorium and were completed through a combination of manual and mechanical excavation. Footings 1-3, 5-9 and 11-17 generally commenced from a shallower depth similar to the trench excavations. In most cases, the footing excavations first removed the 0.3-foot-thick layer of loose clay silt [1] found throughout most of the church interior and interpreted as a modern accumulation of dust and dirt. This layer typically overlaid a clayey silt with decayed shale [2] interpreted as B-horizon subsoil which extended to approximately two feet below the ground surface. This layer in turn overlaid a dense weathered shale [3] which ultimately blended into a solid shale bedrock. Few artifacts were recovered and the principal cultural features of interest were traces of the foundations of the original church of 1767 and the robber trenches associated with the removal of these foundations.

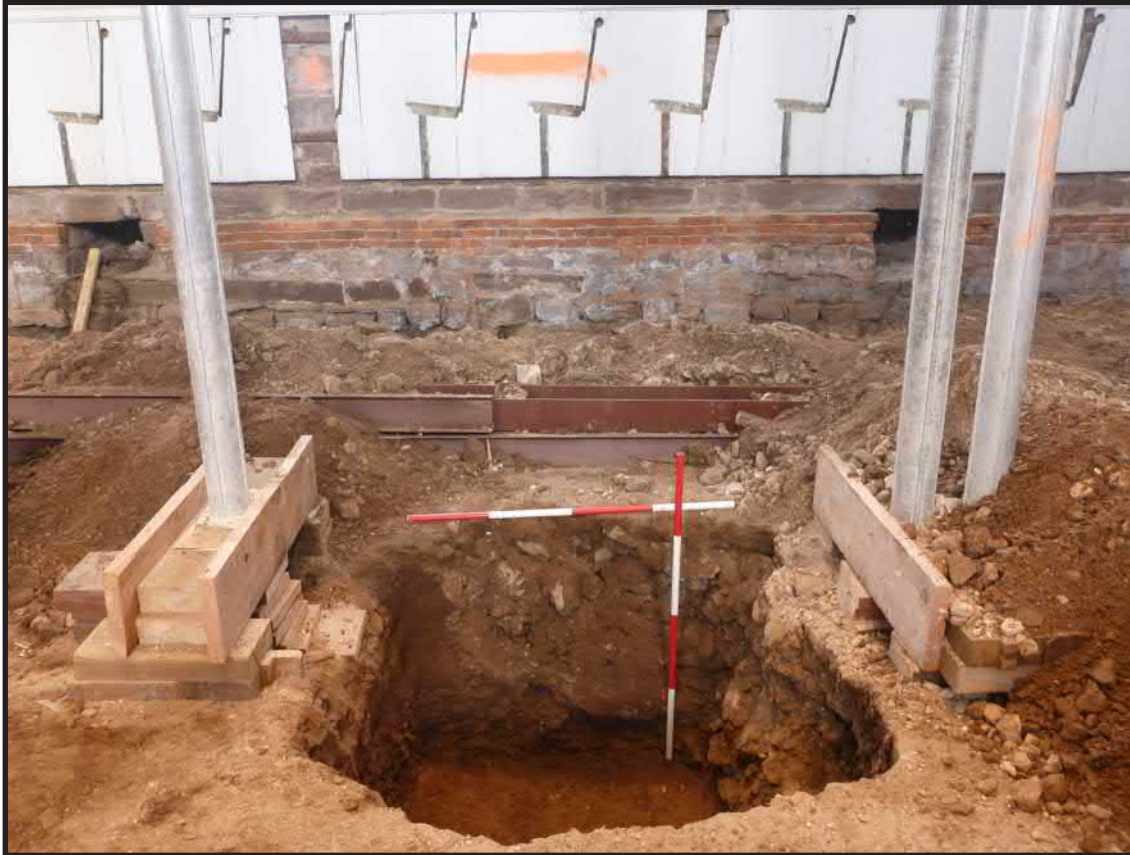
Photograph 3.22. View facing north showing the north profile of the excavation for Pier Footing 1. Behind and to the left of the vertical scale pole is the robber trench resulting from the removal of the foundation for the east wall of the original church built in 1767. Note that in this view the center wood column along the northern side aisle has been temporarily removed (and its mortared stone foundation permanently removed), pending a replacement footing being installed in the excavated pit. Scales in feet (Photographer: Joshua Butchko, February 2015) [HRI Neg. #15001/D3:157].

The excavation pit for **Pier Footing 1** yielded the typical soil profile outlined above (Figures 3.4 and 3.13; Photograph 3.22). In the eastern half of the footing excavation, a shallow cut feature [4 and 5] was visible at the surface where a balcony support pier had been

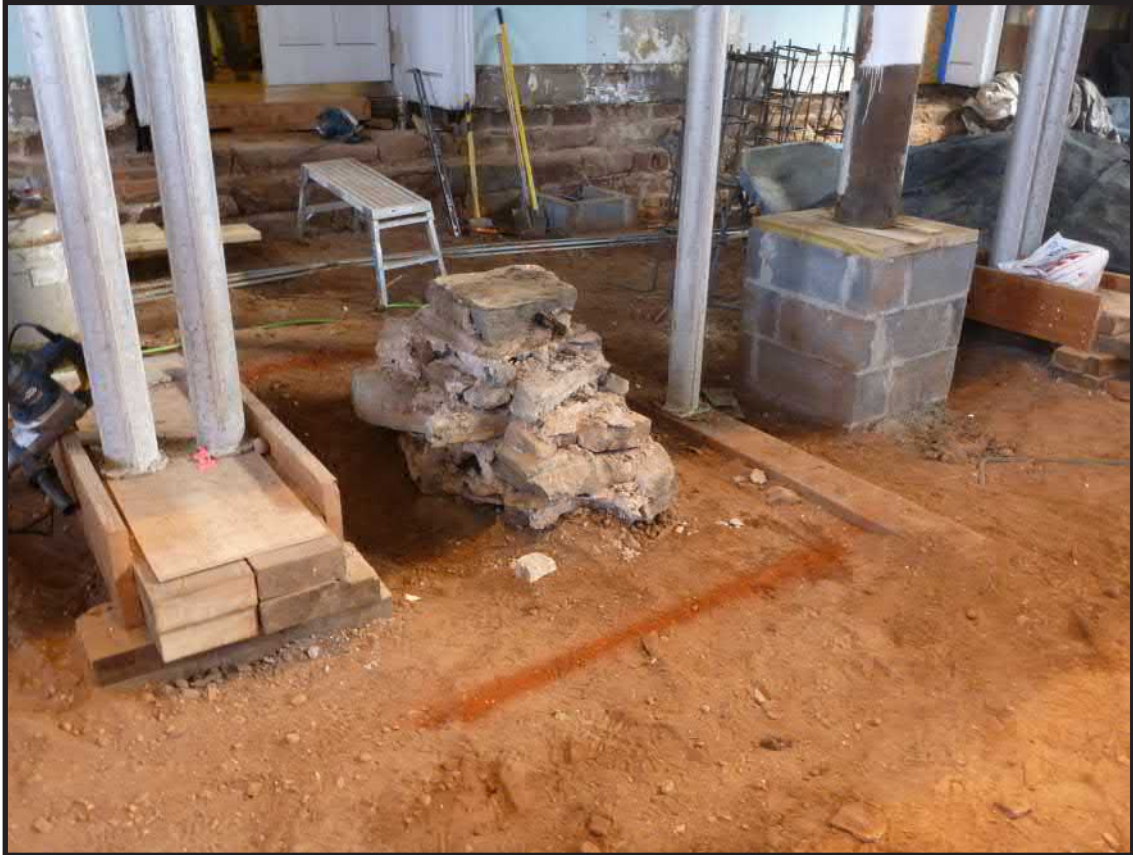
Photograph 3.23. View looking southeast showing the original mortared stone footing for the column that supported the second-floor balcony on the north side of the main aisle (the column has been temporarily removed to allow for replacement of the footing) (Pier Footing 8). The footing for the companion column on the south side of the main aisle has been replaced (Pier Footing 12) and the entire area has by this time been excavated down to the base of the new and old pier footings (Photographer: Joshua Butchko, February 2015) [HRI Neg. #15001/D5:194].

In most cases, the archaeological monitor was able to oversee the dismantling, removal, excavation and replacement of the original mortared stone footings for the second-floor balcony columns as well as excavations for additional footings for the new second floor construction (Photographs 3.23 and 3.24). These excavations generally showed the original support footings extending to a depth of one foot below the surface and cutting into the top of the weathered shale bedrock or other natural subsoil. The excavations for the replacement and new footings extended considerably deeper than this into the weathered shale and subsoil. Pier footing excavations adjacent to the east wall of the auditorium also provided a useful window, allowing inspection of the masonry of the foundations for this wall (Photograph 3.25).

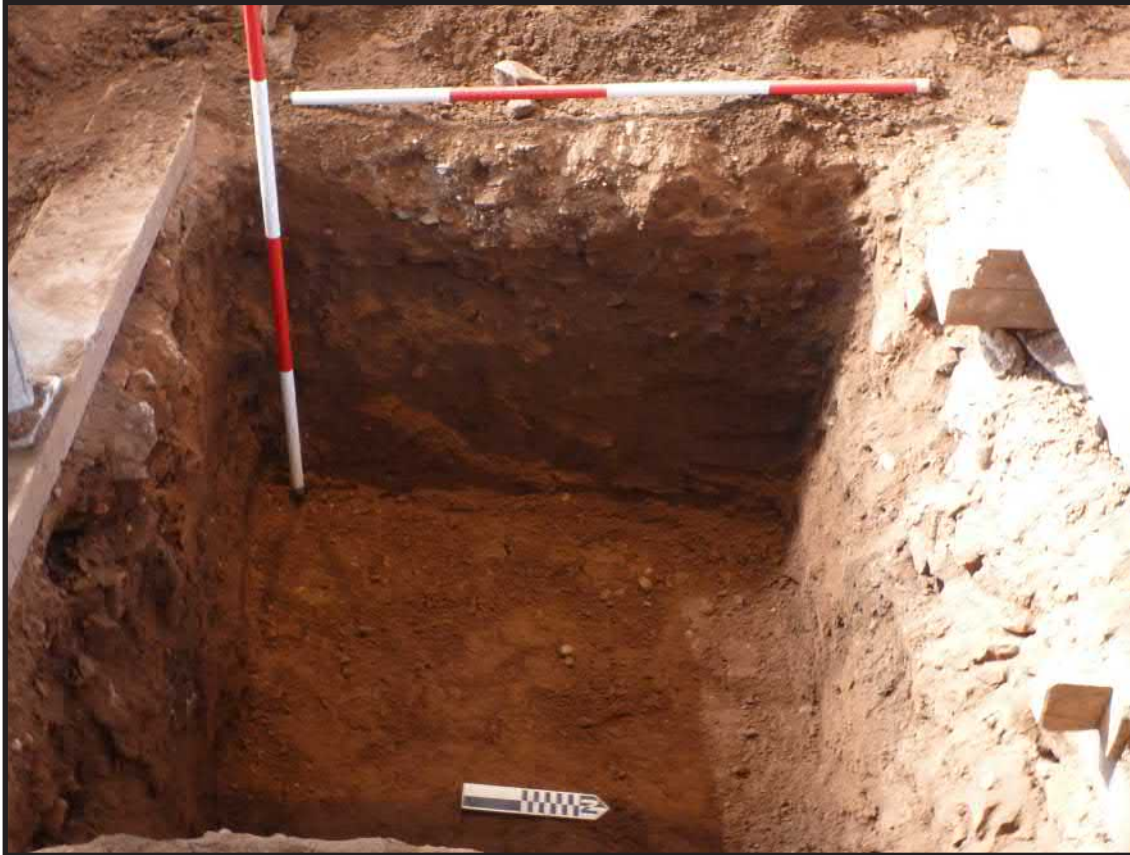
Photograph 3.24. View looking west showing the completed excavation for Pier Footing 8 which facilitated the removal and replacement of the mortared stone footing for the wood column that supported the second-floor balcony on the north side of the main aisle. Scales in feet and tenths of feet (Photographer: Joshua Butchko, February 2015) [HRI Neg. #15001/D5:215].

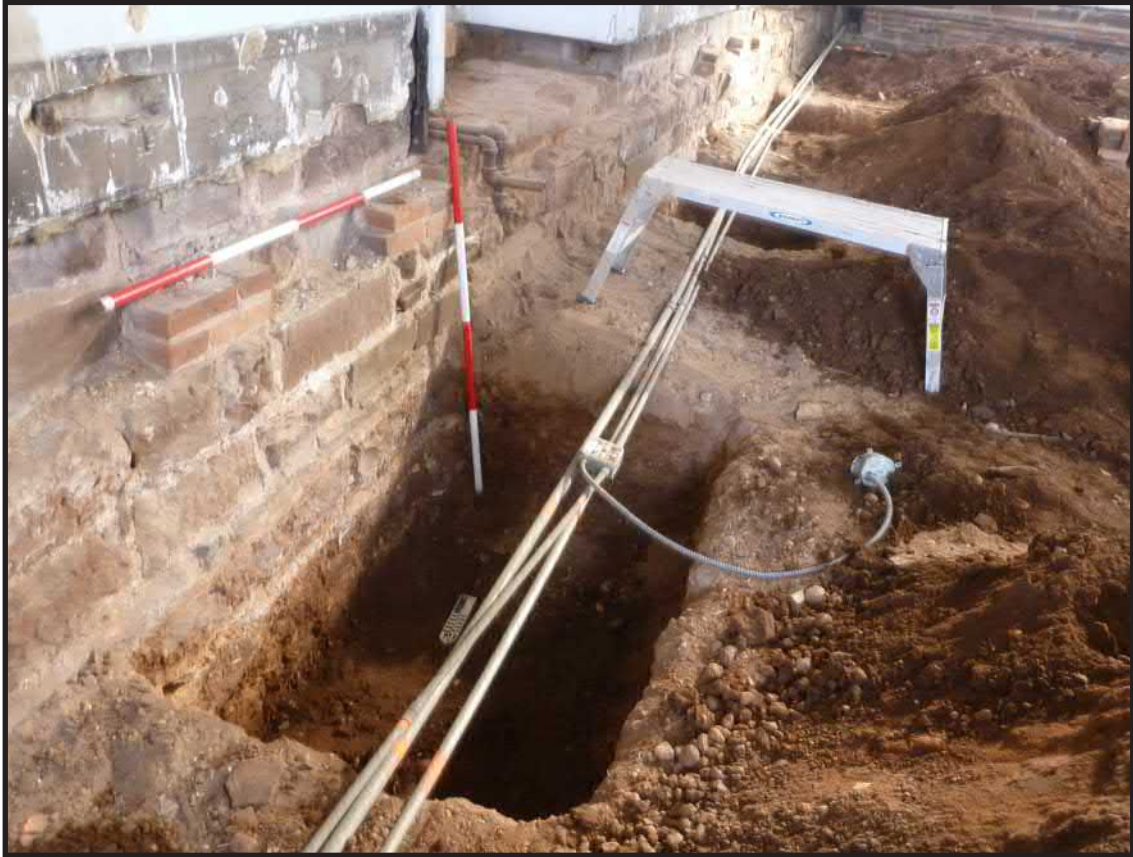
Photograph 3.25. View looking south southeast along the face of east wall of the auditorium showing the excavations for Pier Footings 9, 14 and 17. Scales in feet (Photographer: Joshua Butchko, February 2015) [HRI Neg. #15001/D3:096].

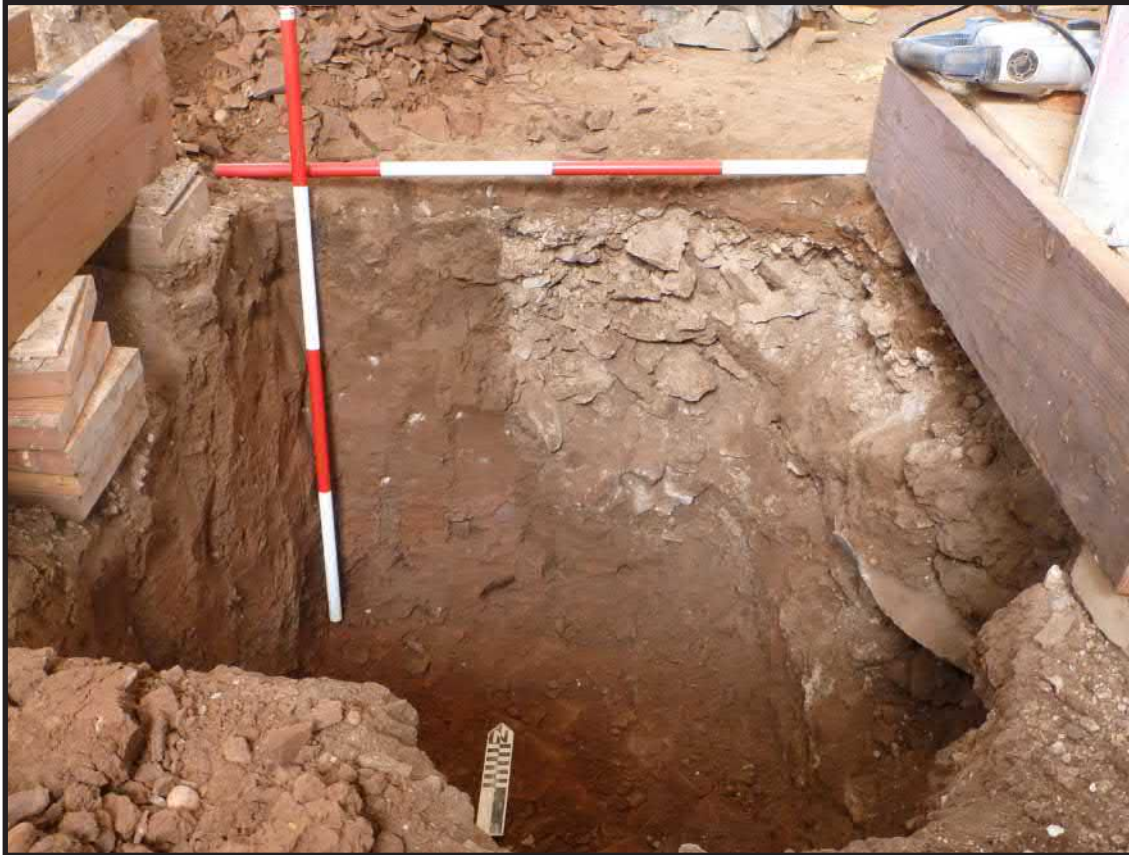
Photograph 3.26. View looking north showing the north profile of the excavation pit for Pier Footing 15. To the right of the vertical scale pole is the cut and rubble fill of the robber trench resulting from the removal of the foundation for the east wall of the original church built in 1767. Scales in feet and tenths of feet (Photographer: Joshua Butchko, February 2015) [HRI Neg. #15001/D3:080].

The excavation pit for **Pier Footing 15** revealed the typical soil profile outlined above (Figure 3.4; Photograph 3.26). In the east half of the pier footing excavation, a cut feature [7] was identified containing a concentration of plaster and mortar mixed with schist and sandstone rubble [6] (see also, Photograph 3.16). This feature was 2.4 feet wide (east to west) and approximately 2.8 feet deep. It appeared to run north-south continuing the line of the foundation remnants exposed in the Elevator Excavation Area and the

robber trench exposed in Trench 6 and in the excavation for Pier Footing 1. Once again, the feature found in the excavation for Pier Footing 15 was interpreted as part of a robber trench reflecting the removal of the foundation for the east wall of the original church built in 1767.

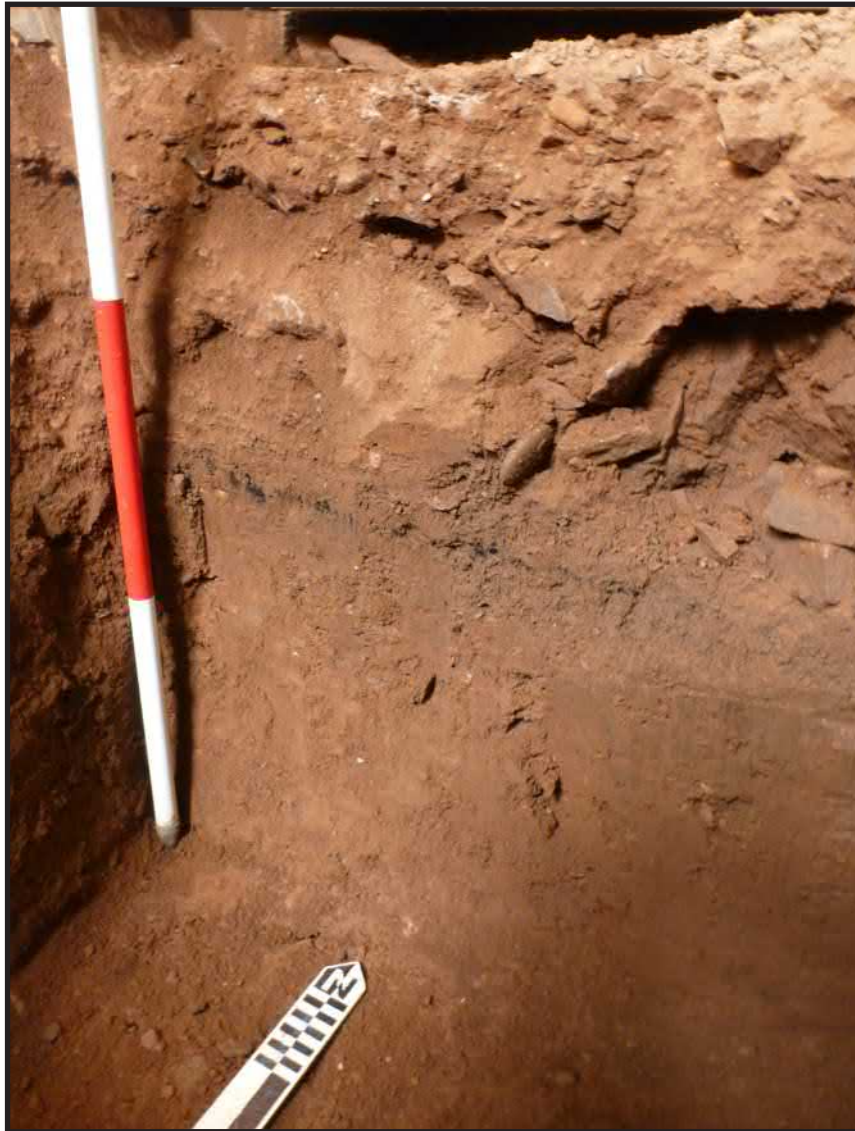
Photograph 3.27. View looking northwest showing part of the north profile of the excavation pit for Pier Footing 16 with a dark band in the soil profile possibly representing an episode of burning. Scales in feet and tenths of feet (Photographer: Joshua Butchko, March 2015) [HRI Neg. #15001/D7:022].

The excavation pit for **Pier Footing 16** also revealed a profile resembling those observed in other nearby pier footing excavations (Photograph 3.27). In the east, west and south profiles, the loose silty clay [1] interpreted as a disturbed subfloor accumulation directly overlaid a clayey silt with dense shale [2] interpreted as a B-horizon subsoil, which, in turn, overlaid dense weathered shale [3]. However, the upper half of the north profile was noticeably disturbed and a deposit of mottled silty clay with dense shale fragments extended to 1.5 feet below grade. This appeared to overlie a narrow band of darkened silt with shale fragments. This anomaly in the soil profile was interpreted as a possible burn layer in the field and may relate to 20th-century disturbance of the site. It directly overlaid the naturally occurring weathered shale which continued to the full depth of the excavation.

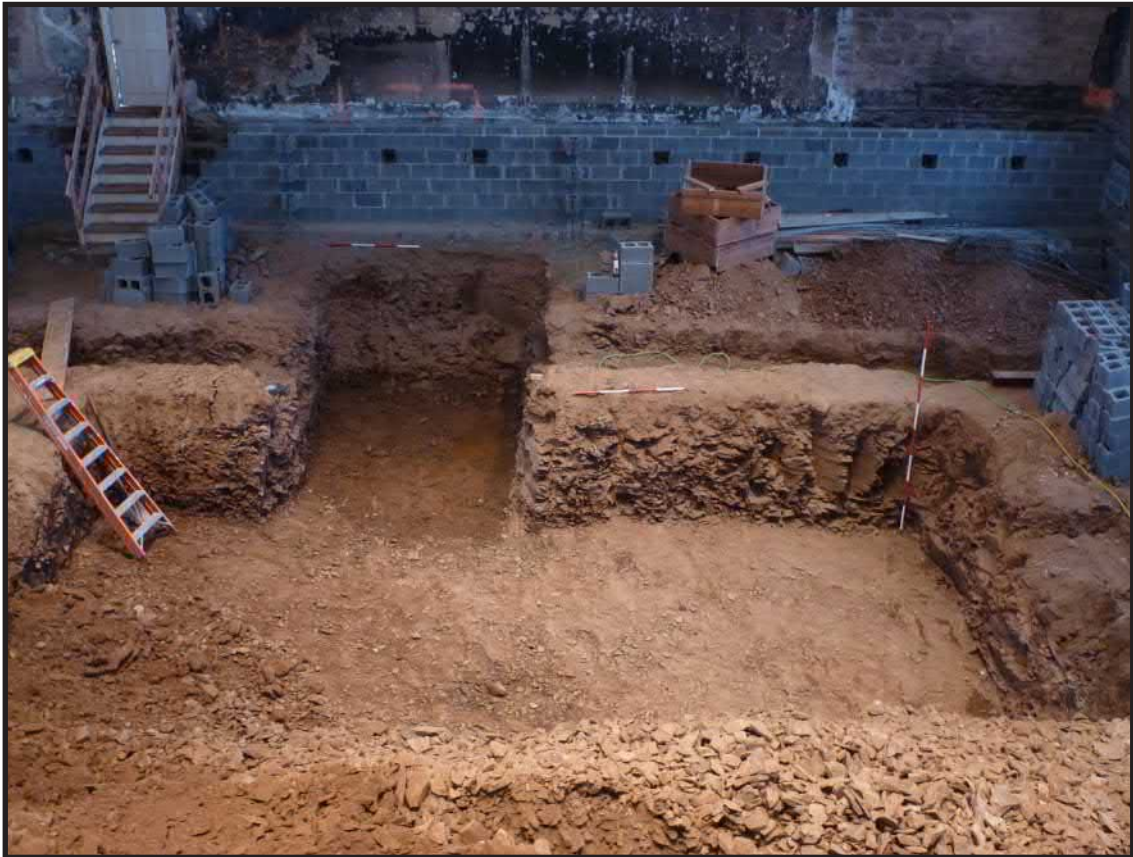
Photograph 3.28. View looking west showing the fully excavated Basement Excavation Area at the western end of the auditorium. Note the cinderblock foundation has been installed to reinforce the interior face of the church’s western foundation. Scales in feet (Photographer: Joshua Butchko, March 2015) [HRI Neg. #15001/D6:052].

The **Basement Excavation Area** was excavated to a depth of roughly five feet in the western half of the auditorium (Photographs 3.28 and 3.29). The irregularly shaped area measured 41 feet from east to west and between nine and 27 feet from north to south. The narrow eastern end was excavated for construction of a basement stairway, while the western end made room for a new hot water heater. The large space in between was to contain a large basement room. The soil profile was generally consistent with most of the other interior excavations, especially Trenches 4 and 5. The soil sequence opened with a 0.4-foot-thick layer of loose silty clay [1] interpreted as a disturbed

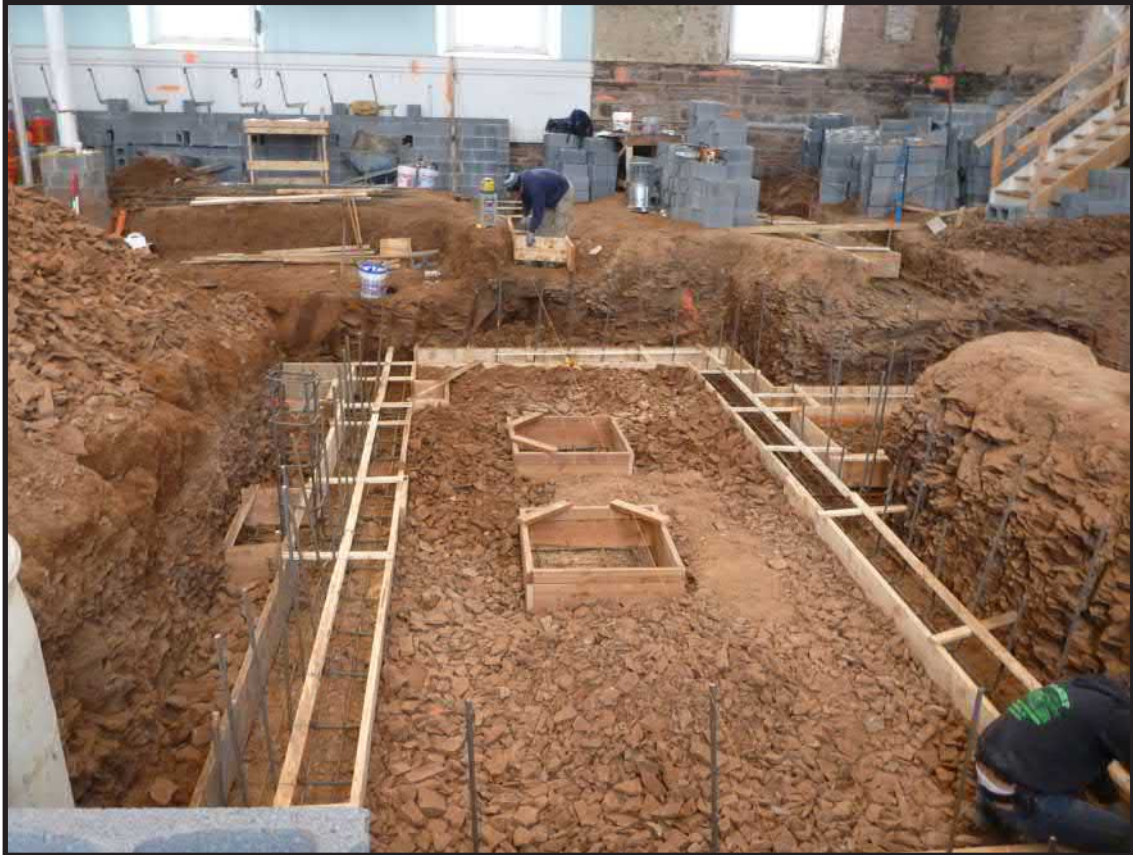
Photograph 3.29. View looking south showing the Basement Excavation Area with the installation of new footings in progress (Photographer: Joshua Butchko, March 2015) [HRI Neg. #15001/D6:169].

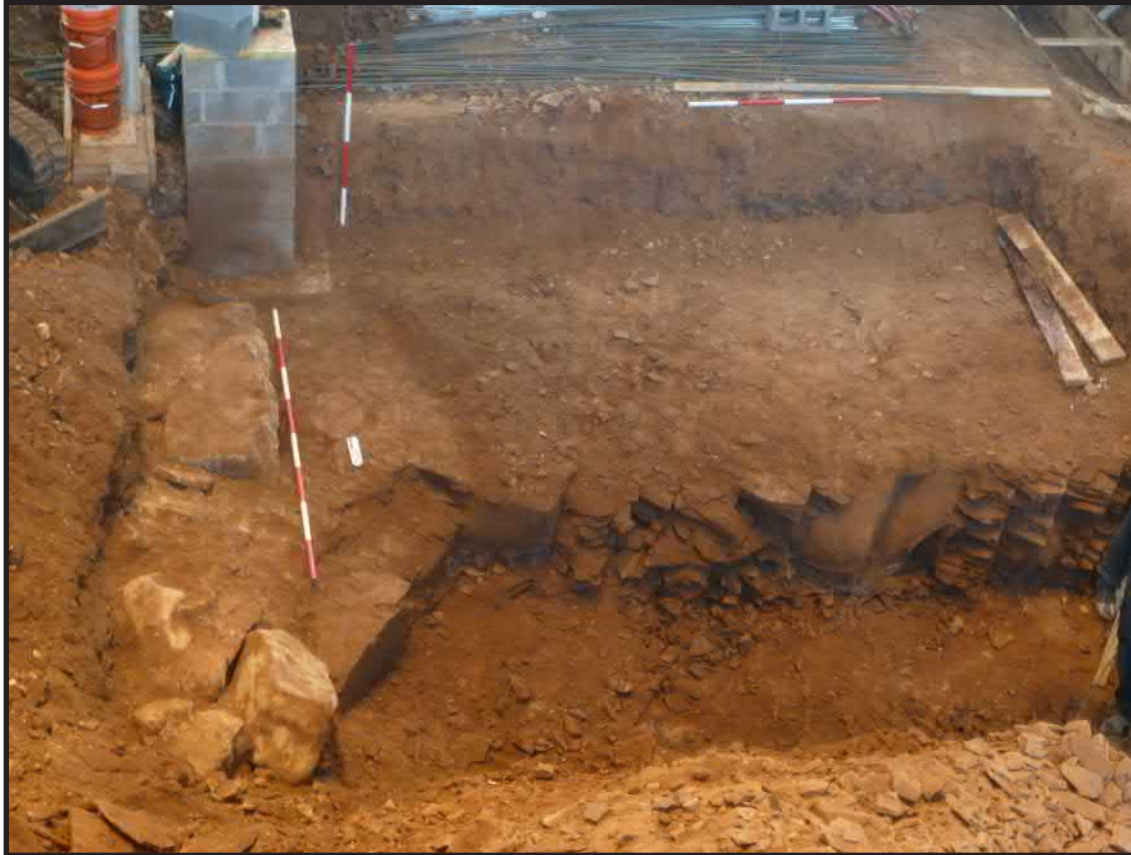
Photograph 3.30. View looking south showing the excavation of the Elevator Excavation Area in progress. The mortared masonry at left is interpreted as part of the foundation for the east wall of the original church built in 1767. Scales in feet and tenths of feet (Photographer: Joshua Butchko, March 2015) [HRI Neg. #15001/D6:133].

The **Elevator Excavation Area** was located immediately south of and adjacent to the location of the basement stairs at the east end of the Basement Excavation Area (Photograph 3.30). The soil profile was essentially the same as revealed in other nearby excavations. However, in the east profile, the modern subfloor accumulation [1] overlaid a 0.8-foot-thick layer of plaster and mortar mixed with schist and sandstone rubble [2]. This latter layer directly overlaid a substantial mortared stone foundation [3] running north to south along the east end of the excavation area (Figure 3.14). This remnant masonry feature comprised white mortar on boulders, smaller rocks and at least one partially dressed stone. The exposed portion of the foundation measured approximately 12 feet in length and was three feet wide and 1.4 feet thick. Along its eastern edge, a builders' trench [4] appeared to cut into the culturally sterile weathered shale [6] which is presumed to overlie solid bedrock. Along its western edge, two large stones had been dislodged by the contractor's excavations. However, traces of the robber trench [5] associated with the removal of the upper portion of the foundation were also observed, filled with mortar, plaster and rubble material similar to that identified in Trench 6 and the excavations for Pier Footings 1 and 15. This feature was generally encountered at a depth of between 3.65 and 3.95 feet and shared the same north-south alignment as the robber trench found in these other nearby excavations. On this basis, the masonry was interpreted as remnants of the foundation for the east wall of the original church built in 1767.

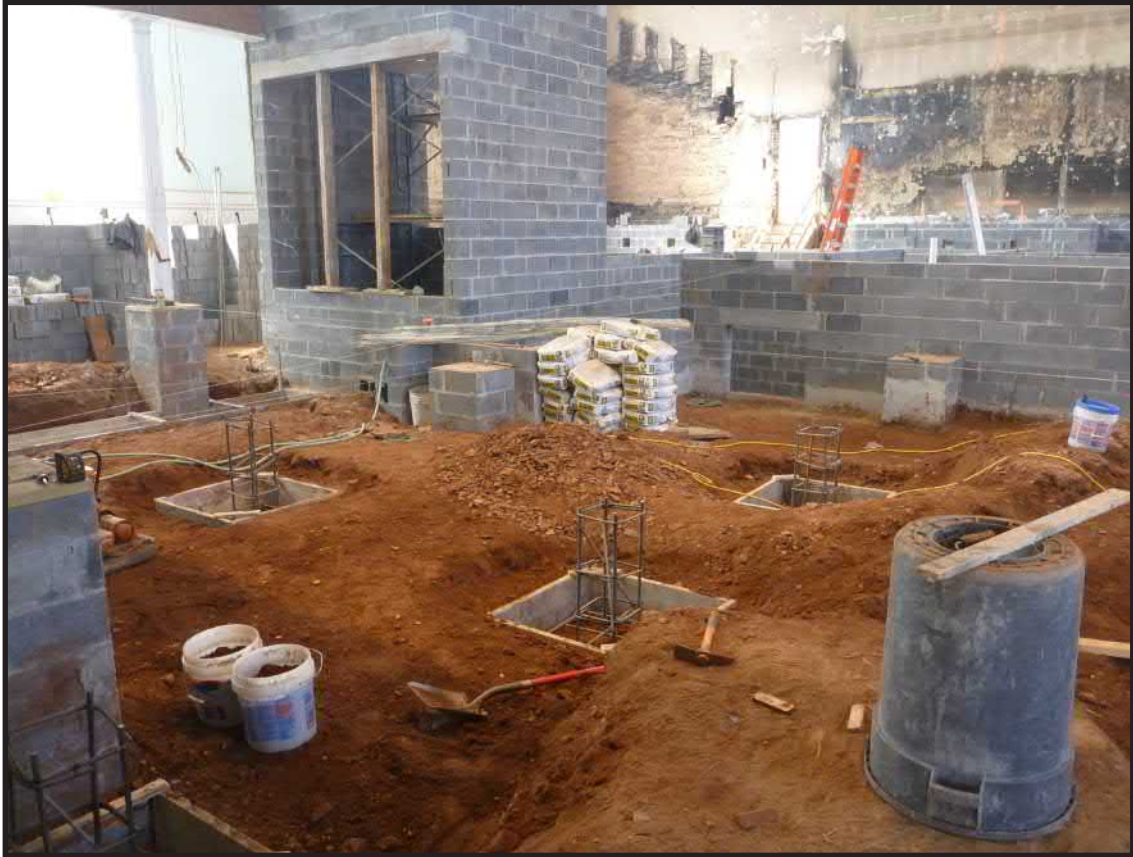
Photograph 3.31. View looking southwest showing the progress of interior construction following completion of most of the excavation monitoring (Photographer: Joshua Butchko, March 2015) [HRI Neg. #15001/D8:264].

Excavation Area was covered in construction fabric before new concrete was eventually poured atop it to facilitate the proposed new foundations at that location. By the time these excavations had concluded within the auditorium, many new foundations had already been built (Photograph 3.31).
