**ARCHAEOLOGICAL MONITORING
FIRST REFORMED CHURCH OF NEW BRUNSWICK
CITY OF NEW BRUNSWICK, MIDDLESEX COUNTY
NEW JERSEY**

AUGUST 2019

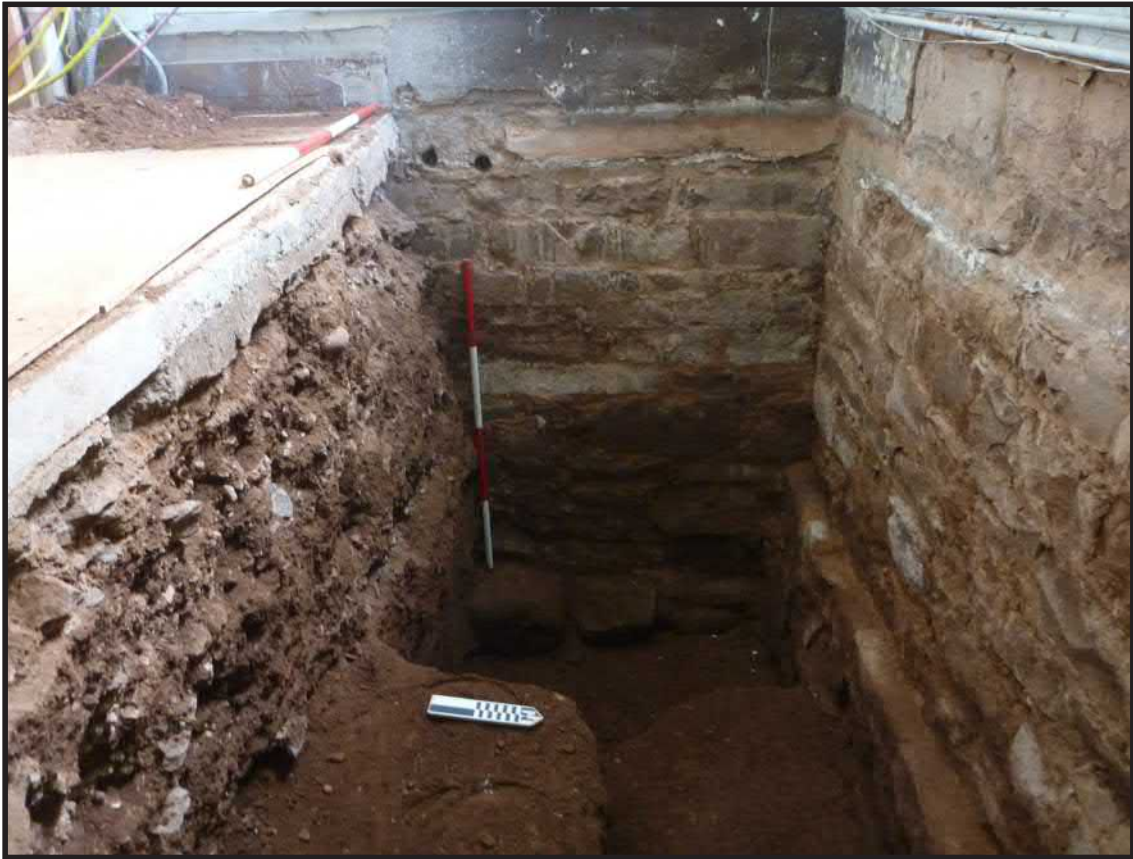
Photograph 3.32. View looking west showing the western end of the Utility Excavation Area in the church foyer. At right is the foundation for the north wall of the church with a stone offset near the base. In the center is the east face of the foundation for the interior wall separating the foyer from the auditorium. Scales in feet and tenths of feet (Photographer: Joshua Butchko, August 2015) [HRI Neg. #15004/D2:040].

The **Utility Excavation Area** consisted of an east-west trench excavated across the northern end of the interior of the church foyer. This trench, approximately 12 feet long, 4.5 feet wide and 8 feet deep, extended west from the northeast corner of the foyer along the interior face of the foundation for the church's north wall to the foyer's northwest corner. After drilling holes through the foundations at either end of this trench, utilities were installed from Trench 8, outside the church, across the foyer connecting to Trench 6 within the auditorium. Excavation commenced by penetrating a 0.5-foot-thick stone floor [1] set on a 0.4-foot-thick concrete sub-base [2] (Photograph 3.32). Beneath the concrete was a deep deposit of compact mottled clayey silt densely filled with shale fragments and cobbles [3]. This deposit, interpreted as historic upcast soils related to the construction of the present church, overlaid a clayey silt with weathered shale [4], a B-horizon subsoil, which extended to the full depth of the trench which reached approximately 8 feet at its western end. Exposure of the masonry foundations in this trench revealed that the foundation for the north wall of the church extended approximately two feet deeper than the foundation for the interior wall separating the foyer from the auditorium. The latter foundation appeared to abut the former, suggesting that the foundations for the outer shell of the church were constructed first and then the foundation for the interior wall separating the auditorium from the foyer was added afterwards.

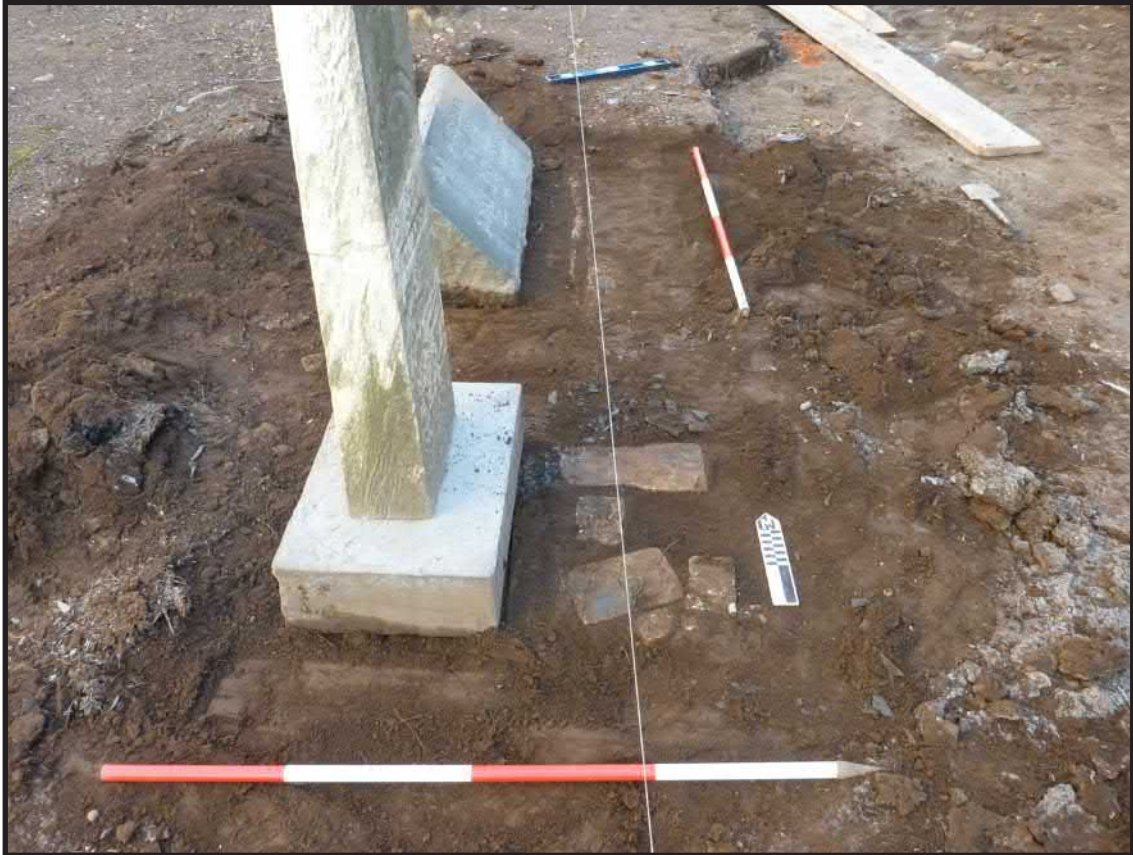
Photograph 4.1. View looking north showing the shallow excavations performed for the relocation of two burial markers west of the church. The grave markers are in their new locations in this view and originally stood two feet to the right. Note the in-situ marble fragments in the foreground used to stabilize the nearer of the two grave markers in its original position. Scales in feet and tenths of feet (Photographer: Joshua Butchko, March 2015) [HRI Neg. #15001/D8:017].

The archaeological monitor observed the relocation of two grave markers immediately west of the western edge of Excavation Unit 4. These two stones accounted for five members of the Clark-De Foreest family. It is likely that the two individuals on the marker at the northwest corner of the unit (Henry James Clark 1811-1855 and his wife Catharine De Foreest 1801-1876) were mother and father to the three children marked on the second stone immediately to the south (James Henry Clark deceased 1836, Sarah De Foreest born and deceased in 1842 and another Henry born and deceased in 1843). The plot where the burial disturbance was identified in nearby Excavation Unit 4 (see below) did not have a marker. The shallow excavation around these two extant markers allowed for them to be repositioned two feet further to the west and thus clear of the west wall of the new addition (Photograph 4.1). The original bases of both grave markers were exposed and ultimately left in place after the markers themselves were moved. During observation of this task, the archeological monitor observed several indications of fracture and subsequent repair on these markers, which suggests they had likely been moved previously.

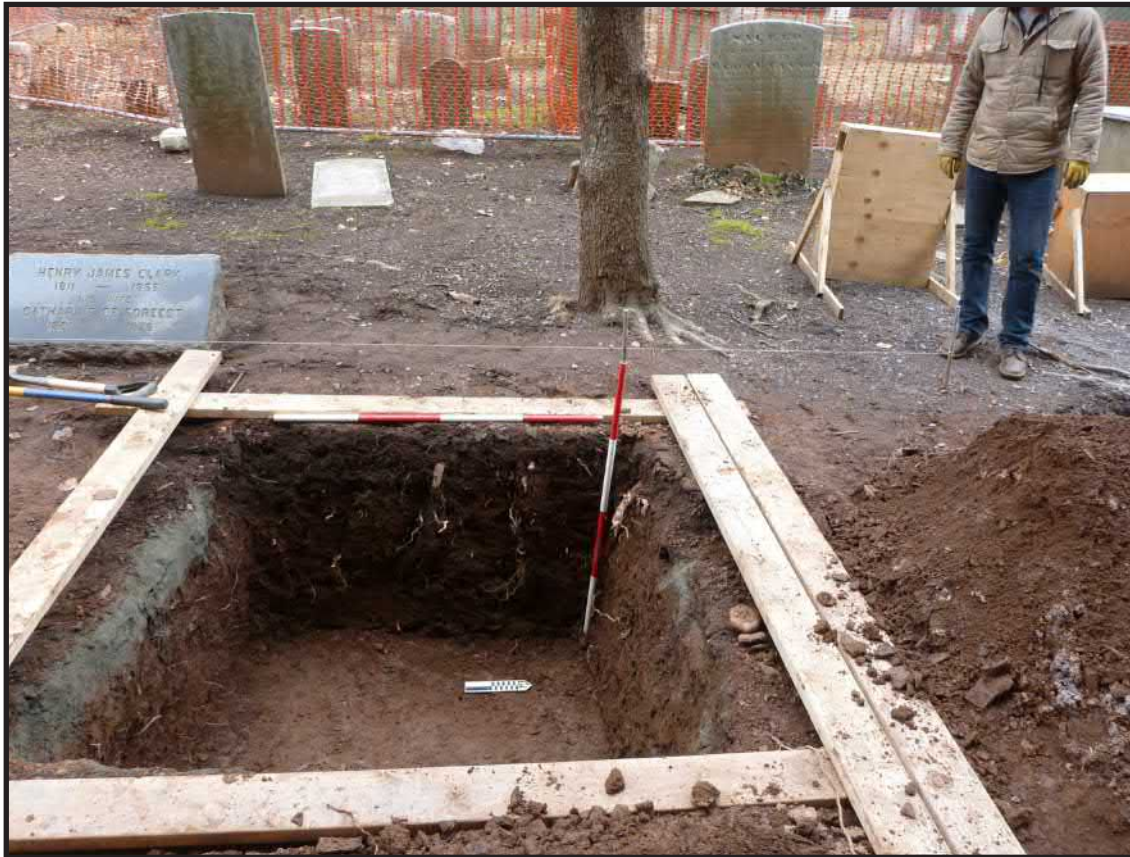
Photograph 4.2. View looking west showing Excavation Unit 3 Extension. Scales in feet and tenths of feet (Photographer: Joshua Butchko, March 2015) [HRI Neg. #15001/D8:150].

Excavation commenced at the then existing ground surface where a modern brick patio and walkway, documented in the earlier investigations, had just recently been removed by the contractor (Figure 4.2; Photograph 4.2). The uppermost soil layer consisted of a 0.4-foot-thick layer of clean compact gritty sand [1] which appeared to be the bedding material for the recently removed brick surface. A clay layer with fragments of weathered shale [3] was exposed at surface grade across much of the unit, but had been cut [2] for the installation of the brick patio at the western end. This deposit, which extended to 1.7 feet below the ground surface, was interpreted as an upcast C horizon. It overlaid a previously unidentified burial shaft [5] filled with clay [4]. The burial shaft cut into a layer of clay with shale fragments [6], interpreted as an undisturbed C-horizon subsoil. A fragment of probable human bone was identified at a depth of around a foot within the fill of the burial shaft [4] in the southeast corner of the excavation unit. These remains appeared displaced; they were not removed from the excavation when the monitor was assured by the contractor that he would be able to work around this location without further disturbance. Another probable human bone fragment was recovered from the spoil pile of this excavation, documented in the field, and then returned to the church for safe keeping. Excavation into the subsoil [6] terminated at 2.8 feet below grade.

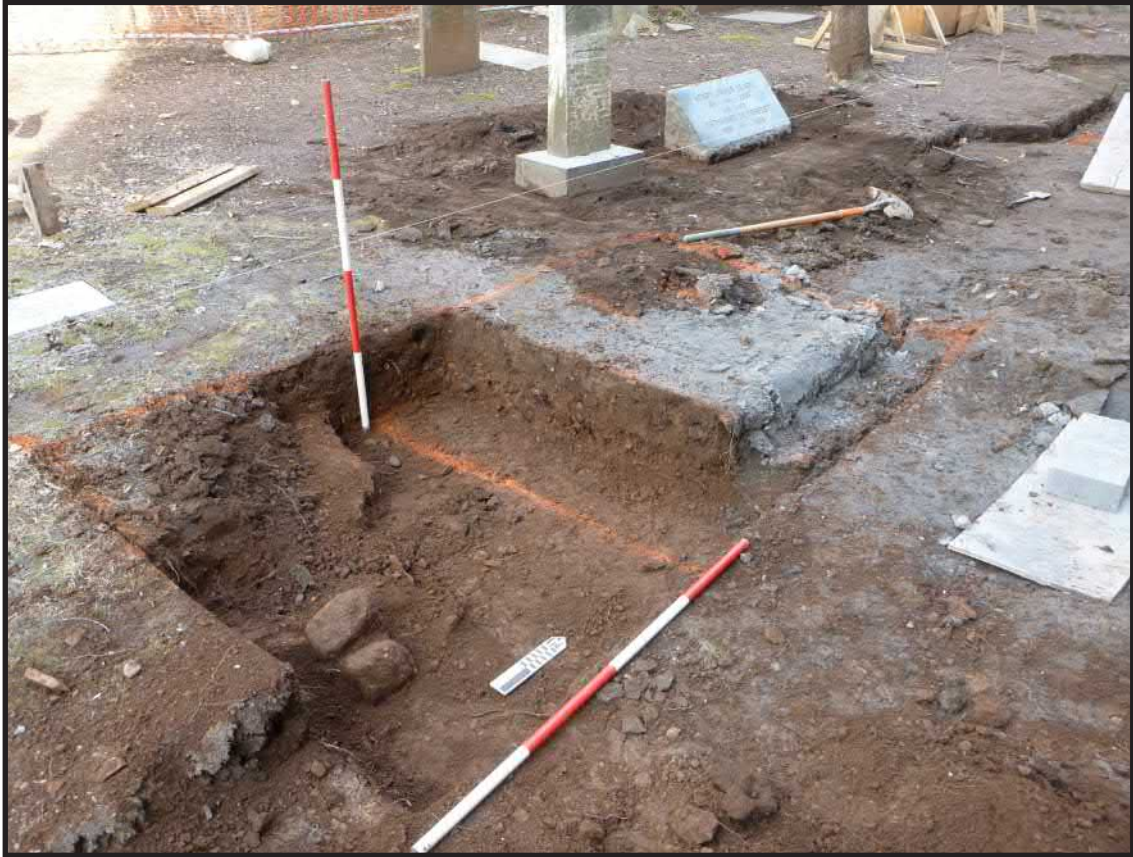
Photograph 4.3. View looking northwest showing Excavation Unit 4. The incorrectly located, partially excavated portion of the unit is in the foreground with its northern edge marked out with orange spray paint. The correctly located Excavation Unit 4, whose excavation is about to commence, extends north from the orange spray-painted line toward the shovel. The horizontal scale pole in the foreground lies on the line of the recently removed north-south brick pathway that ran west of the church. Scales in feet and tenths of feet (Photographer: Joshua Butchko, March 2015) [HRI Neg. #15001/D8:027].

Contractor excavations were resumed at the adjusted location further to the north (Photograph 4.3). During the removal of the uppermost 1.5 feet of soil, which was expected to be 20th-century fill, the archaeological monitor observed evidence of displaced human remains in the southwest corner of the unit. From this point onward, all further excavation was conducted by the archaeological monitor and additional Hunter Research staff to ensure appropriately controlled investigation and recovery of any human remains. The New Jersey Historic Preservation Office (NJHPO) was notified of the find and this agency requested that Hunter Research should continue excavation of the displaced human remains until it was determined whether or not the human remains were located *in situ*. Ultimately, the goal in these excavations was to identify a workable space, free of human remains, which could accommodate a new pier footing. In order to achieve this goal, archaeologists eventually re-excavated the southwest corner of the former Excavation Unit 2, previously investigated in 2013 (Hunter Research, Inc. 2013a).

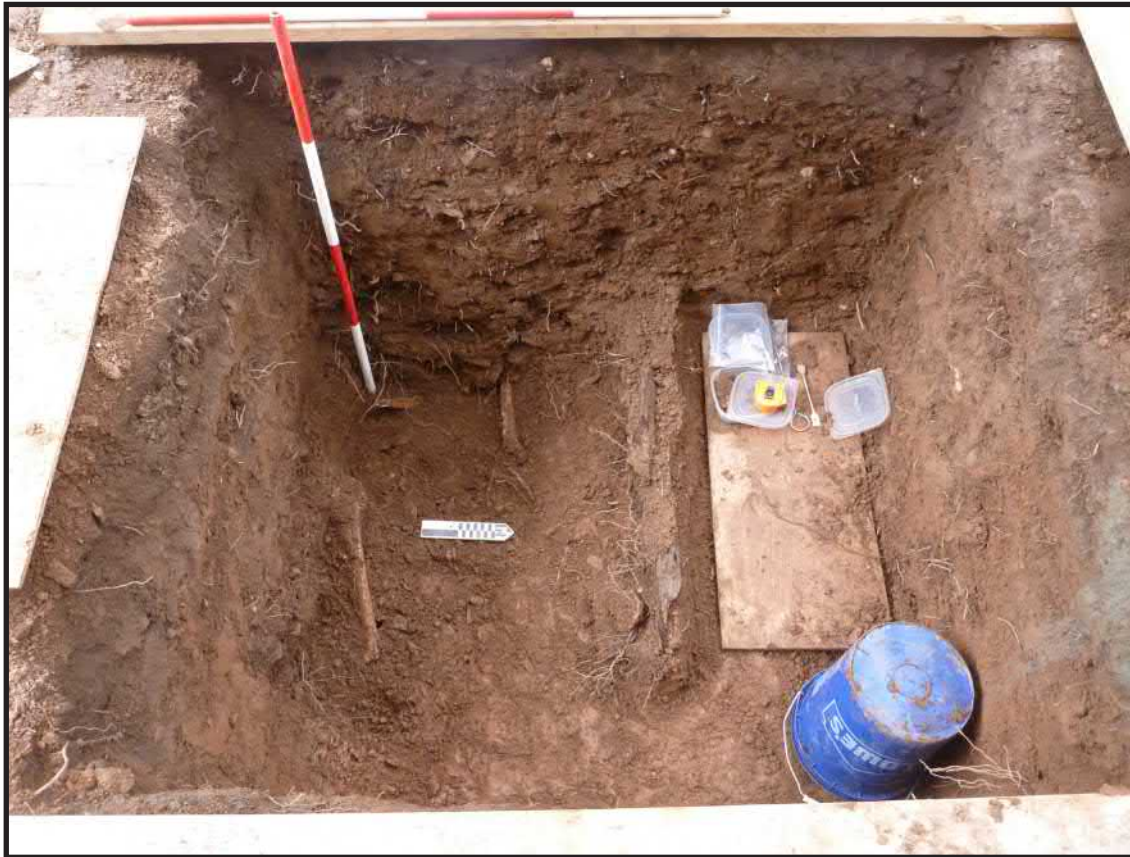
Photograph 4.4. View looking west showing historically disturbed burial feature in Excavation Unit 4. In the base of the excavation at left is an adult tibia freshly exposed. Scales in feet and tenths of feet (Photographer: Joshua Butchko, March 2015) [HRI Neg. #15001/D8:098].

As required by the archaeological monitoring protocol, specific to matters of human burials, and based on direction received from the NJHPO, excavation of the identified burial disturbance in Excavation Unit 4 was conducted by trained archaeologists and halted immediately as soon as *in-situ* human remains were recognized. Approximately 37 fragmentary displaced human remains (at 15 different locations and elevations) were identified within the burial disturbance layer [11, 12] in Excavation Unit 4. Examination of these remains indicated the presence of potentially two adults (based on the type and number of limb fragments) and perhaps one child (based on the recovery of one tooth). One of the two adults appeared to be partially *in situ* at 3.8 feet below grade in the southwest corner of the unit. Two probable explanations are offered concerning the burial disturbance. One is that the whole area was disturbed by construction-related excavation and grading when the present church was erected in 1811-12. Alternatively, while the burial plot where this disturbance occurred did not have a grave marker, it may have been part of a larger space set aside for interments of members of the Clark-De Foreest family. Since at least five family members are known to have been buried in this immediate vicinity, it is likely that this family plot saw significant soil turnover as new interments were introduced. Furthermore, it is possible that the 19th-century family members for whom there are markers may have been buried on top of or in amongst the remains of ancestral members of the family (or of the families of previous or nearby plot owners) who died in the later 18th century.

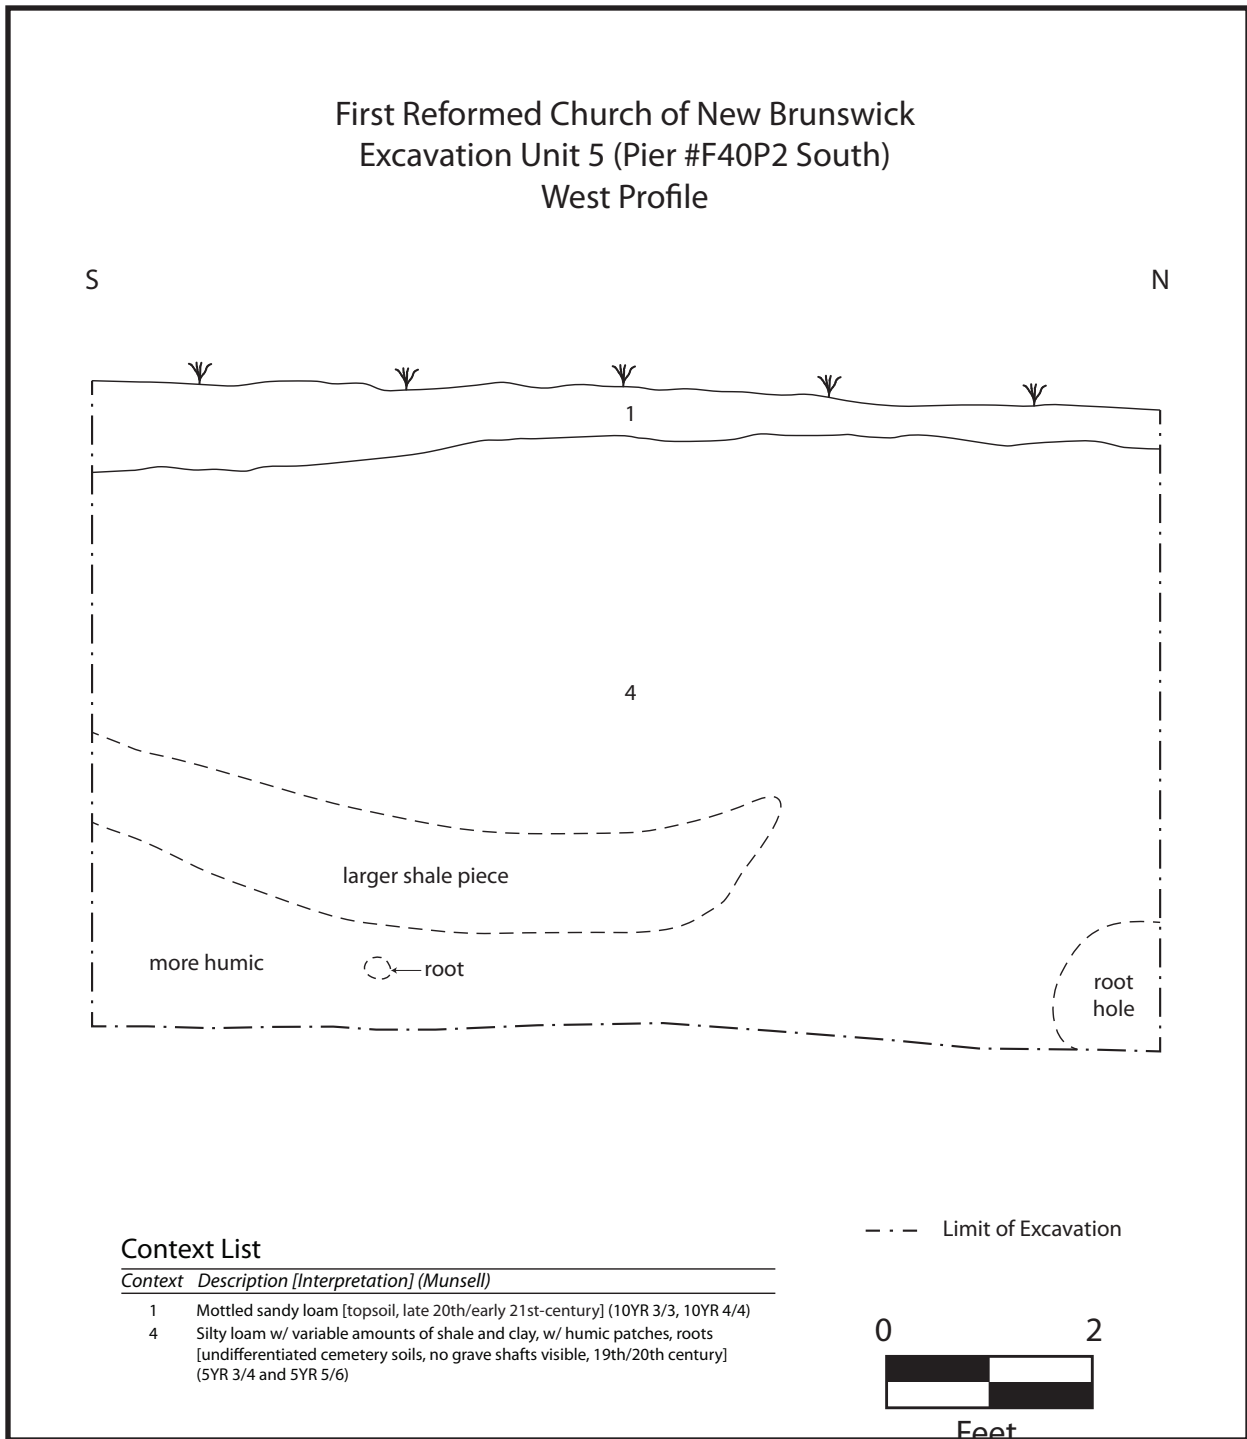
Figure 4.5. Churchyard, Excavation Unit 5, West Profile

Excavation Unit 5, five feet square in plan, was placed at the proposed location of Pier Footing F40, P2 South, per the engineers' plans. Excavation was completed by the contractor and observed by the archaeological monitor (Figure 4.5; Photograph 4.5).

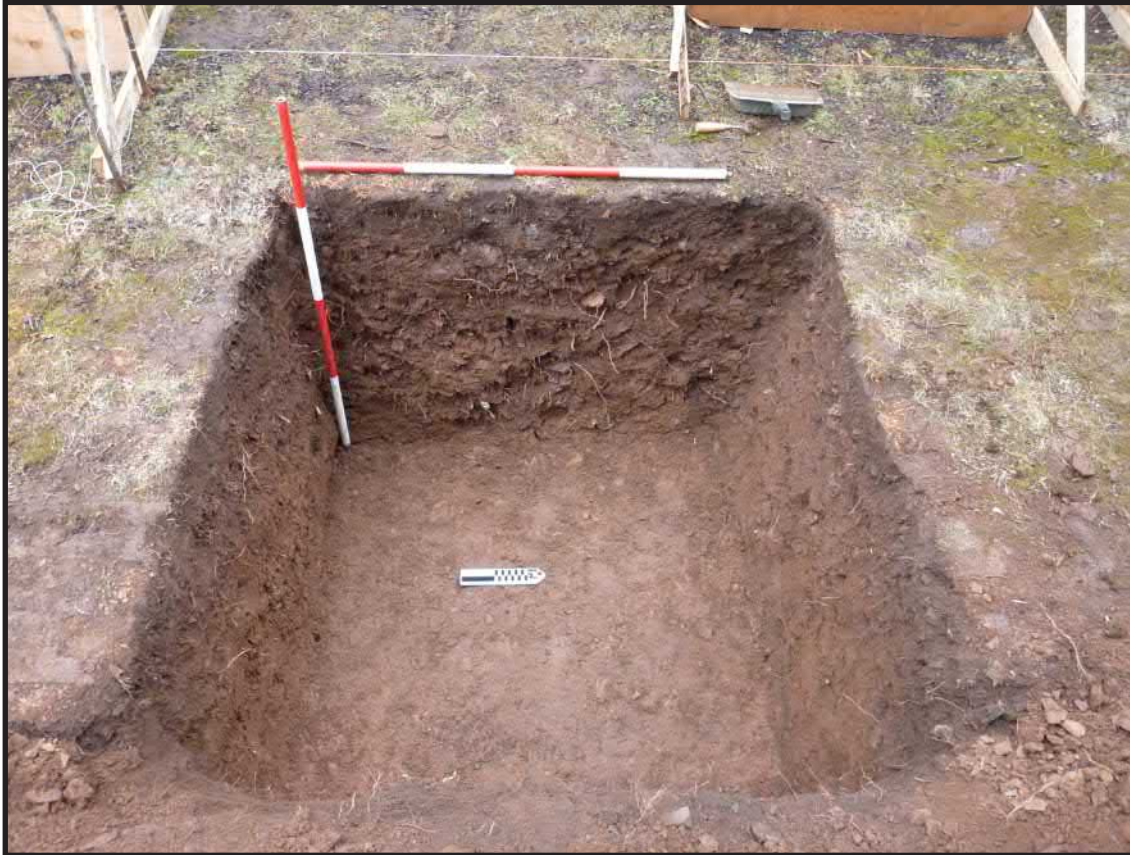
Photograph 4.5. View looking west showing Excavation Unit 5. Scales in feet and tenths of feet (Photographer: Joshua Butchko, March 2015) [HRI Neg. #15001/D8:050].

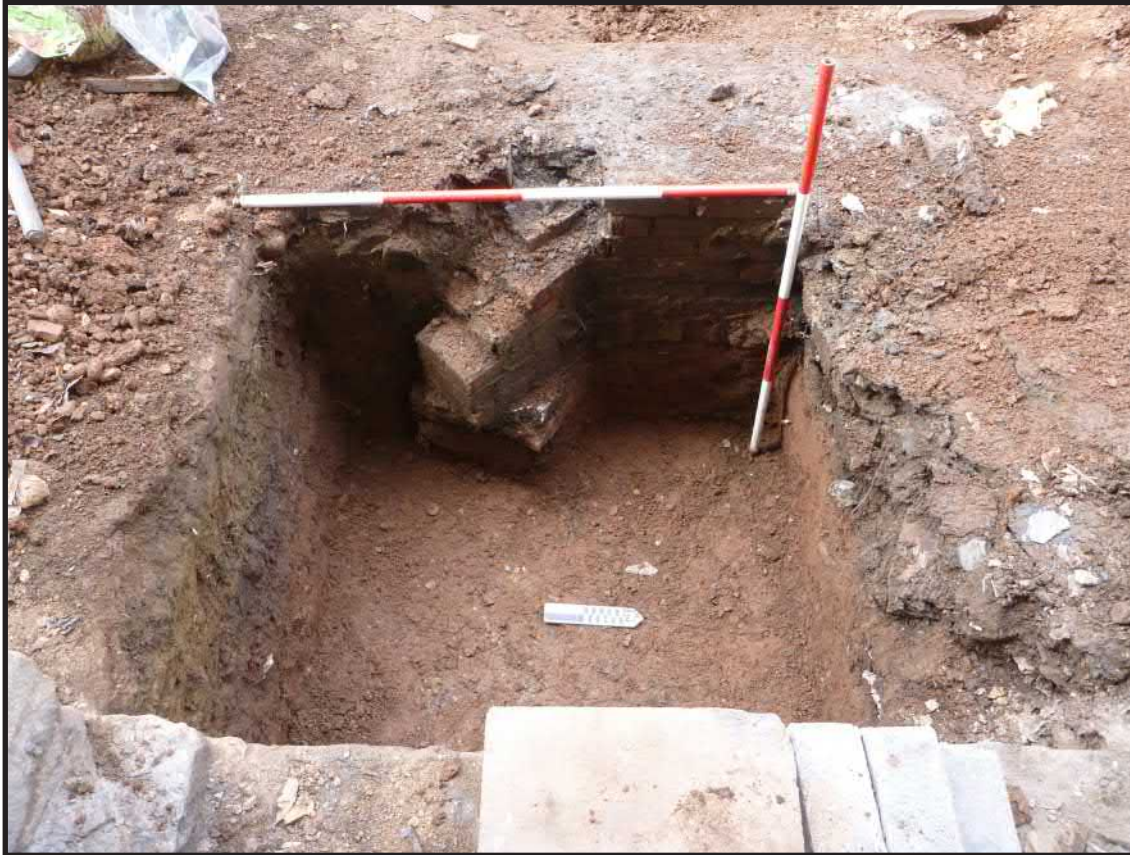
Photograph 4.6. View looking west from the rear doorway in the church's west wall showing Excavation Unit 7. The mortared brick porch footing is visible in the far wall of the excavation unit. Scales in feet and tenths of feet (Photographer: Joshua Butchko, March 2015) [HRI Neg. #15001/D8:177].

2013a). Excavation was completed by the contractor and observed by the archaeological monitor (Figure 4.6; Photograph 4.6).

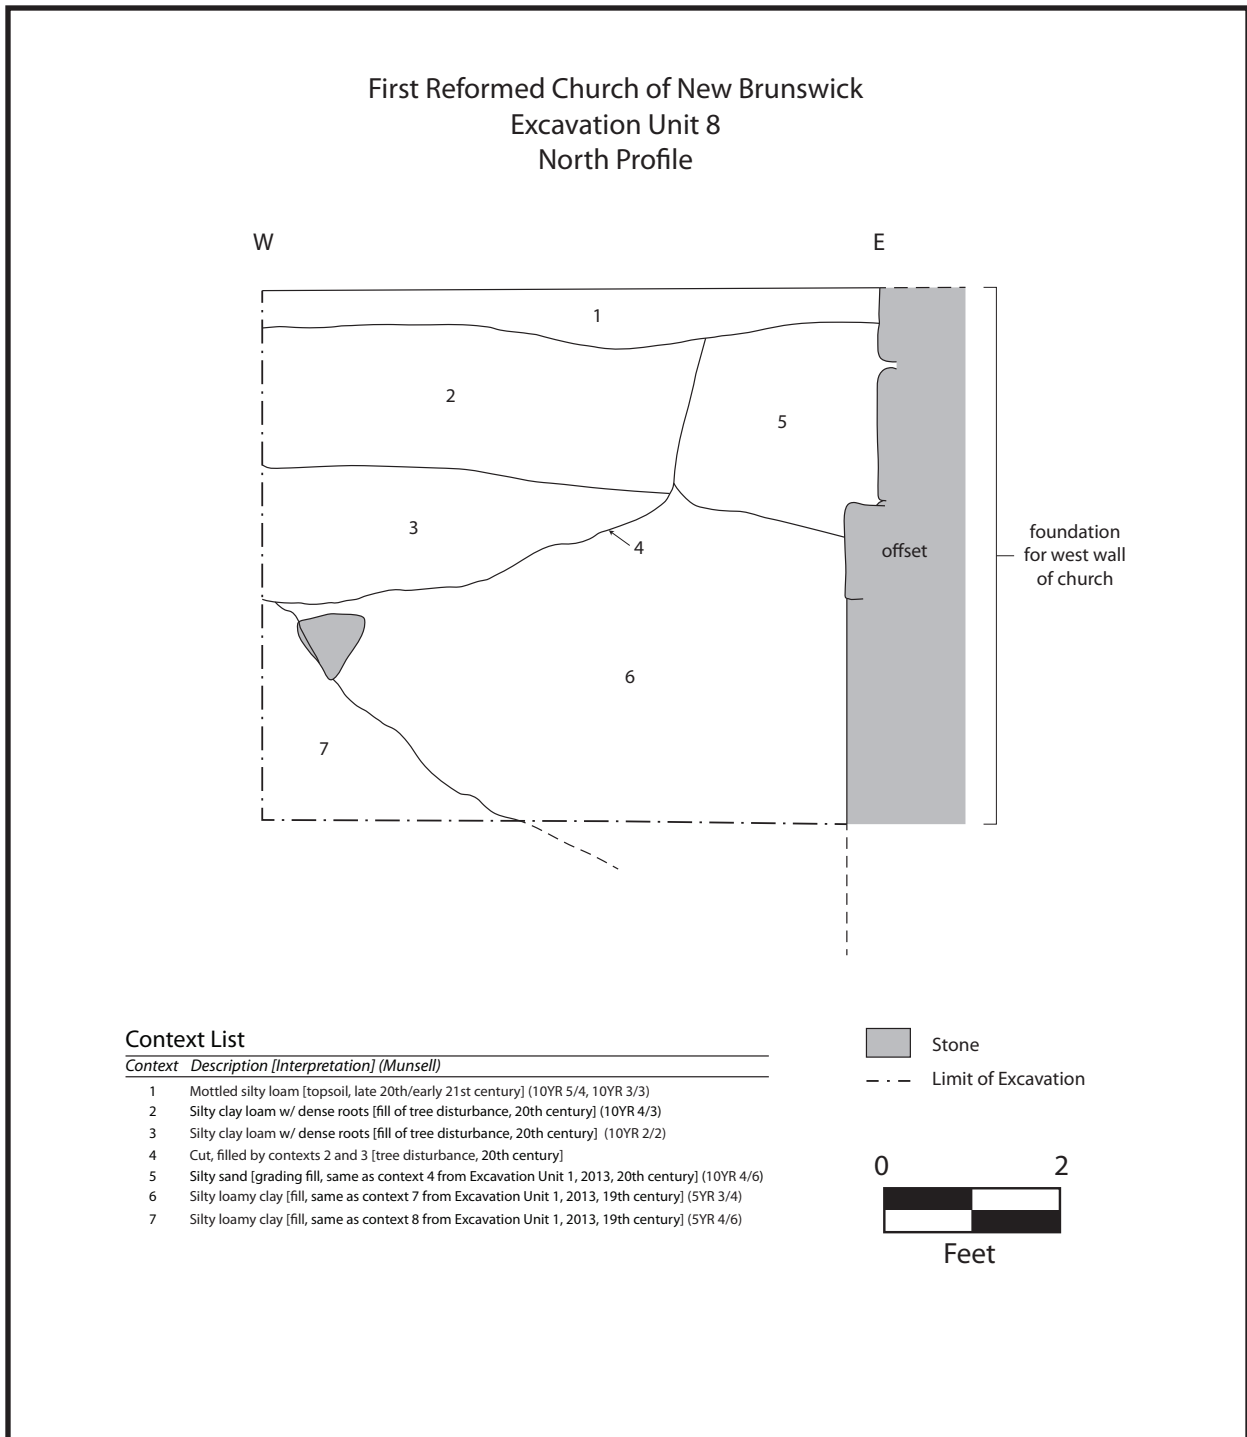
Figure 4.7. Churchyard, Excavation Unit 8, North Profile

Excavation Unit 8, 3.5 by 5 feet in plan, was placed at the proposed location of Pier Footing F30, P1 South, immediately adjacent to the west wall of the church. The unit's northern edge was located 1.5 feet south of the south side of Excavation 1, excavated in 2013 (Hunter Research, Inc. 2013a). The southern edge of Excavation Unit 8 was approximately 1.3 feet north of the southwest corner of the church. Excavation was completed by the contractor and observed by the archaeological monitor (Figure 4.7; Photograph 4.7).

A 0.2-foot-thick topsoil layer of mottled silty loam [1] covered the majority of the unit at modern grade. Much of the upper 1.5 feet of soils within the unit, particularly in the west half, were disturbed by a modern tree planting and its root system which spread throughout the southwest corner of the unit. The tree planting hole [4] was filled by silty clay loam deposits [2, 3] that contained a dense web of roots. The tree planting hole cut into a 1.1-foot-thick silty sand layer [5] associated with the late 19th-century grading deposit that raised the ground surface above the level of the church's west wall foundation offset (the same deposit was identified as Context 4 in Excavation Unit 1 in 2013). In the eastern half of the unit, Context 5 overlaid a silty loamy clay [6] interpreted as fill, again relating to the late 19th-century grading around the foundation of the church's west wall (the same deposit was identified as Context 7 in Excavation Unit 1 in 2013). Excavation of the unit was terminated within a silty loamy clay [7], which was encountered at 1.4 feet below grade. Context 7 was interpreted as an upcast fill layer from construction of the church in 1811-12 and was previously identified as Context 8 in Excavation Unit 1 in 2013. Excavation Unit 8 was concluded at approximately three feet below modern grade, the necessary depth of excavation for the new construction.

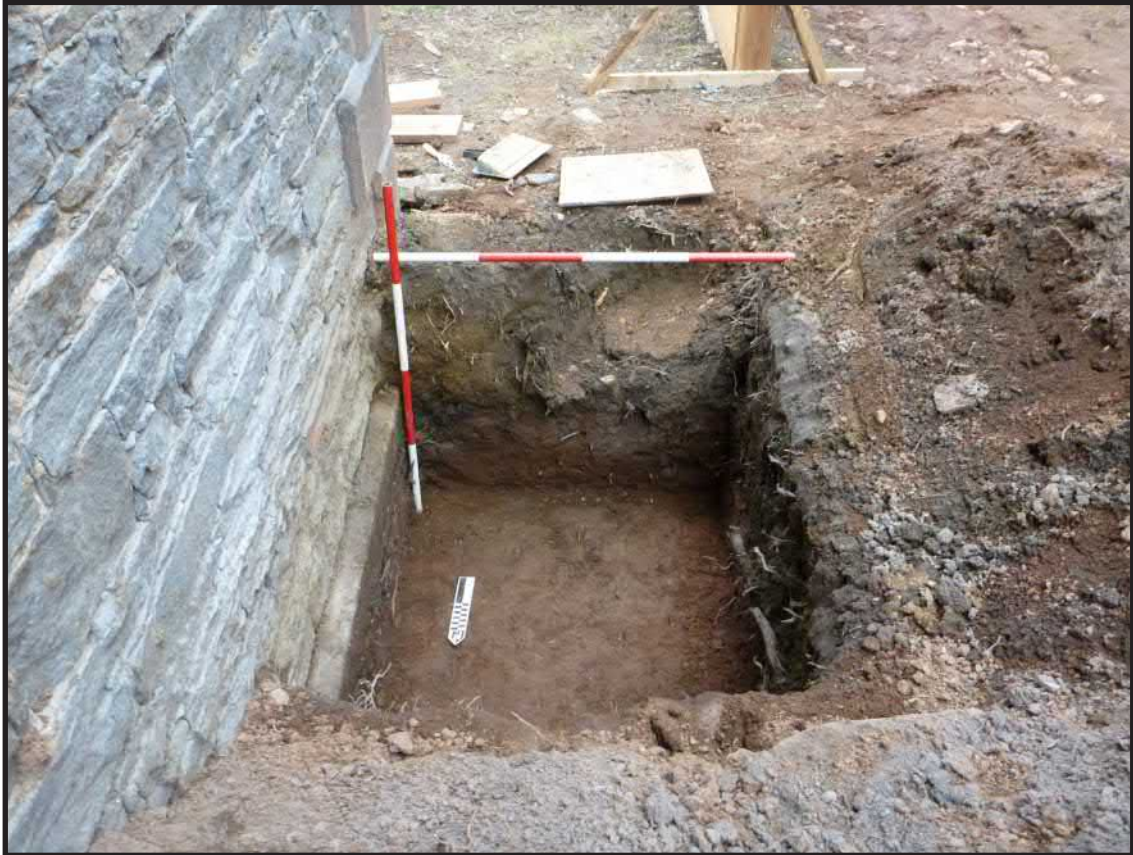
Photograph 4.7. View looking south showing Excavation Unit 8. Scales in feet and tenths of feet (Photographer: Joshua Butchko, March 2015) [HRI Neg. #15001/D8:128].

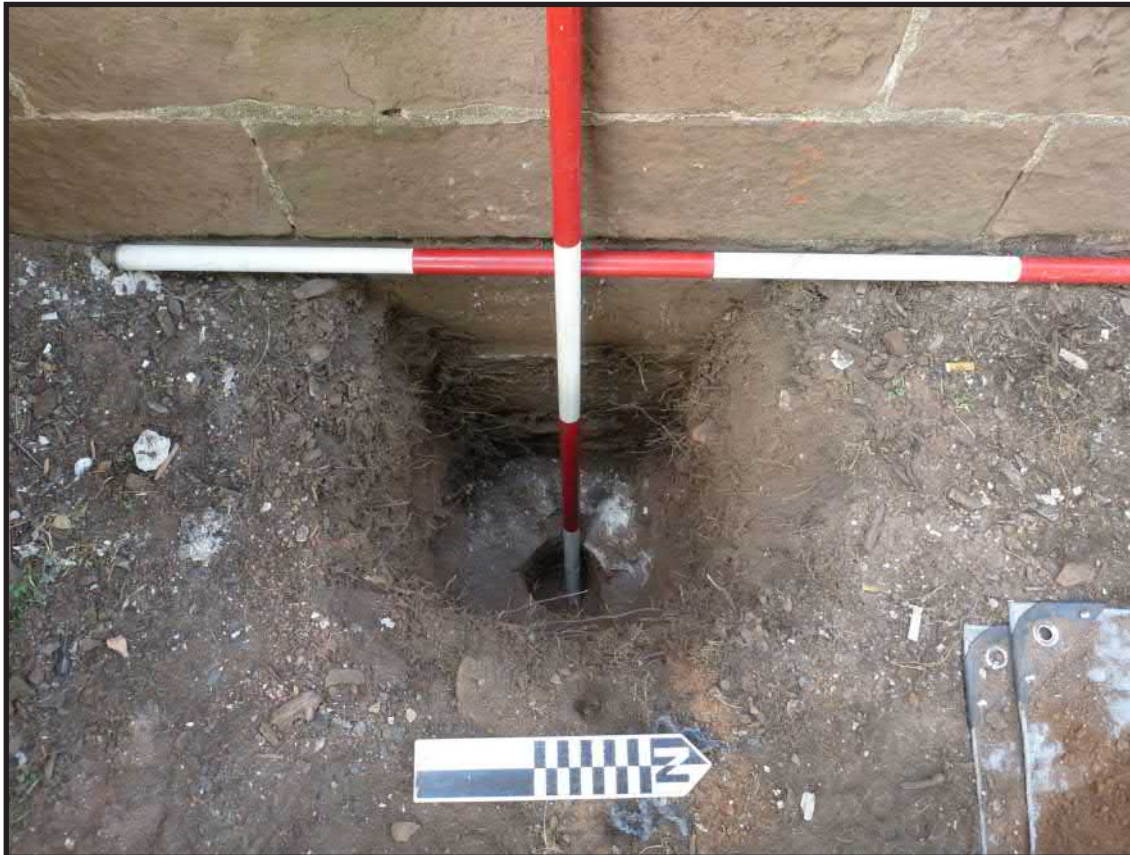
Photograph 4.8. View looking west showing Shovel Test 1 placed alongside the east wall of the church exterior. The mortar deposit at the bottom of the shovel test is a construction deposit associated with the building of the church in 1811-12. Scales in feet and tenths of feet (Photographer: Joshua Butchko, August 2015) [HRI Neg. #15004/D1:018].

church, documented the footings for the porch structure that protected this entry. Shovel Test 1, placed against the northeast corner of the building, at the northern end of the east wall, found evidence of a construction deposit, chiefly composed of mortar, relating to the erection of the 1811-12 church.

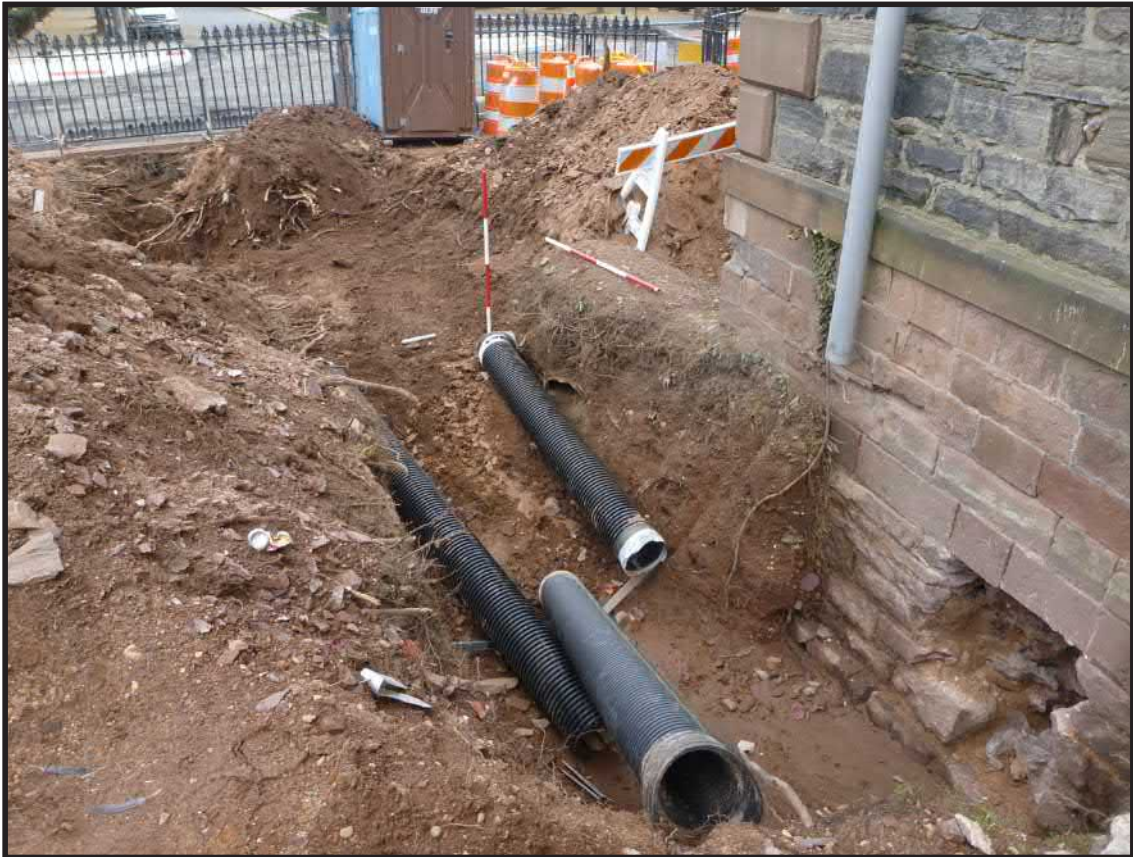
Photograph 4.9. View looking east showing Trench 8 fully excavated and awaiting installation of utilities. Scales in feet (Photographer: Joshua Butchko, October 2015) [HRI Neg. #15004/D4:059].

Trench 8 was excavated across the narrow east lawn of the churchyard to facilitate installation of a new utility line extending from the northeastern edge of the church and connecting to existing utilities running under Neilson Street (Figure 4.8; Photograph 4.9). The trench, which commenced 12 feet west of the church's northeast corner, was approximately 40 feet long. Alongside the church's north wall, the trench was approximately 5.5 feet wide. It then widened to approximately ten feet moving east of the church (where a large tree stump was also removed) and terminated along the eastern edge of the church property close to the perimeter wall.

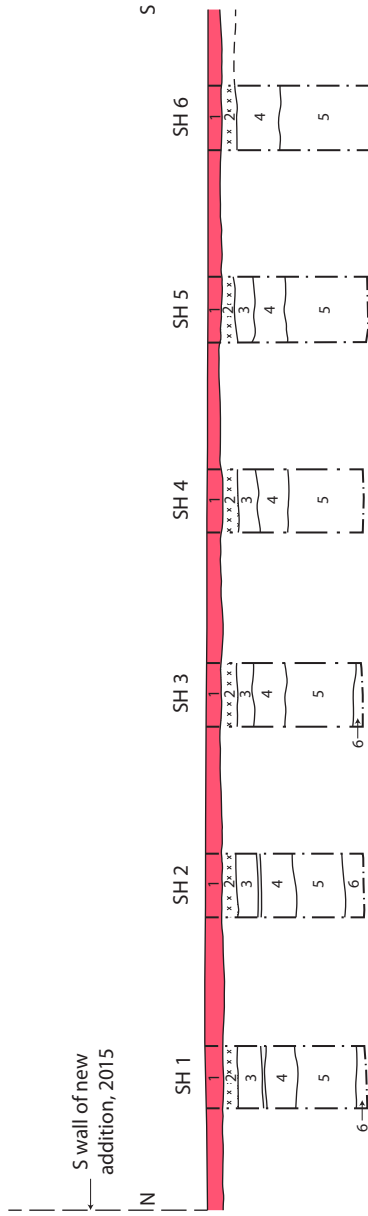
First Reformed Church of New Brunswick
 Sonotube Holes 1-6 (ADA Ramp)
 East Profile

Figure 4.9. Churchyard, Sonotube Pits 1-6, East Profile

On October 15, 2015, the archaeological monitor observed the contractor's excavations for laying the footings for a proposed American Disabilities Act (ADA) ramp that would extend north-south and provide access to the rear entrance of the church. These excavations, circular pits for sonotubes (referenced here as Sonotube Holes 1-6), were generally spaced four feet apart, 1.5 feet in diameter and terminated 3.4 feet below grade (Figure 4.9; Photograph 4.10). The profiles observed in these excavation pits were consistent throughout beginning with the modern brick walkway and underlying concrete base [1, 2], together 0.6 feet in thickness. These features overlaid a 0.6-foot-thick layer of mottled gravel [3], interpreted as historic fill, which, in the case of Sonotube Holes 1 and 2, yielded a limited quantity of historic artifacts. This deposit overlaid a 0.7-foot-thick layer of culturally sterile sandy silt [4], interpreted as a probable B-horizon subsoil. This layer typically overlaid a more compact sandy silt with dense weathered shale [5] at a depth of around 1.8 feet below the ground surface. The latter layer was interpreted as a C-horizon subsoil and generally extended to the full depth of excavation at 3.4 feet below the ground surface. No burial shafts or other historic features were observed during the monitoring of the excavations of the sonotube pits.

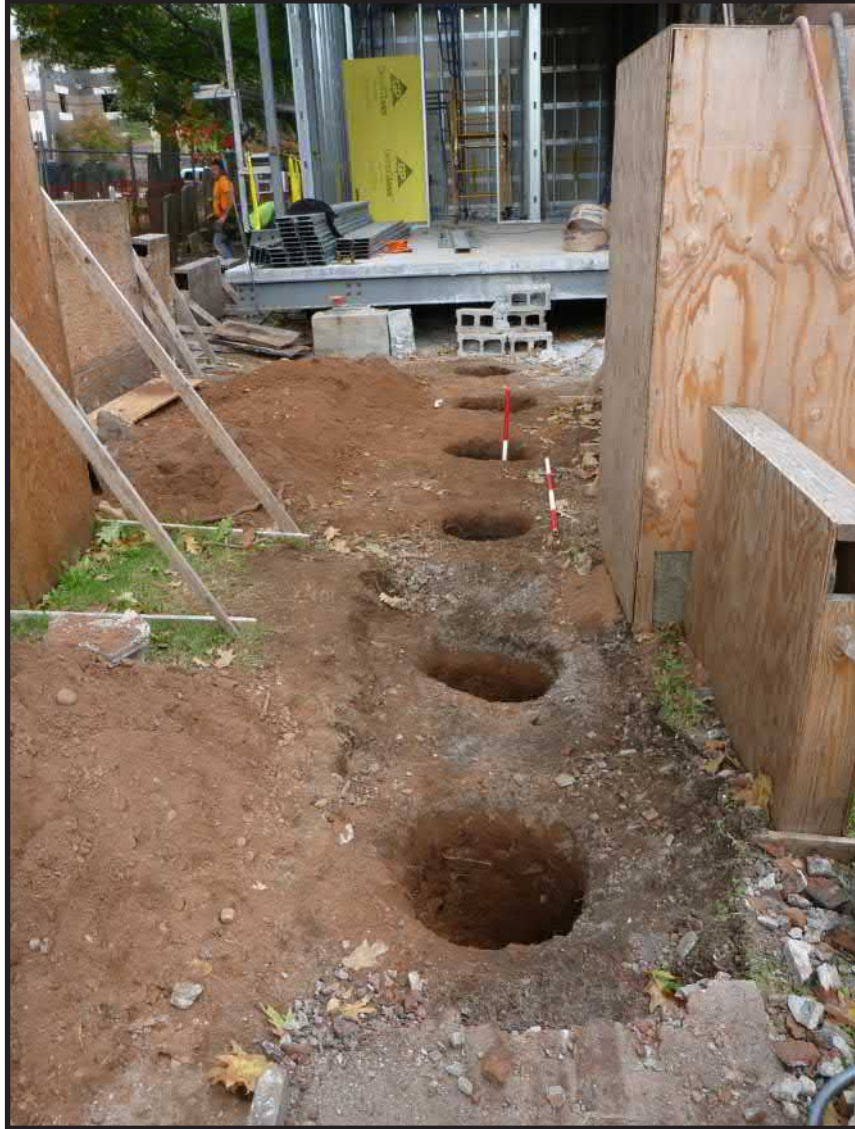
Photograph 4.10. View looking north showing Sonotube Pits 1-6 which were excavated for the footings of an ADA-compliant ramp providing access into the rear of the church. Scales in feet (Photographer: Joshua Butchko, October 2015) [HRI Neg. #15004/D4:073].
