**ARCHAEOLOGICAL MONITORING
FIRST REFORMED CHURCH OF NEW BRUNSWICK
CITY OF NEW BRUNSWICK, MIDDLESEX COUNTY
NEW JERSEY**

AUGUST 2019

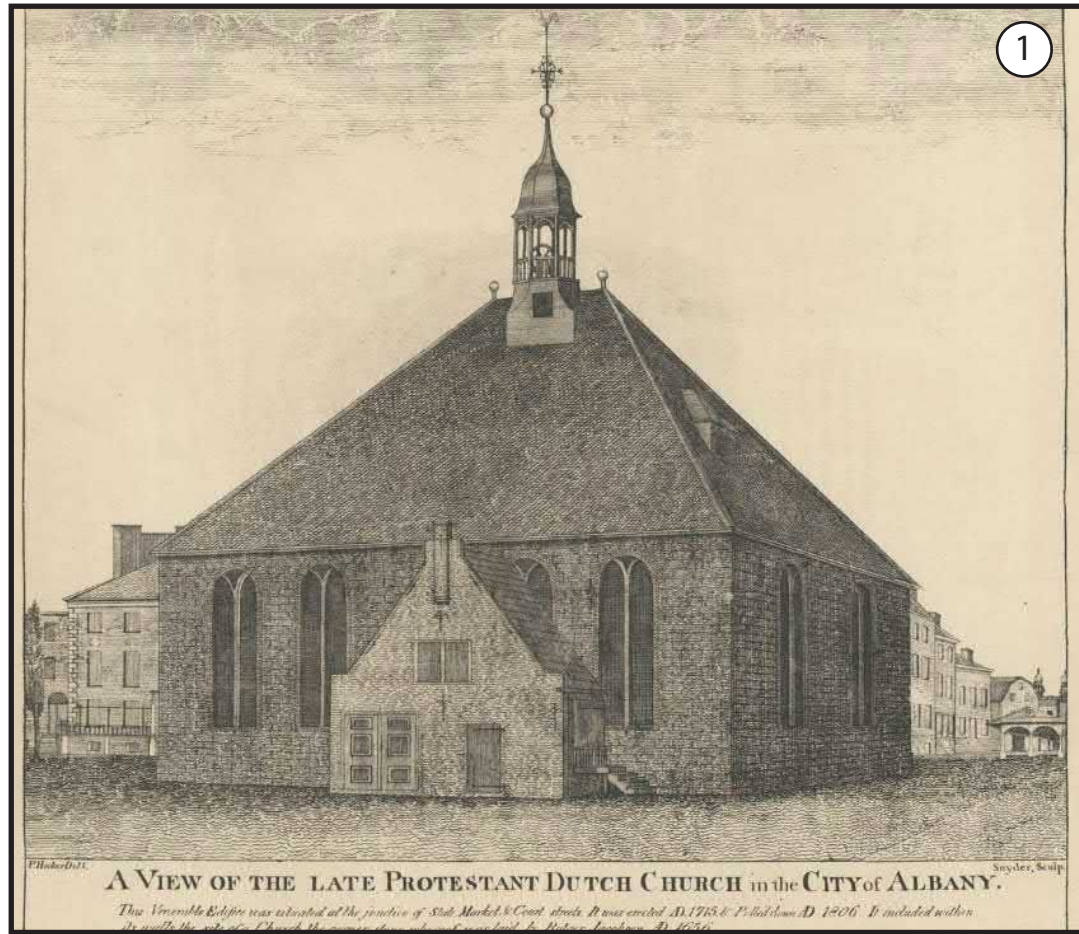
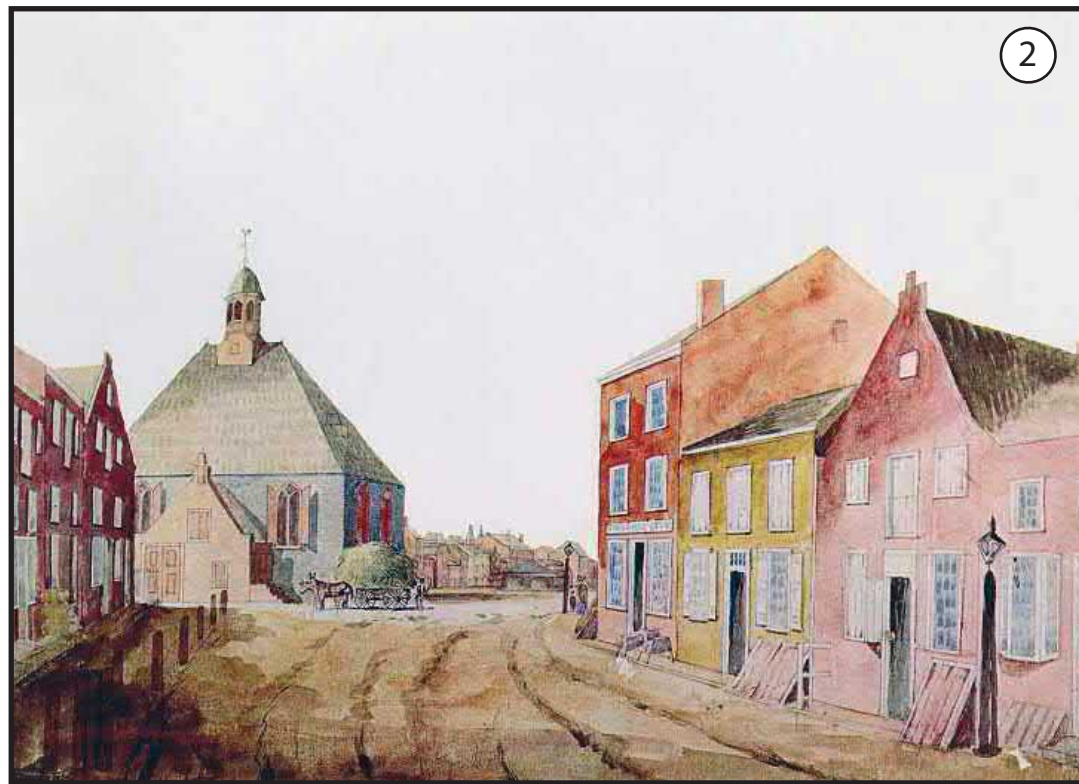
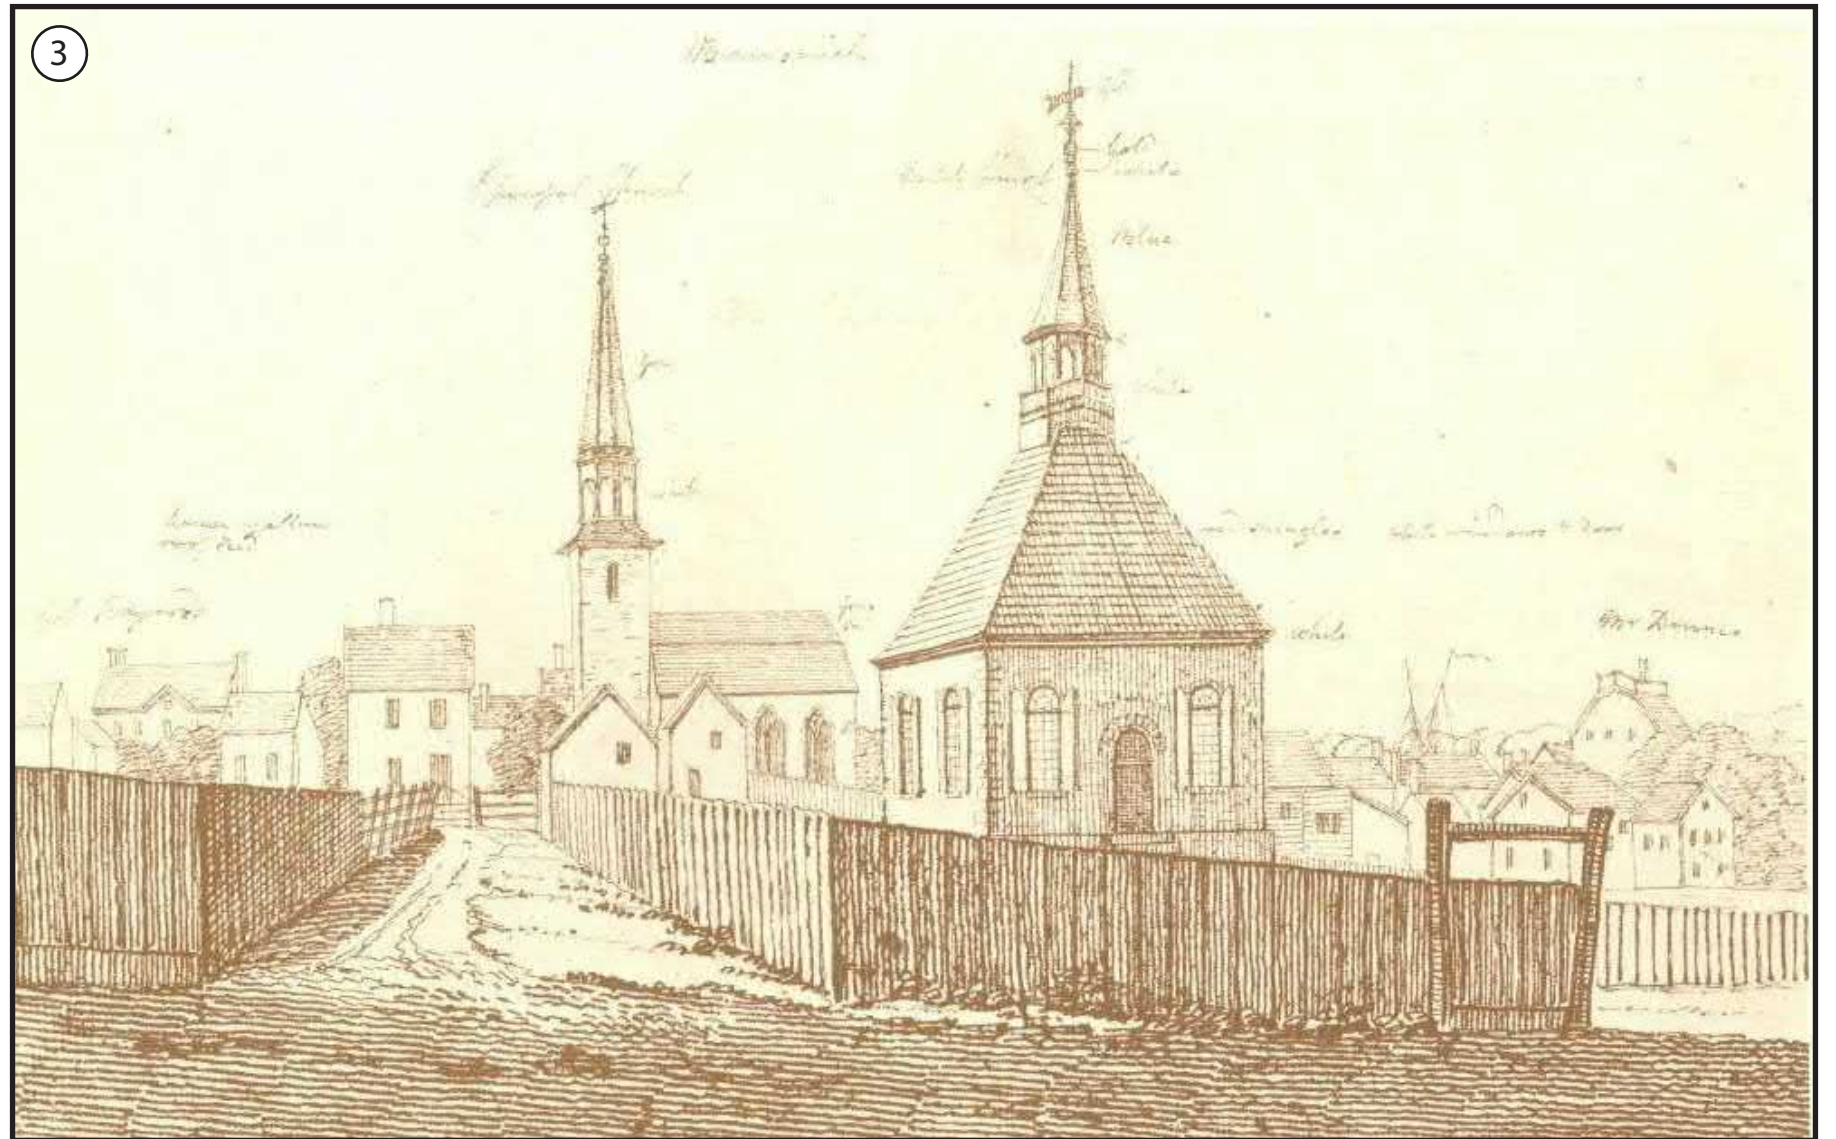
Figure 5.1. The 1767 Church and Some Broad Parallels. 1. First Dutch Reformed Church, Albany, New York. 2. First Dutch Reformed Church, Broadway, New York City. 3. Artist's Rendering of the First Dutch Reformed Church, circa 1790.

On the assumption that the western and southern walls of the 1811-12 church did indeed reuse portions of the foundations of the earlier church, the exterior dimensions of the earlier church of 1767 would have been approximately 50 feet east-west by 60 feet north-south with a foundation width of around three feet. Although not quite square in plan, as is perhaps implied by the view of the church *circa* 1790 (see above, Figure 2.1), it is reasonable to suppose that the general appearance of the building could have resembled this rendering, which shows a building with a hipped roof and central spire not unlike the earlier 18th-century Dutch Reformed churches that were erected in Albany and at the corner of State Street and Broadway in New York City (Figure 5.1). Unfortunately, owing to the limitations of the archaeological evidence and without a clearer attribution for the *circa* 1790s artist’s rendering, it is difficult to go beyond drawing broad
